Design Report

1 Ha’atafu and Kanokupolu Coastline

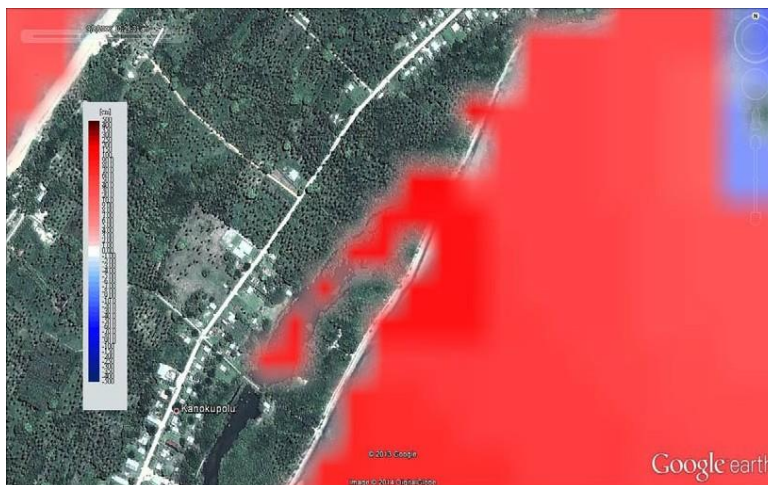
Figure 2-1. Close up of impact of a tsunami wave generated from an 8.7 magnitude earthquake at the Tonga Trench, showing two breaches of the coral foreshore (Geocare and Petroleum Consult, 2014).

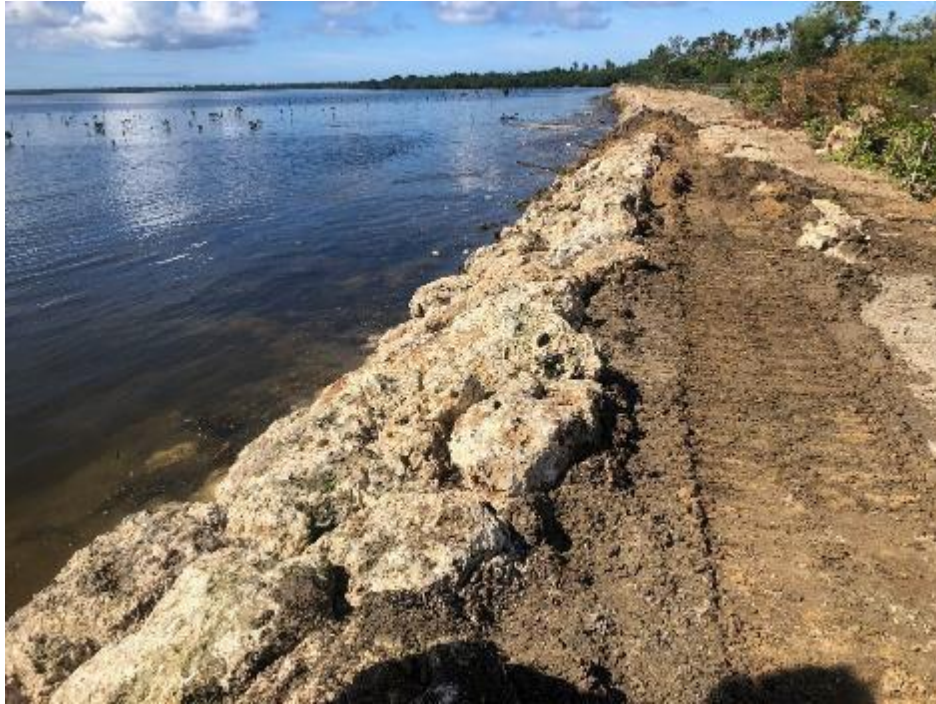
Pre-tsunami

Figure 2-2. The revetment that extends from Ha'atafu to 'Ahau and encloses 2 distinct areas, Kanokupolu wetland in the north, and 'Ahau lagoon in the south. Originally built in the late 1960's, repairs and modifications were carried out in 2014 and 2018; but there are still several areas that require heightening and reinforcing, and the non-return valves along the Kanokupolu section require maintenance.

Repairs to non-return valves on culverts (x2) are also required. Based on observations in 2018 and recent discussions, this is mostly a matter of removing rock and debris that has accumulated against the one-way valves and prevented proper function. Therefore, it is likely that while the revetment is being repaired, these works could also be undertaken with little extra cost.

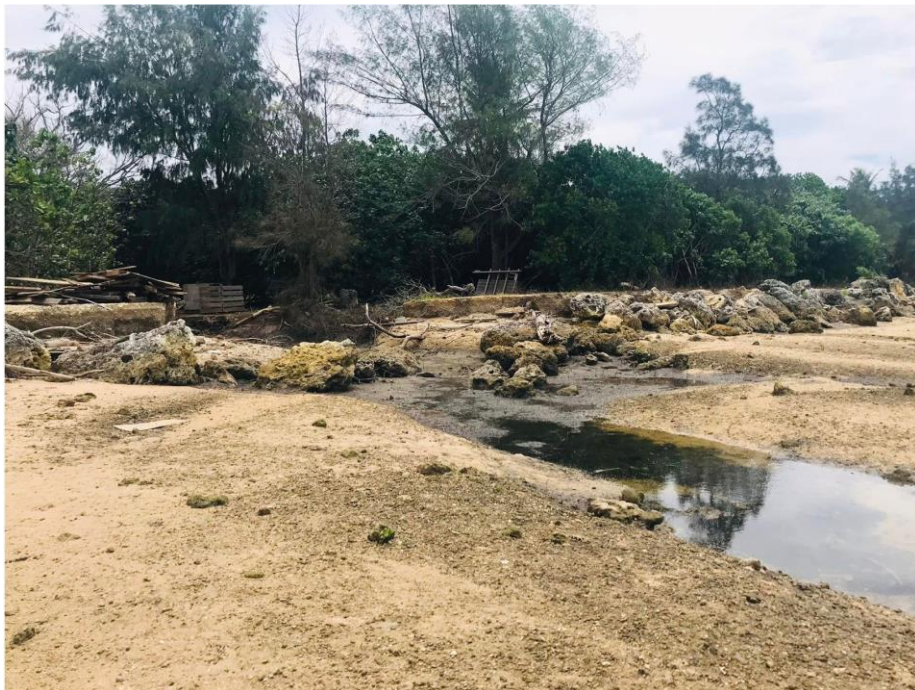
Post-tsunami

Figure 2-3. One of the blowouts through the coastal track and revetment

The same is the case following the 15th of January tsunami, that is, much of the rock of the revetment is still on the foreshore. This material can be reused. In addition, 1,350 m³ of 400-

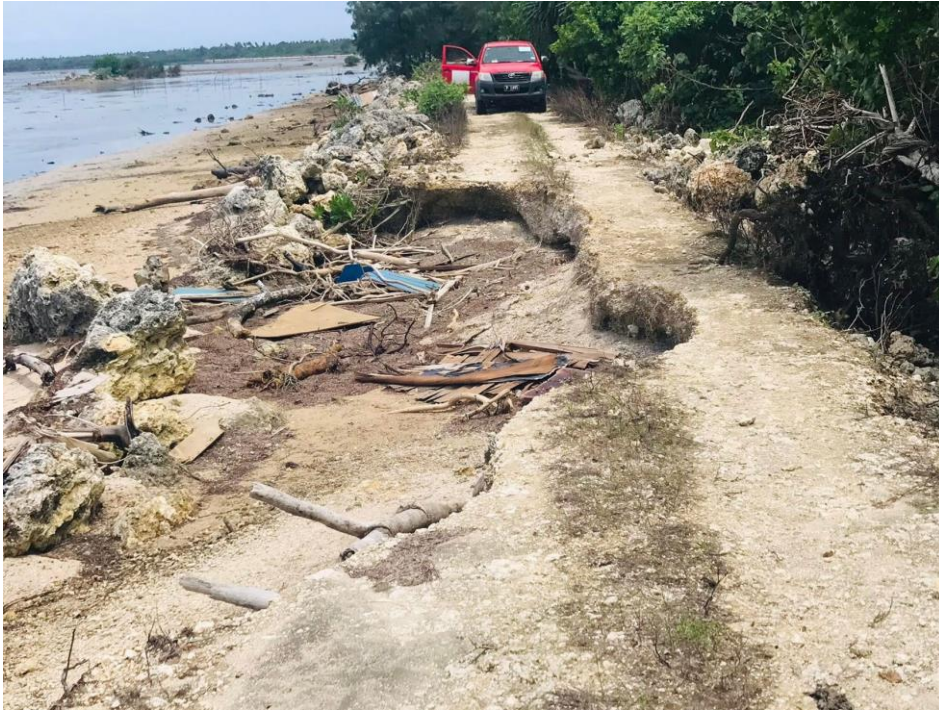
Post-tsunami

Figure 2-4. Damage revetment and coastal track

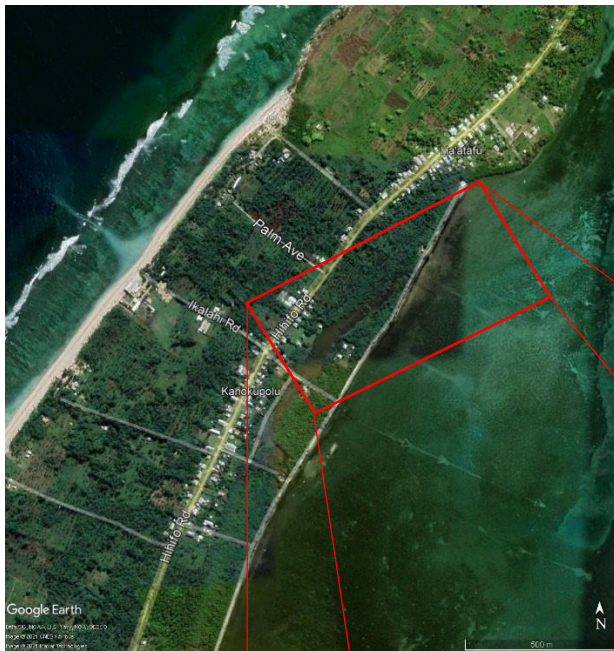
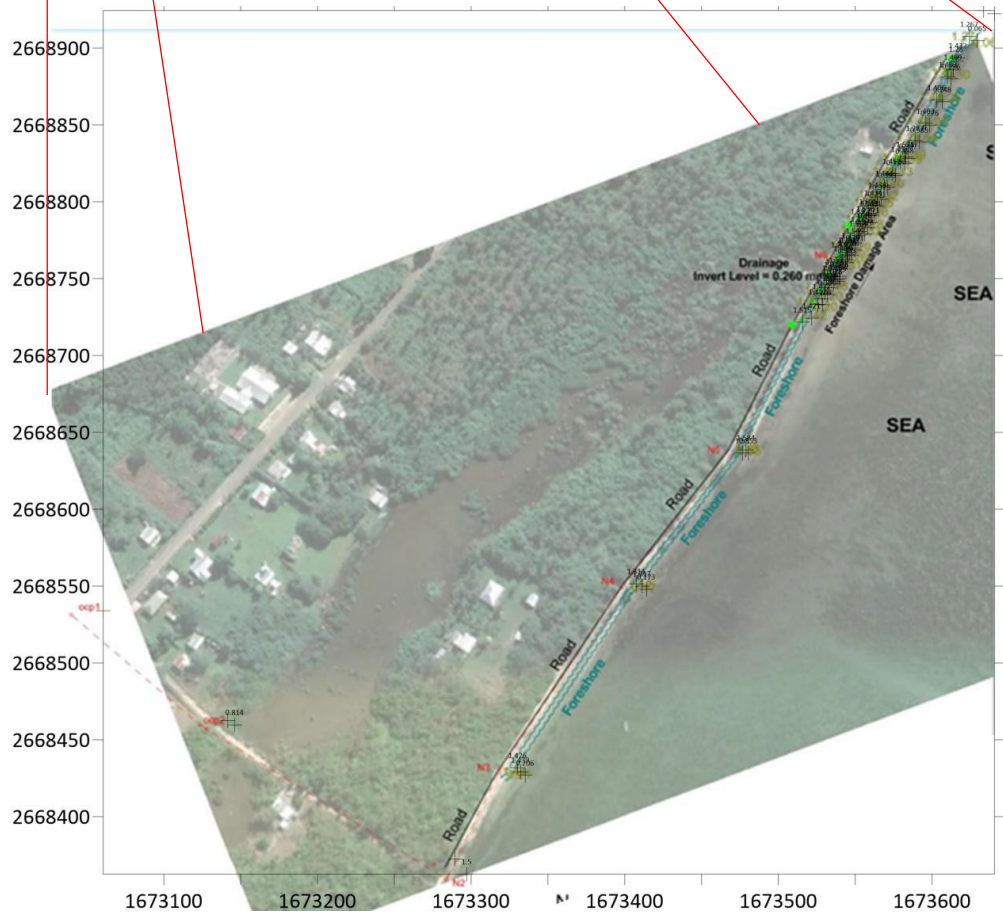
Figure 2-5. The ground survey focused on the lower and damaged northern 600 m section of the revetment. Most of the heightening is required along the northern 200 m of the revetment, with repairs all along this section.

The initial ground survey of the northern Kanokupolu revetment indicated that revetment crest height was as low as 1.2 m (MSL) in some areas, and mostly below 1.4 m along the damaged areas (Figure 2-5 and Figure 2-6). The northern 600 m length required repair works to lift the crest to 1.5-1.6 m, as well as focussed areas of rock placement where there is little to no rock protecting the road. The initial estimate of rock required for this area was 2 m³/linear metre of revetment along the length of revetment. Based on the results of the ground survey and the accompanying photographs, ~300 m³ of rock to carry out the repairs and heightening of this section of the revetment was considered sufficient; most parts required <1 m³ to heighten the revetment, while some areas just north of the drainage channel (Figure 2-5) require more rock. However, even where the damage was extensive (Figure 2-6), the original rock is still on site and only requires moving back onto the revetment.

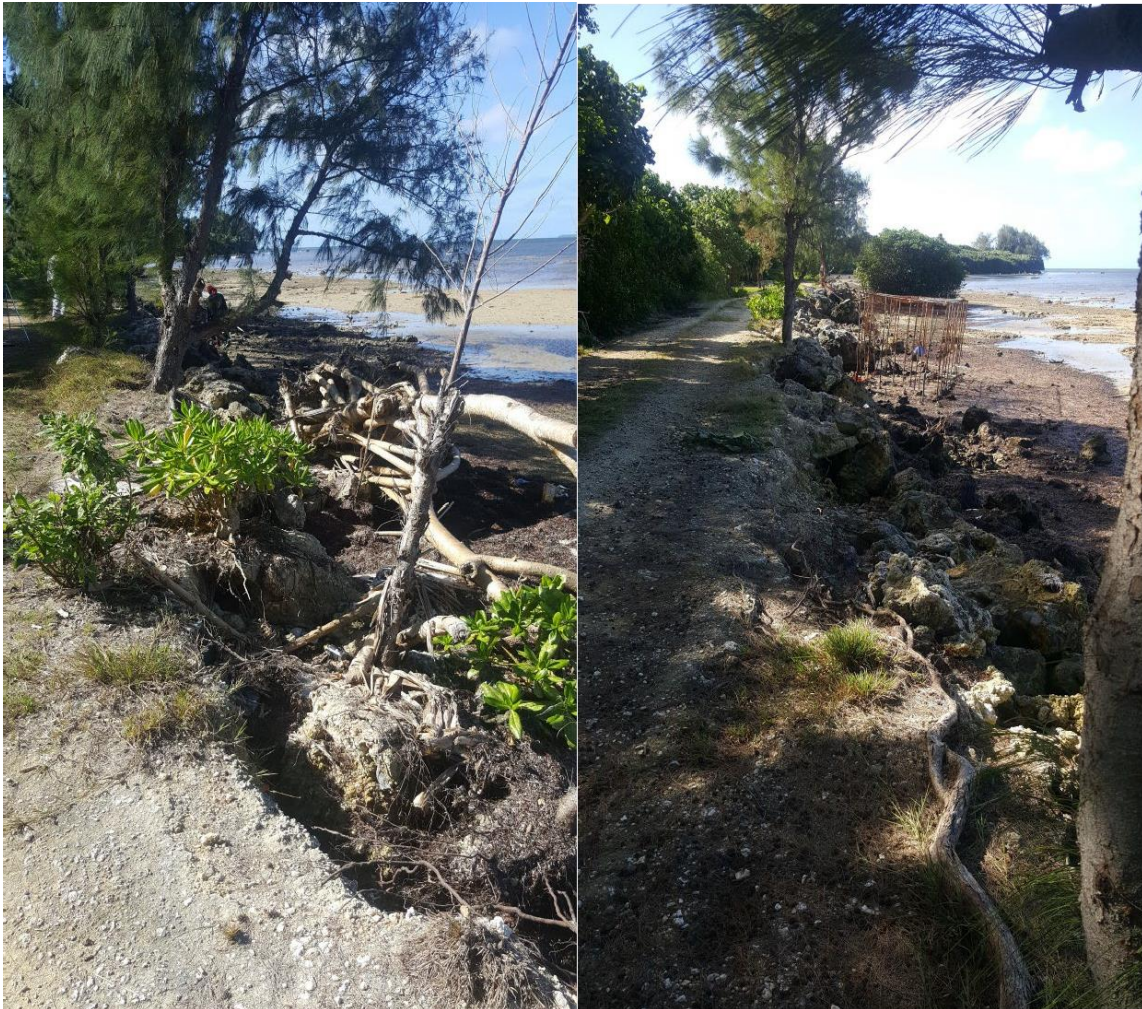
Figure 2-6. Damage to the northern part of the Kanokupolu revetment that occurred during TC Harold.

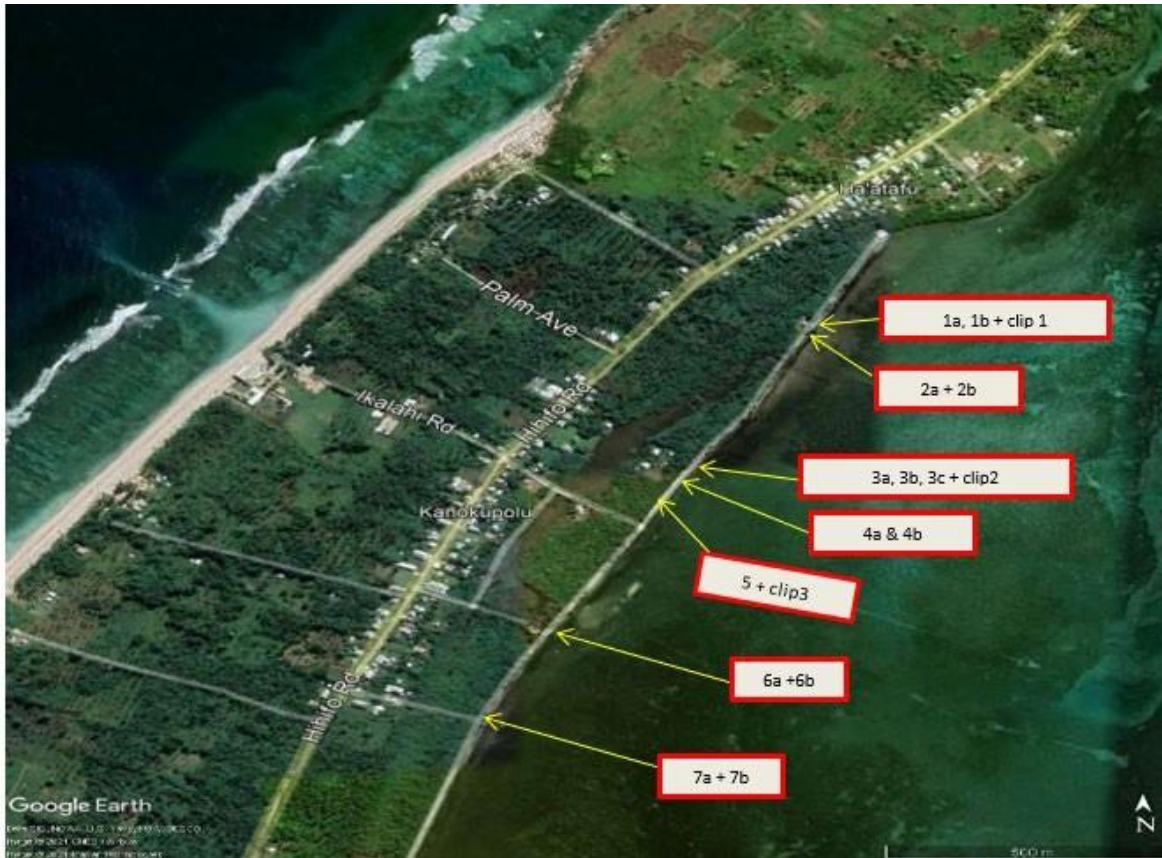
Table 2-1. Brief descriptions of the sites with the most damage along the northern 1,350 m of the revetment (Figure 2-7).

Figure 2-7. Sites of significant damage along the northern 1,350 m of the revetment (Attachment A).

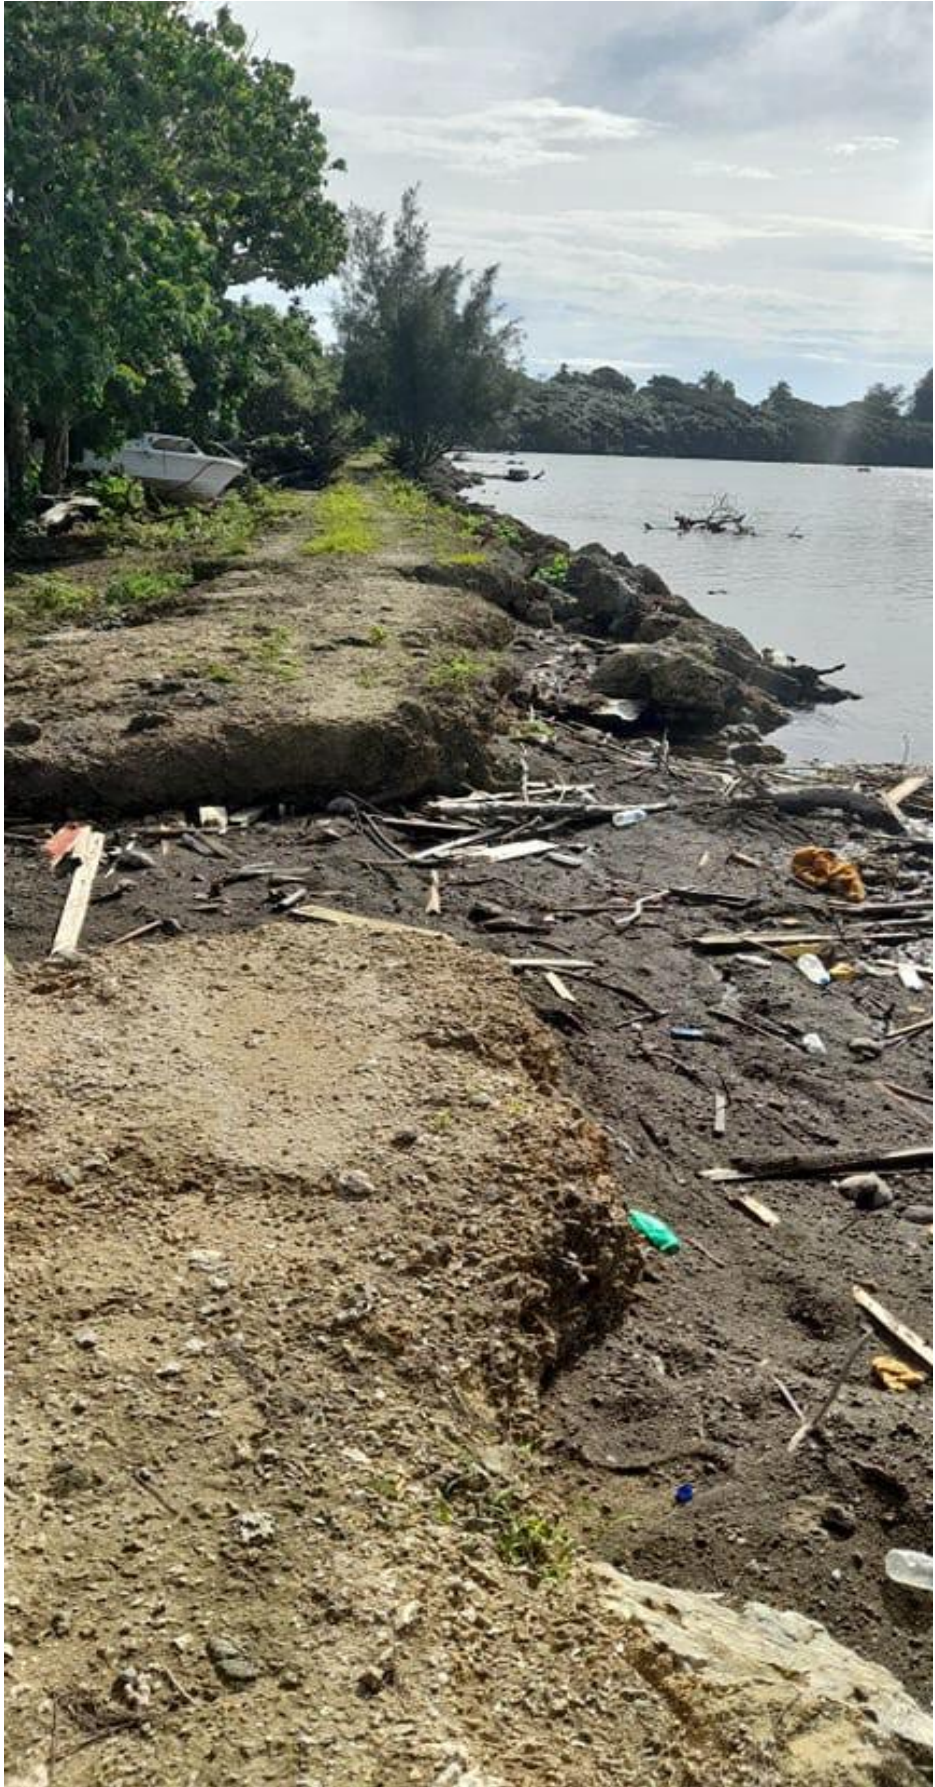
Photo in Attachment A	Site Description
1a & 1b	The foreshore together with the road behind the wall was totally cut off as shown at picture 1a where water easily cross to the other side during high tide. About 6m long and 1.1m deep
2a & 2b	Like 1a above the foreshore and the road behind it was totally cut off – 6m long and 1.2m deep. This is also located next to the second culvert that was installed in Kanokupolu.
3a, 3b and 3c	This is the part of the foreshore that was mostly damaged. About 10m long, 2m deep and new passage is formed
4a & 4b	The wall was totally taken out about 13m long and 1m deep. More than half of the road was swept out
5	Big rocks on top of the wall were swept away reducing the height of the wall 0.3m. The clip showing the real situation of the wall to the north
6a & 6b	6a - showing the access to the sea have been broken down to pieces. 6b - the side of the access to the sea (southern) although affected but remains intact and high enough to withstand the wave - one reason for this could be the root of those trees held the rocks together.
