Annex A - Detailed information on PV sites

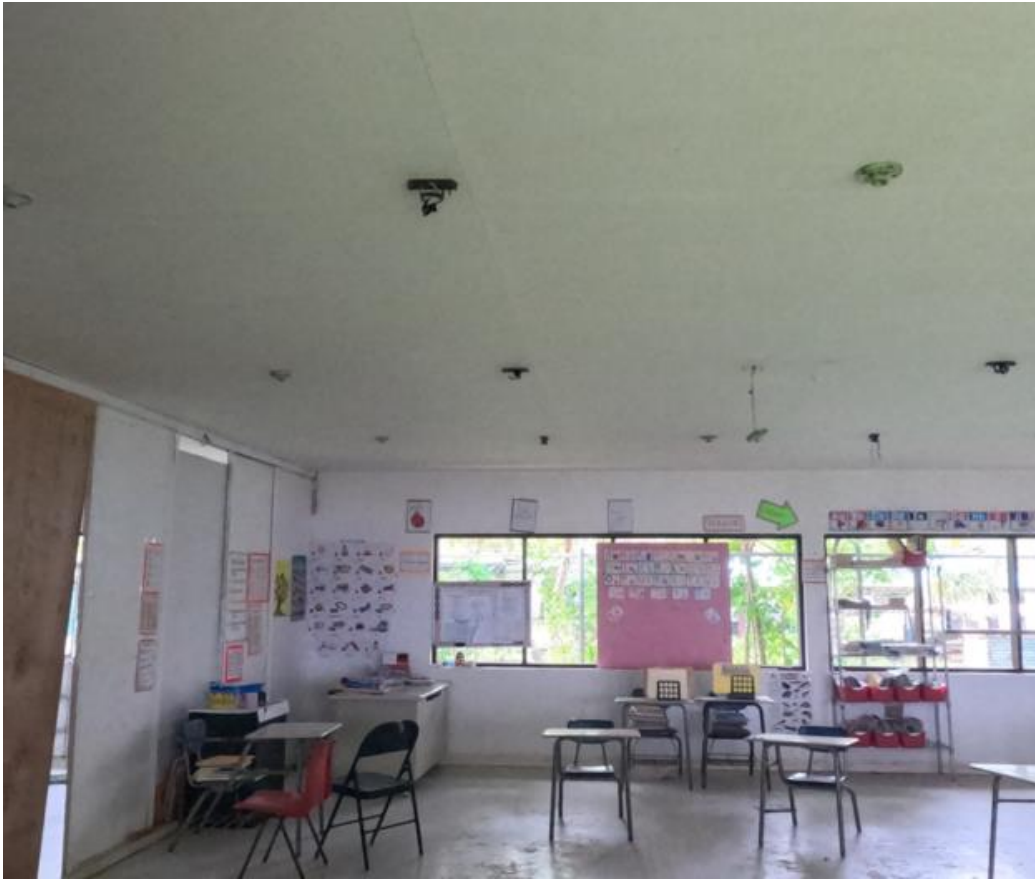
Figure 6. Sapota 1-storey elementary school interior. No visible leakage

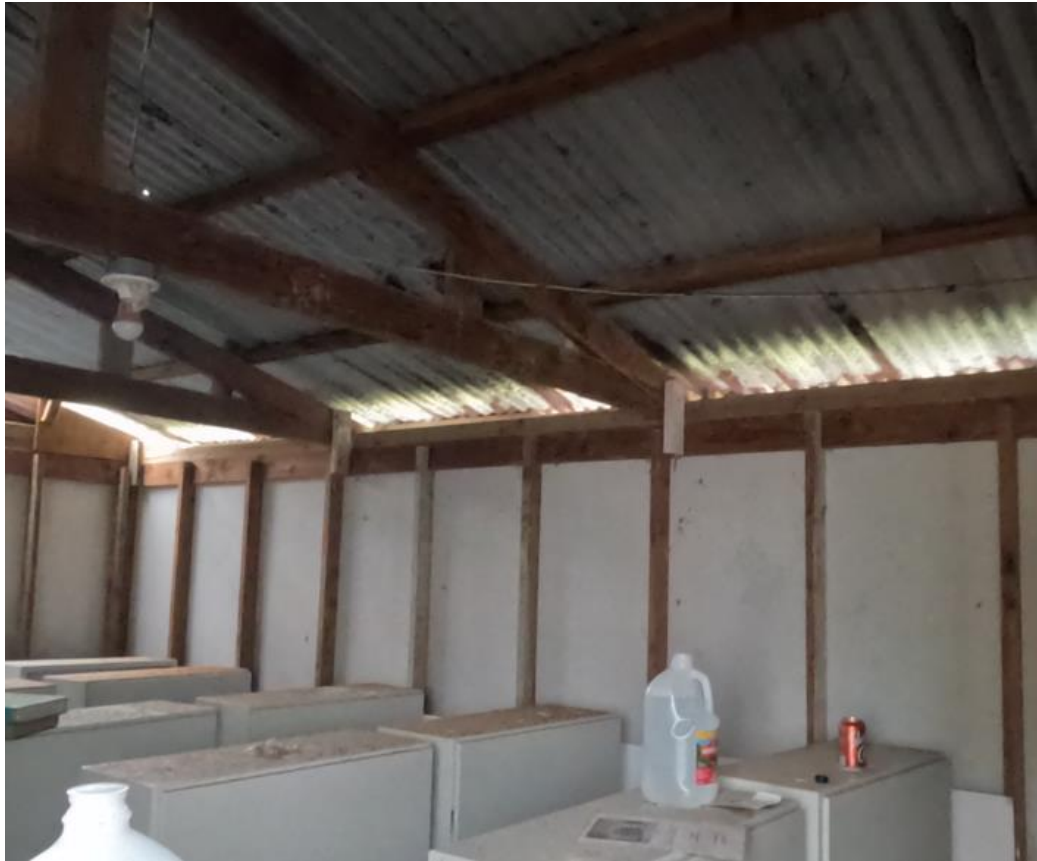
Figure 14. Sapota current technical house for the solar system. It will be emptied such as the small warehouse in order to leave the space for the brand new technical building

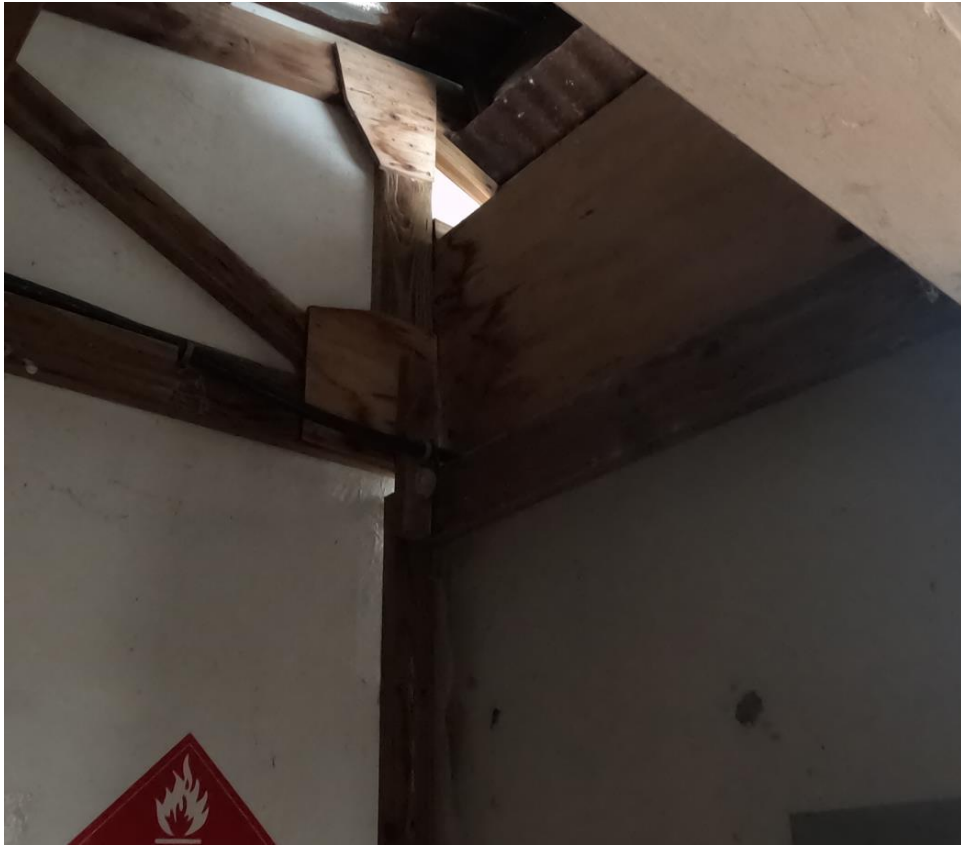
Figure 16: wall and roof structure of the technical building (current)

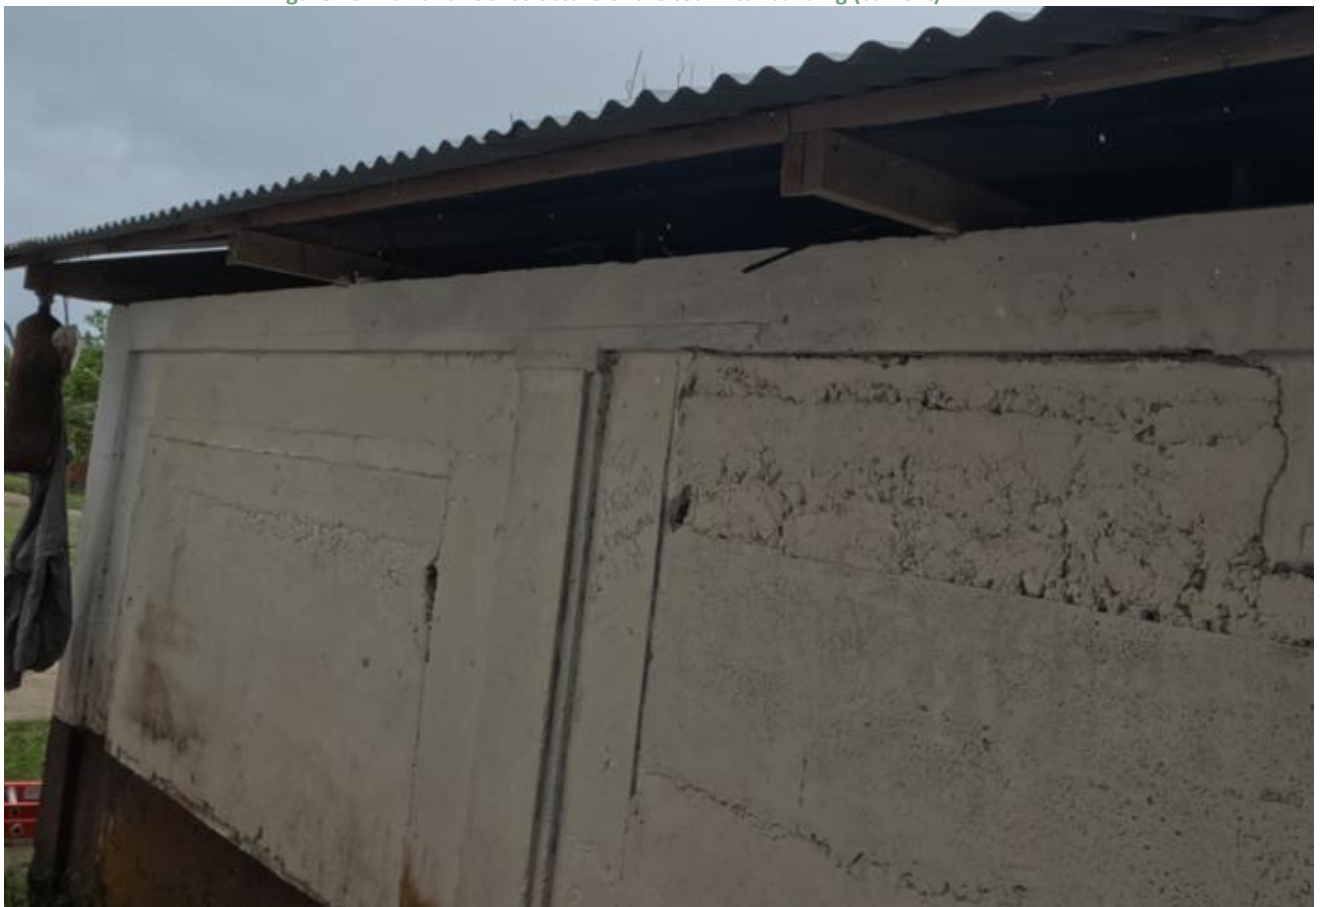
Figure 17. Edge of the current warehouse, to be reused or demolished and rebuilt by the contractor

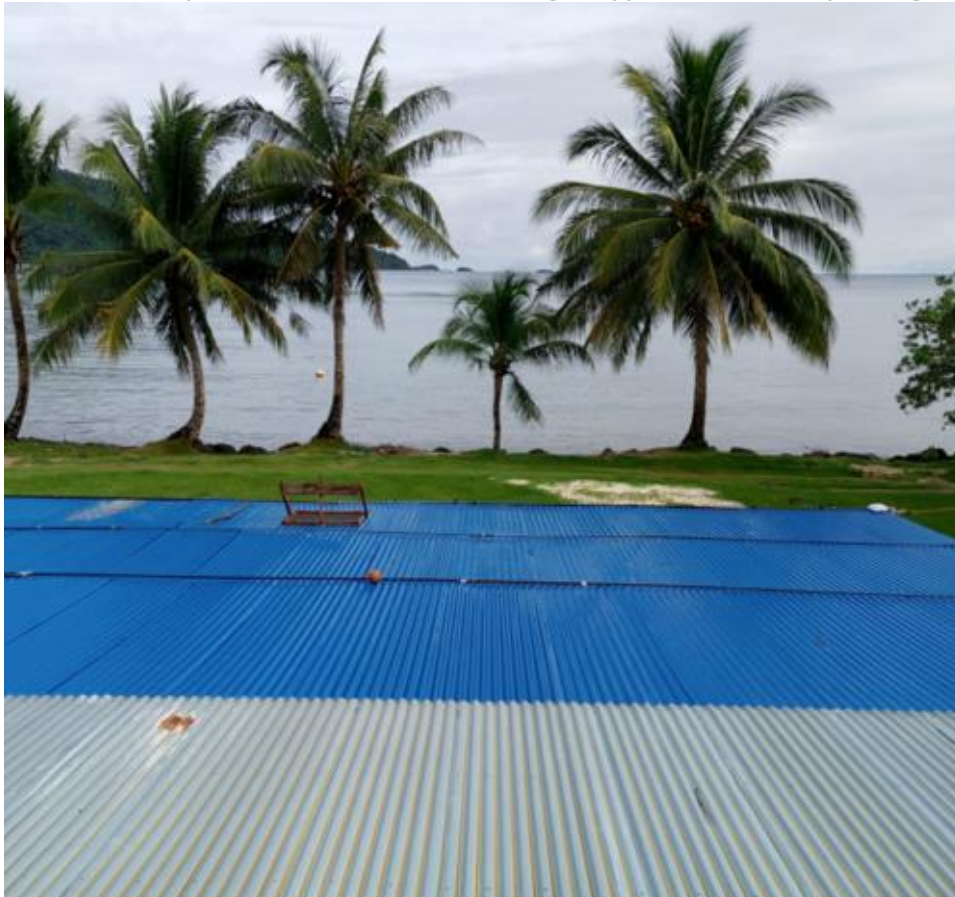
Figure 23. View of existing canopies

These existing small canopies can be removed to accommodate the new canopy (to be supplied and installed by the Contractor) closer to the buildings, in order to avoid any future issues of coastal erosion and waves impacts. The available plot should not step further on the church's entrance.

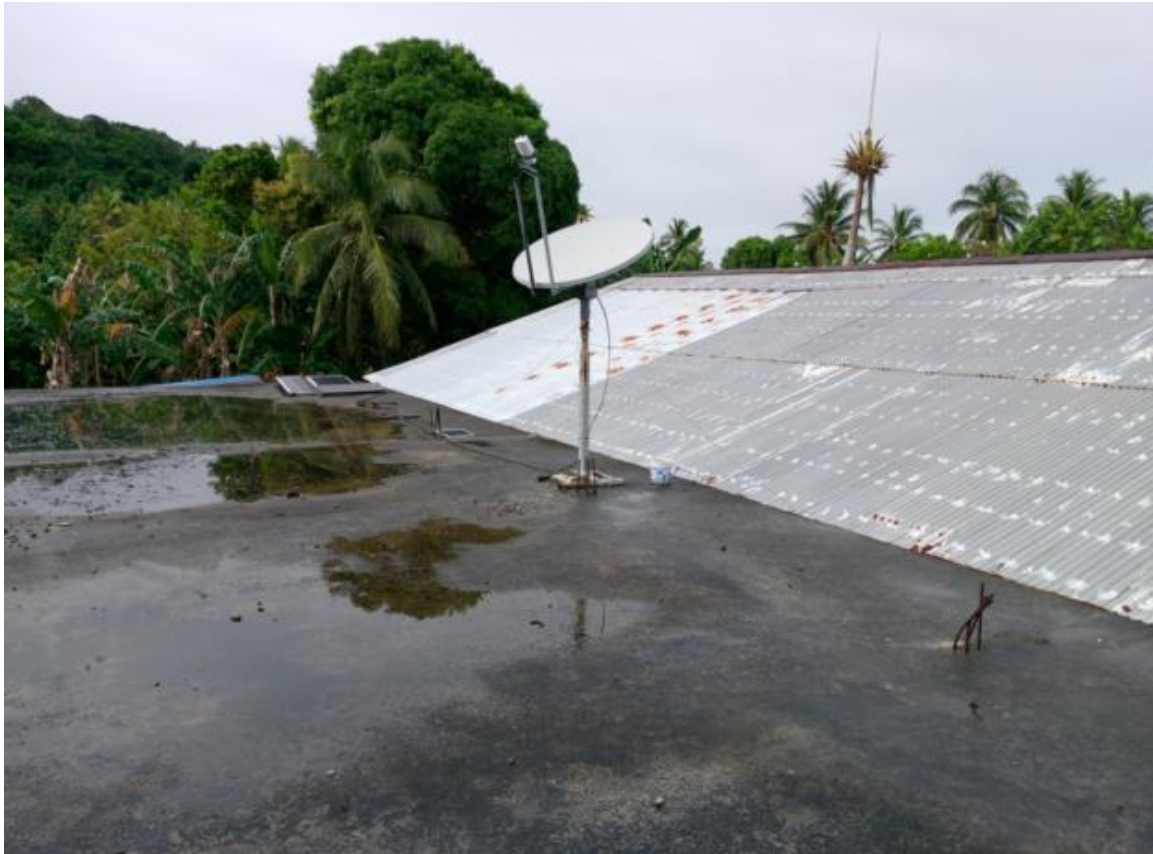
Figure 24. community building and church (right) roofs. Antenna to be removed

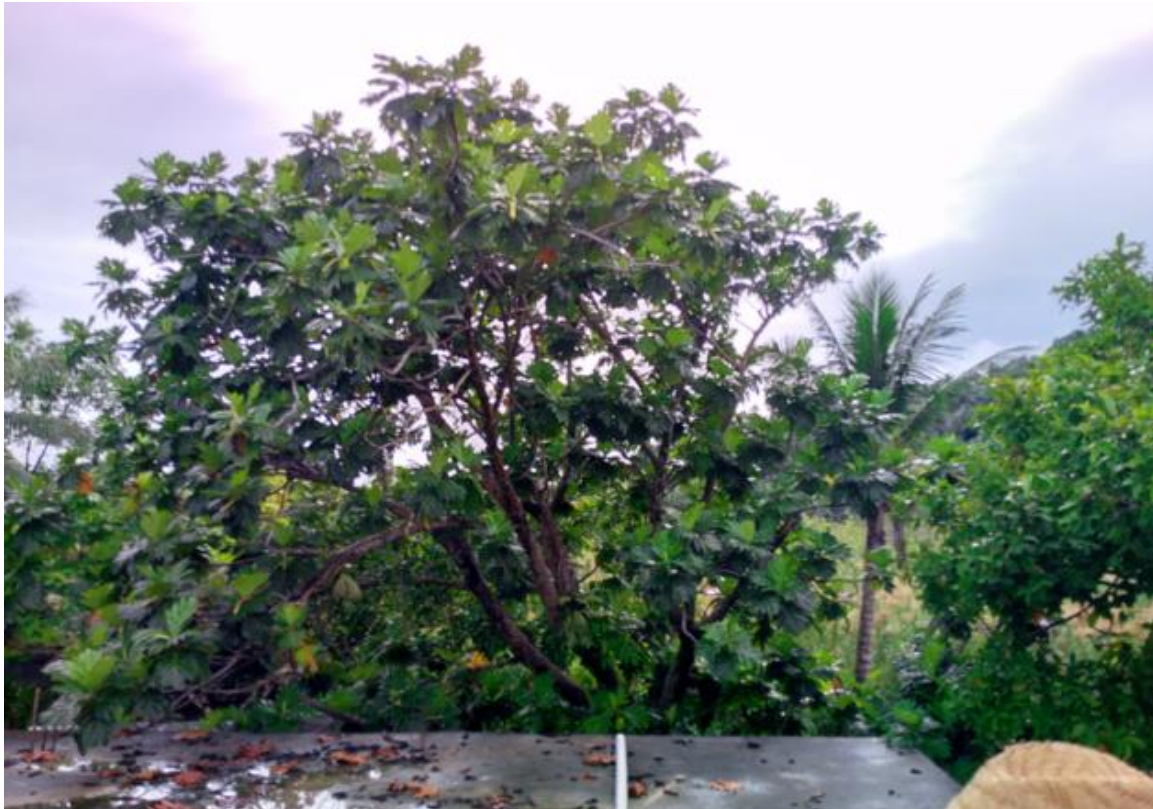
Figure 26. Trees at the south of the community building, to be trimmed by the community

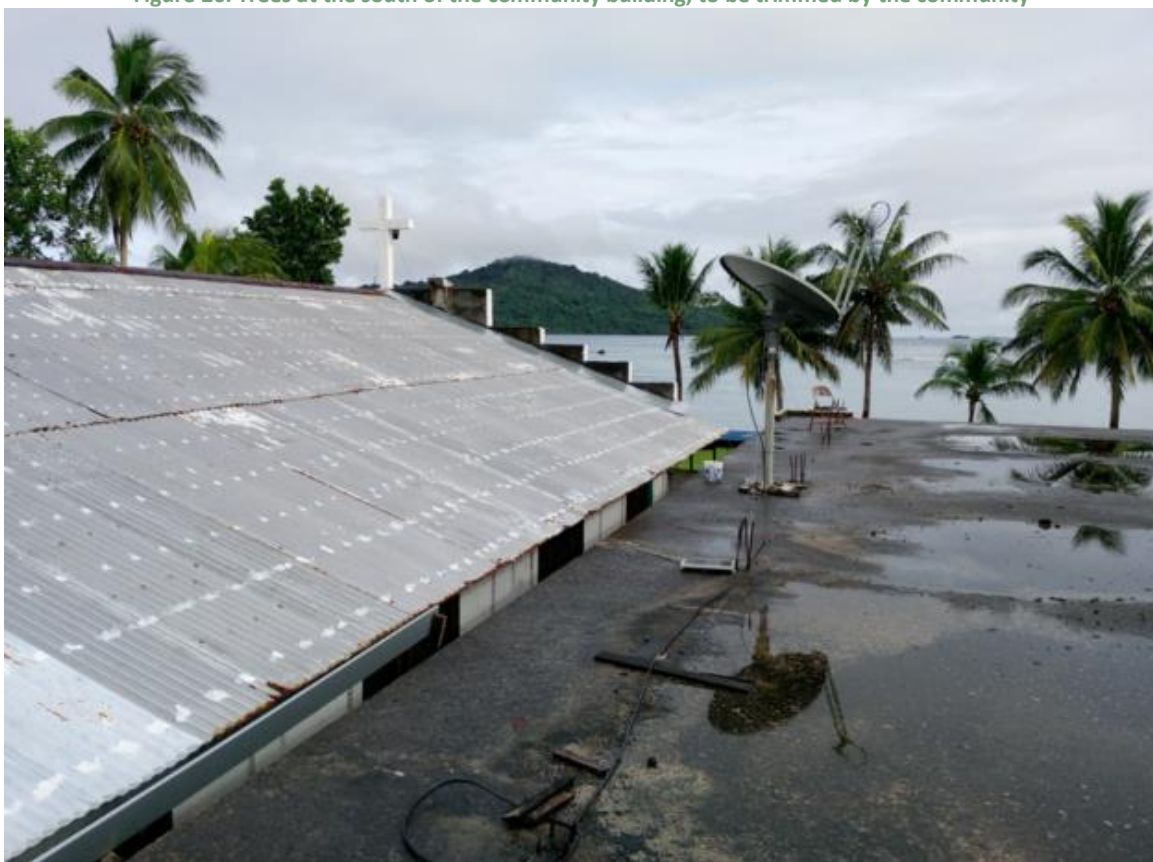
Figure 27. Church and community building (right) roofs, with metal rebars coming out of the structure.

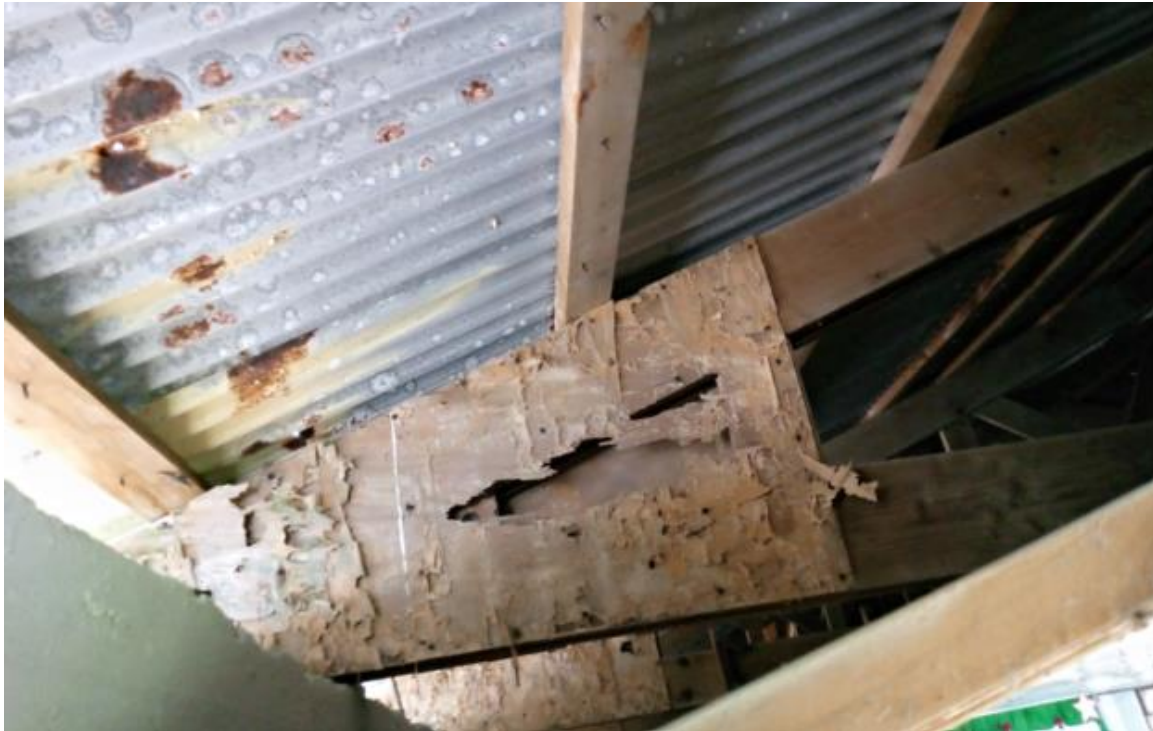
Figure 30. Slightly damaged edge of the Sapota church roof

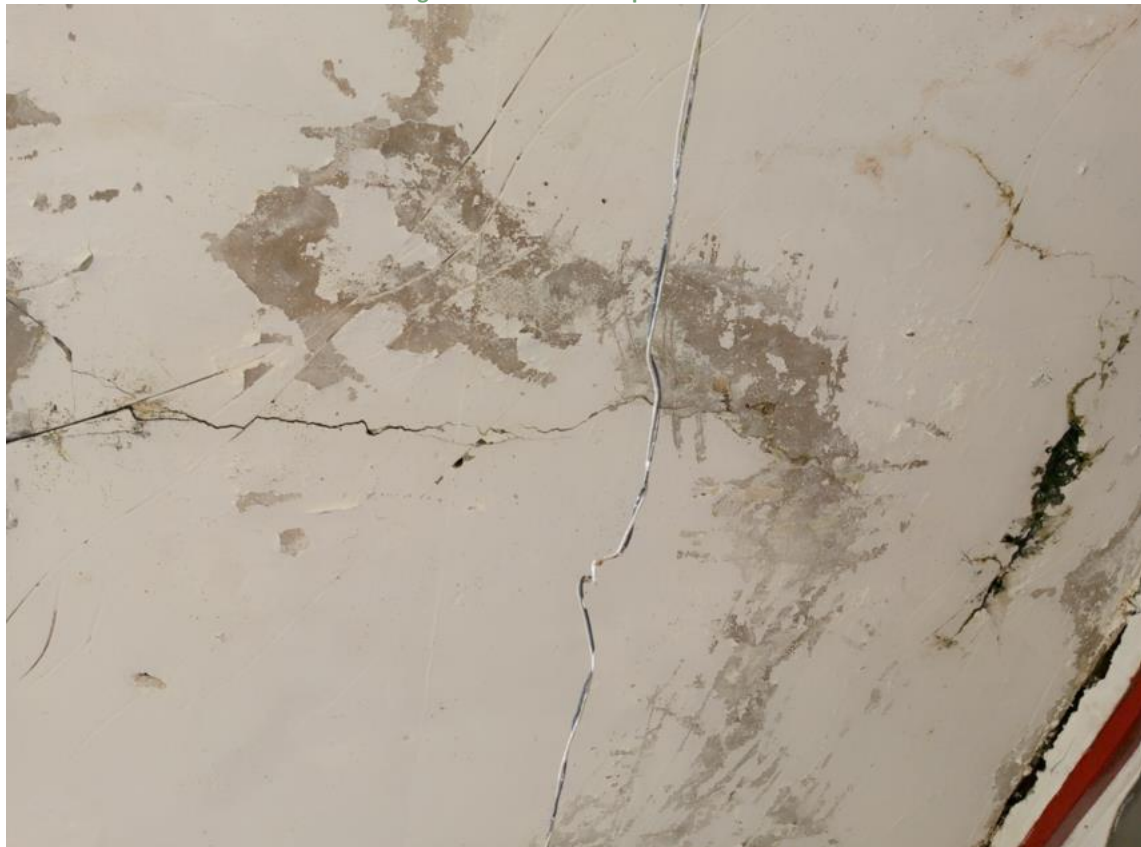
Figure 33. Cracks and humidity on the ceiling of the community building

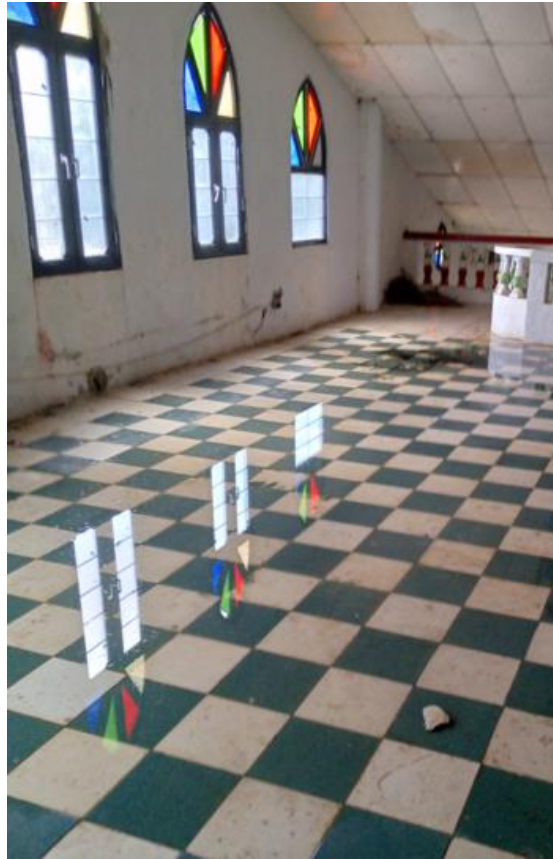
Figure 47. Leaks inside of Fein new church

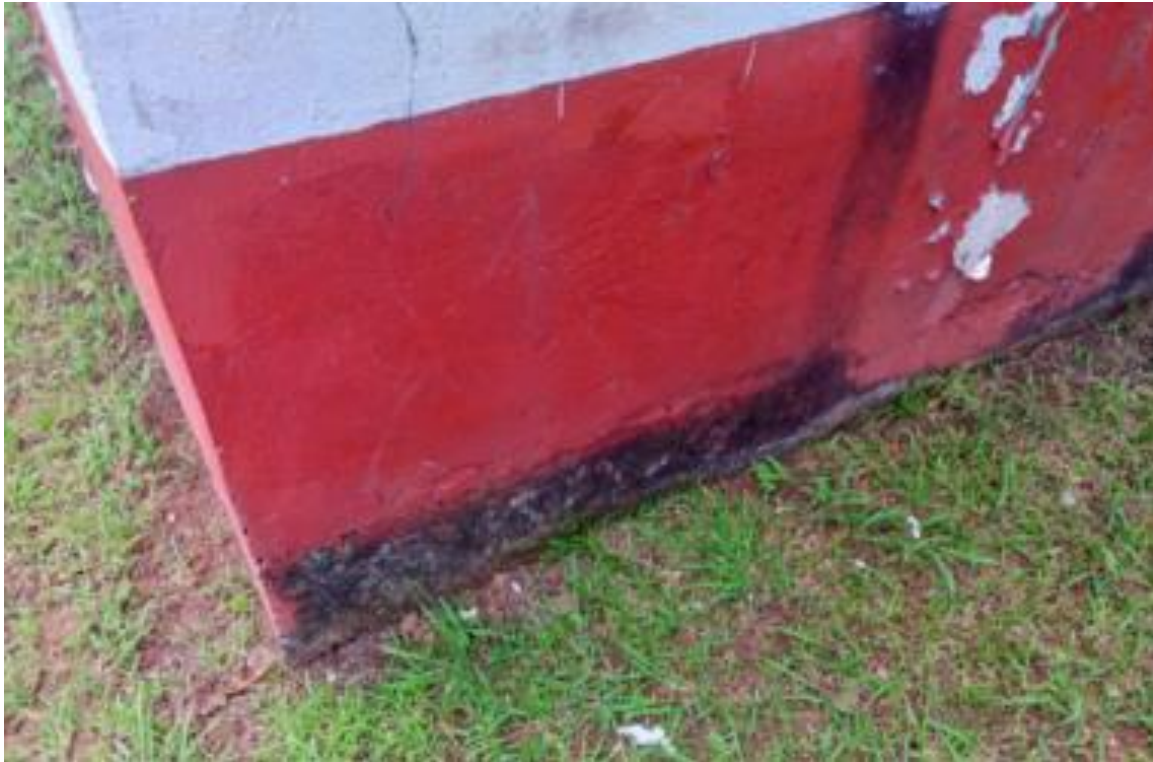
Figure 52. Footings of the Fein new church. no damage, only slightly on the plaster

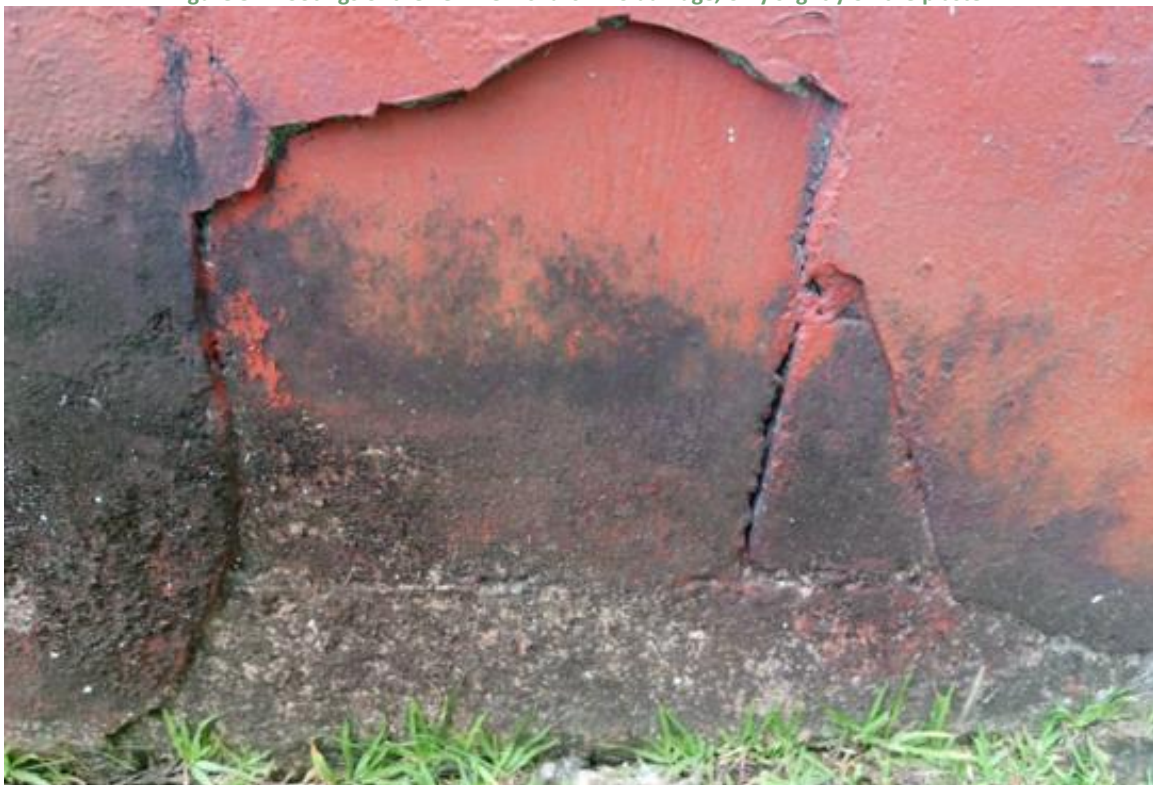
Figure 53. Footings of the Fein new church. No damage, only slightly on the plaster 2

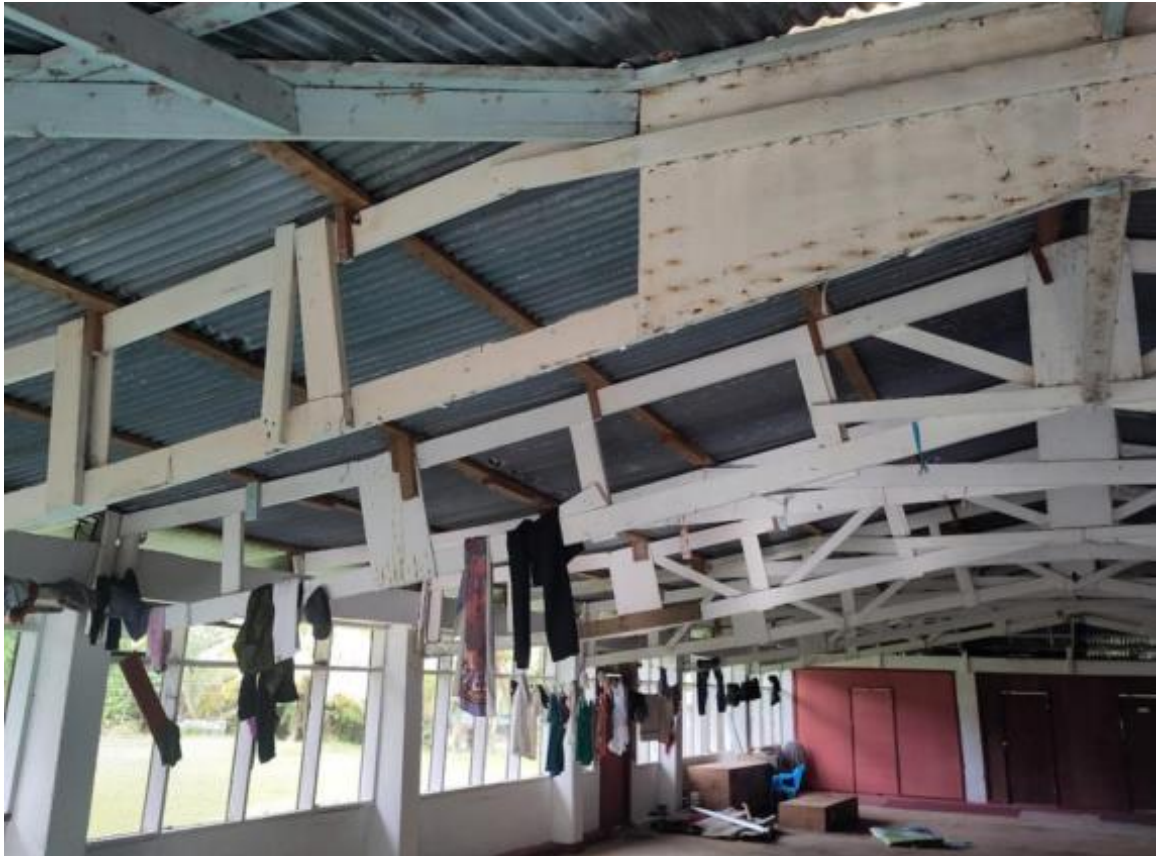
Figure 62. Parish hall damaged wooden structure

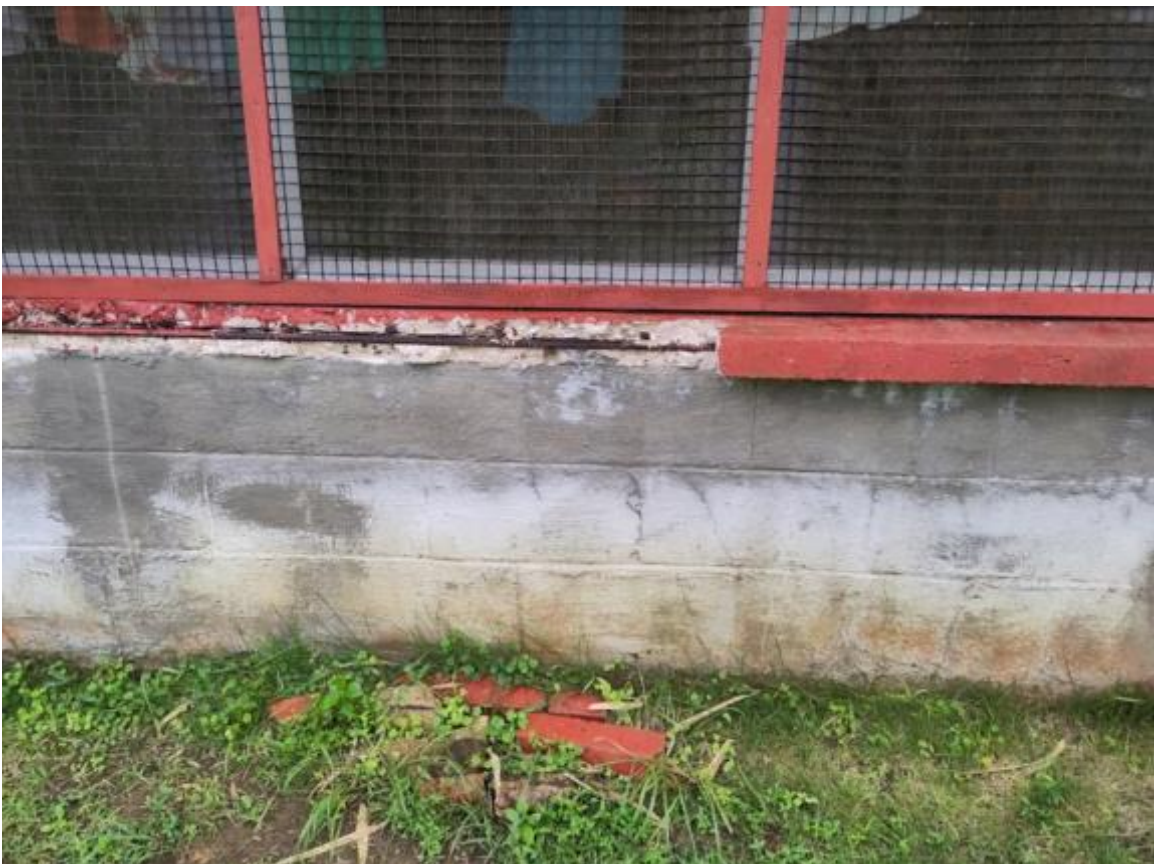
Figure 65. Parish hall damage on outside wall structure.

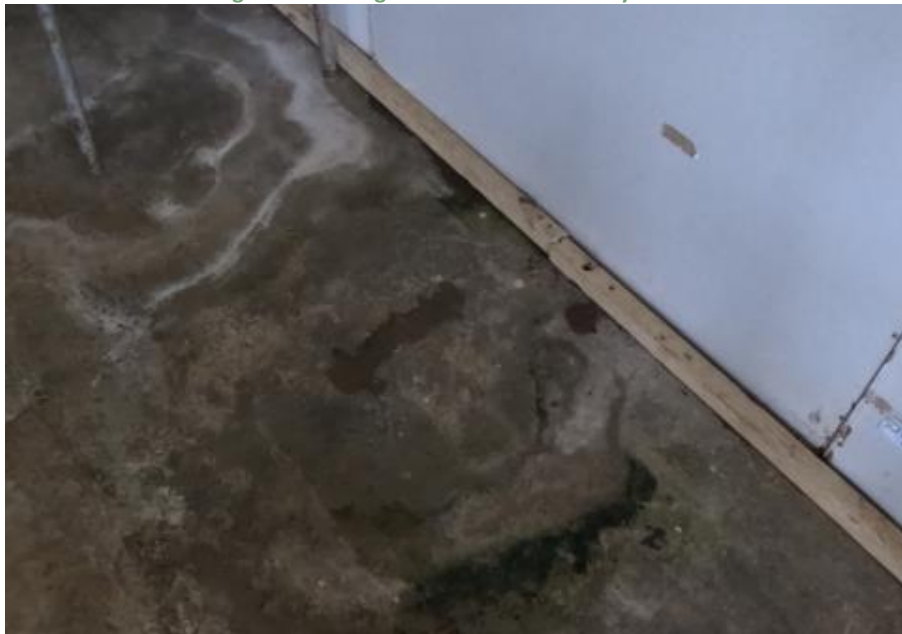
Figure 74. Leak inside the Mesa elementary school

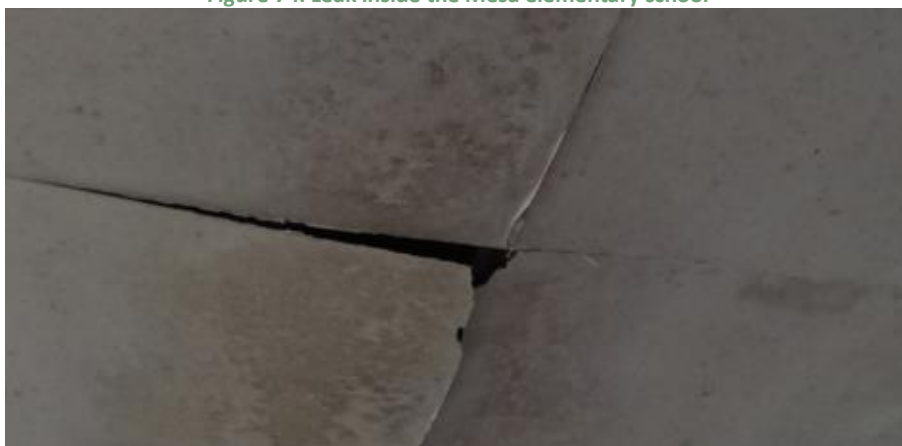
Figure 75. Leak inside the Mesa elementary school 2

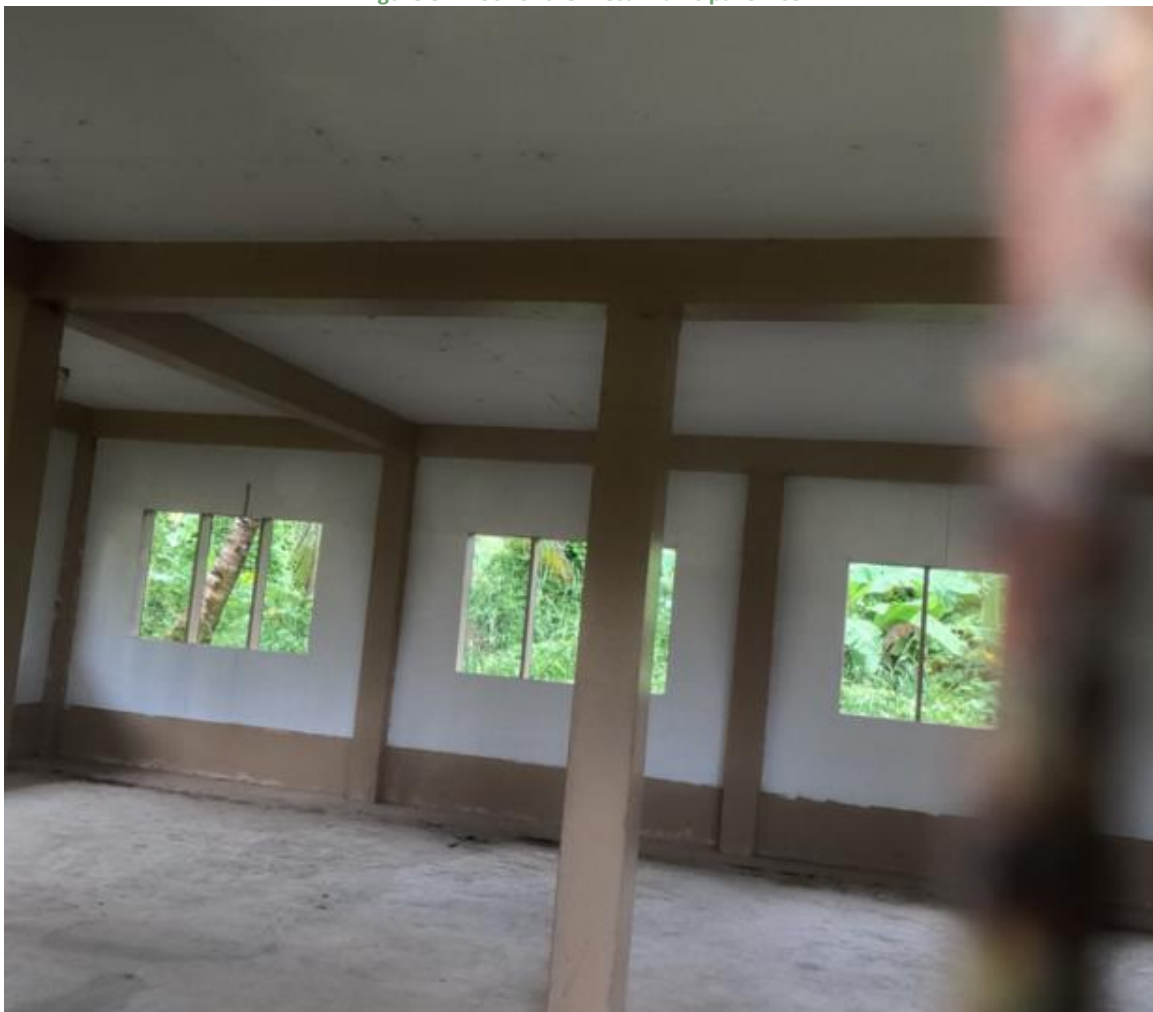
Figure 85. Interior of the Mesa municipal office (solid concrete structure with no leaks)

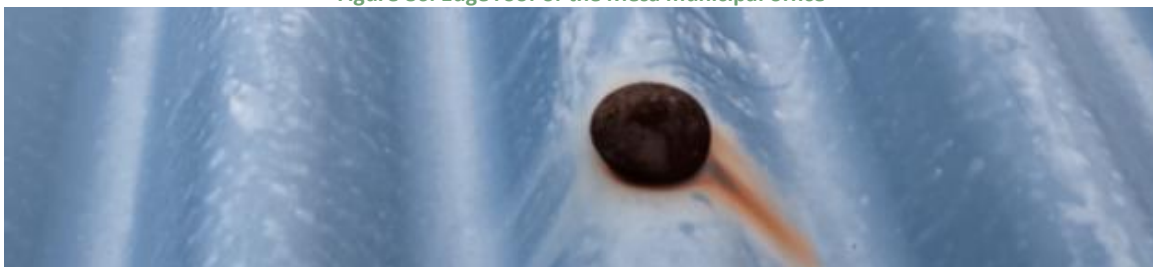
Figure 87. Rusty nails of the Mesa municipal office

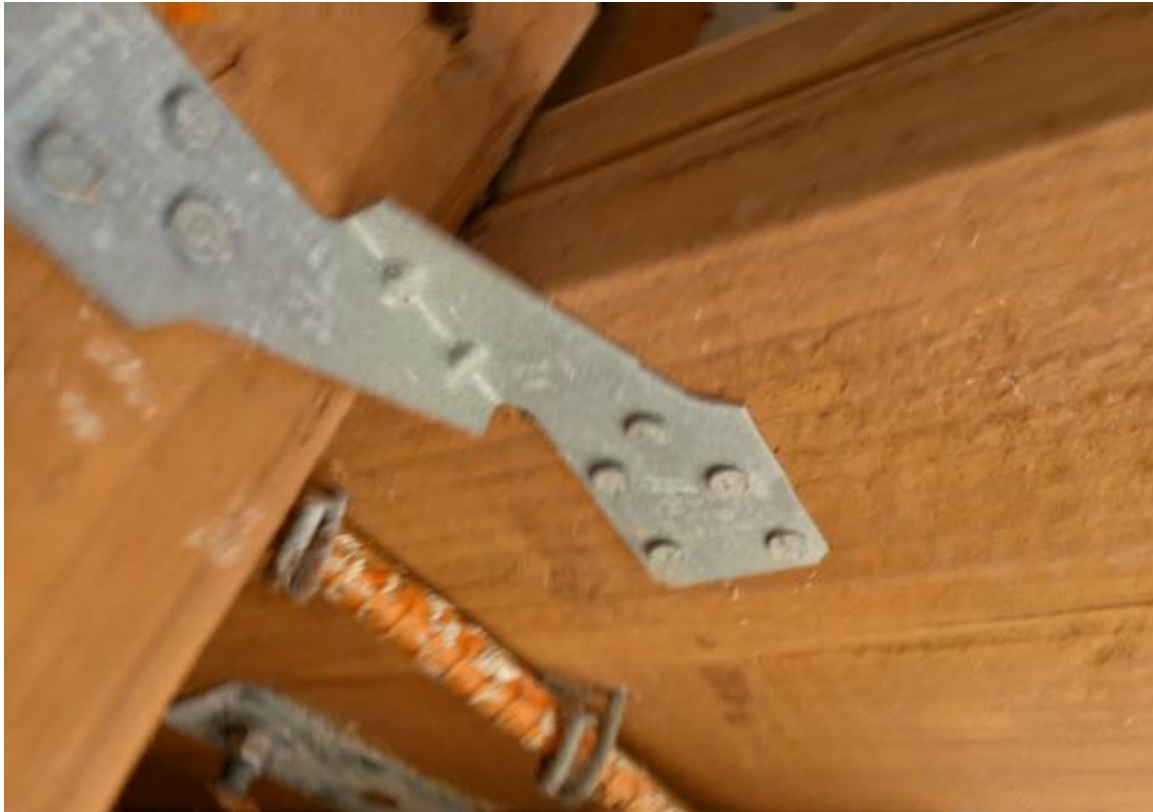
Figure 95. Mesa church rafters-structure fastening, tied to a steel bar coming out of the wall

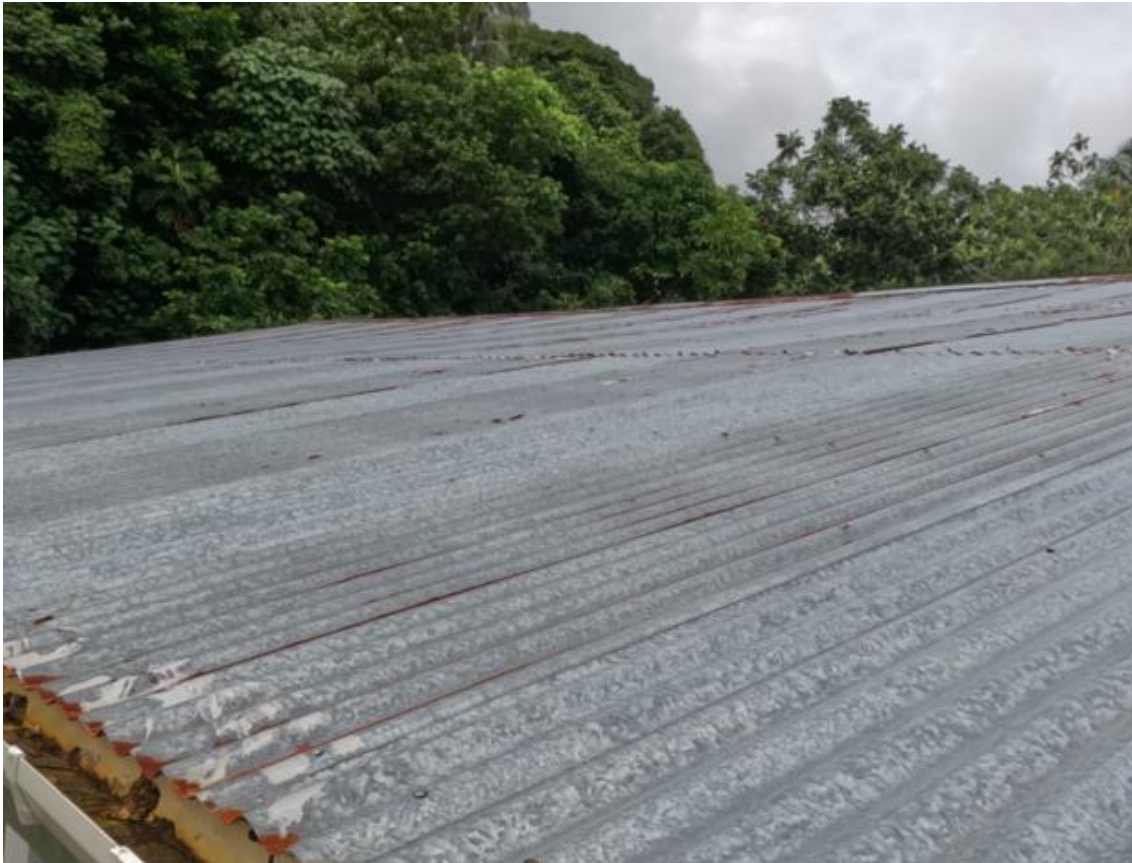
Figure 99. Western view of the Mesa church roof and trees to be trimmed by the community

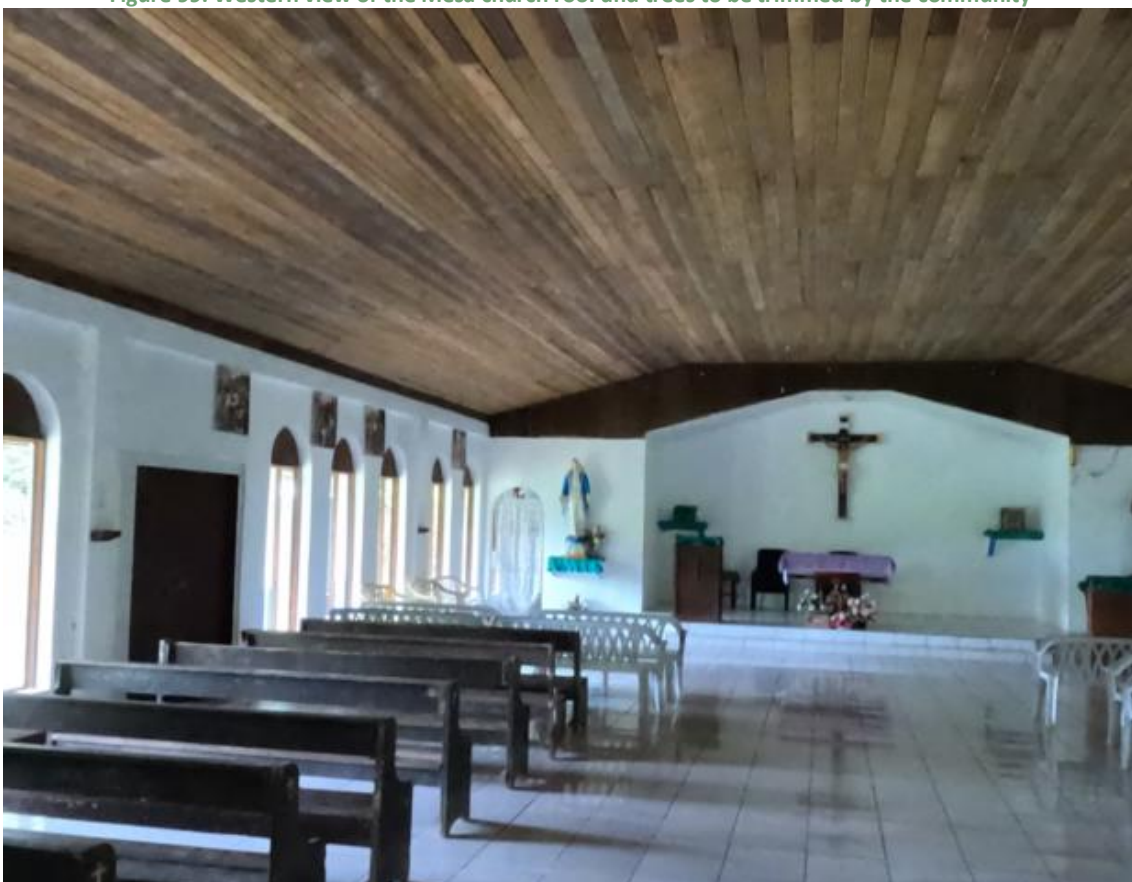
Figure 100. Mesa church interior. No leak
