Pacific Safety of Navigation Project

Risk assessment for Apia Harbour, Samoa

November 2019

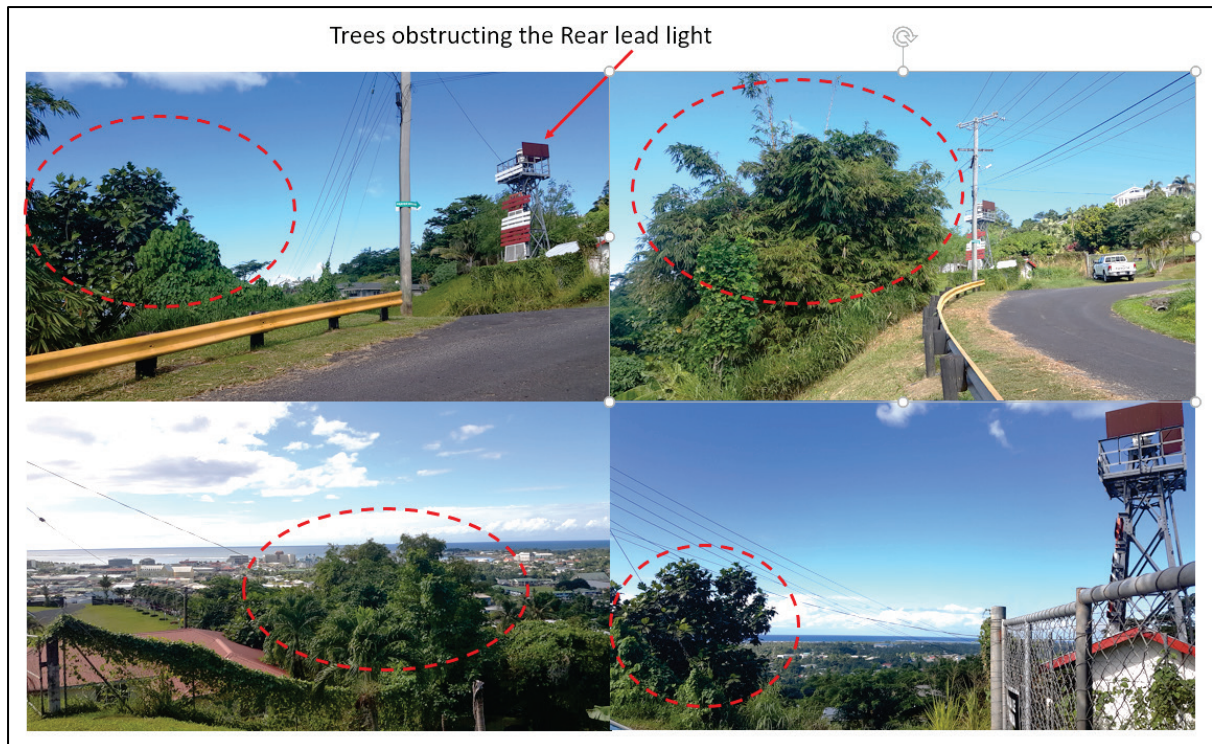
Recommendation 3 (addressing grounding scenario)

This recommendation addresses the potential grounding of vessels coming into port. This is mainly due to the leading lights and dayboard not being conspicuous. Tree in front of the rear leading light obstruct the leading light, and the front leading light is not conspicuous due to the lack of a dayboard.

The following recommendations are made:

- Cut the trees in front of the rear leading light.
- Install a dayboard at the front leading light.
- Relocate the rear leading light to another position if the trees in front of it cannot be cut.

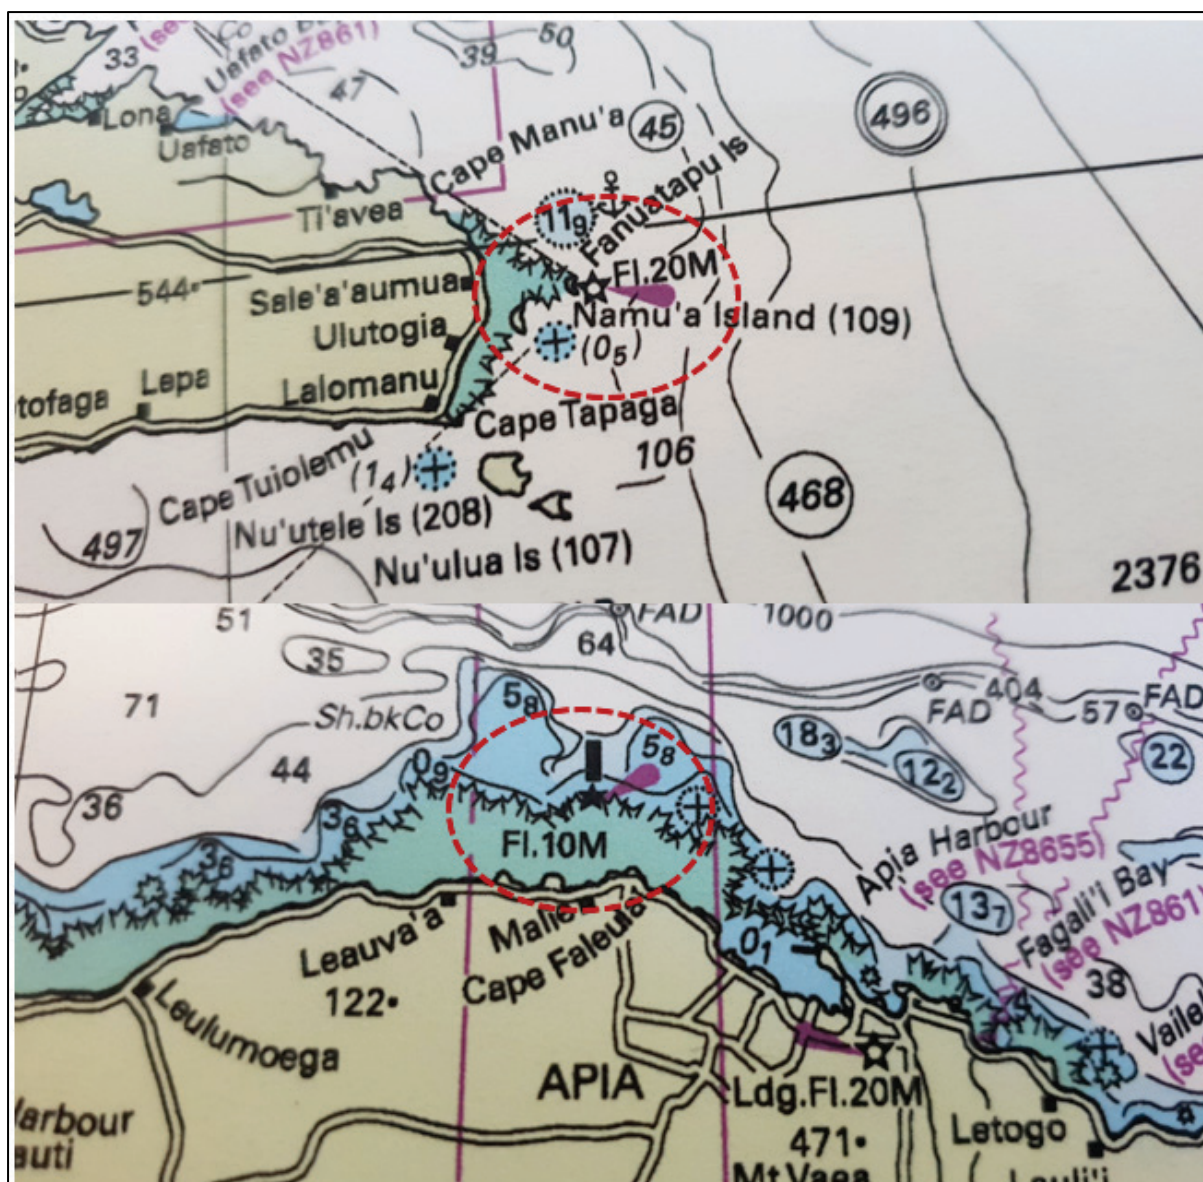
Recommendation 4 (addressing grounding scenario)

This recommendation addresses the potential grounding of vessels along the coast of Apia, mainly due to unlit lights at Namu'a Island and Cape Faleula.

It is recommended that these lights be replaced as soon as practical.

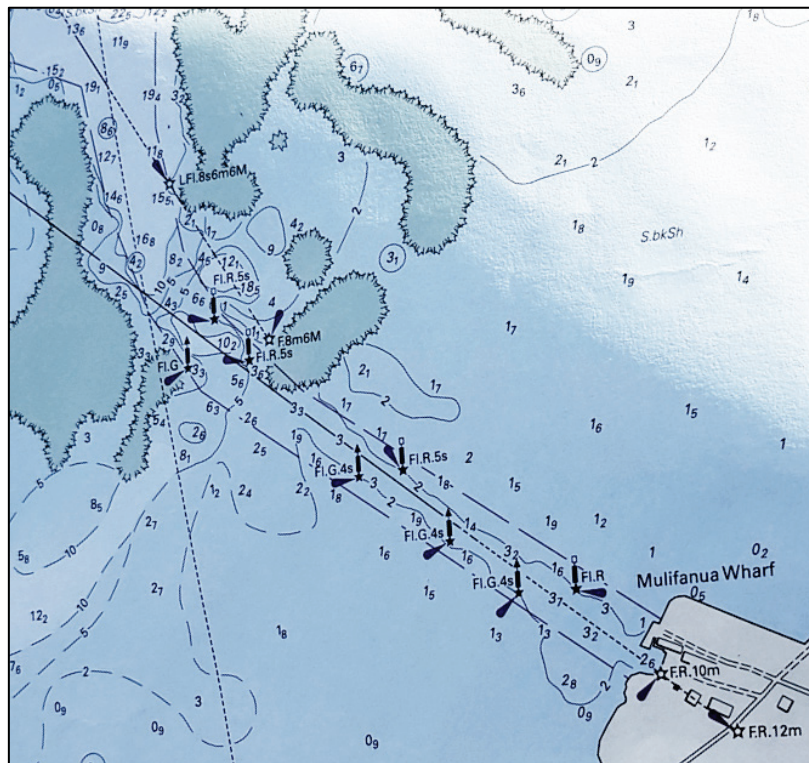
Recommendation 1 (addressing grounding scenario in Salelologa and Mulifanua harbours)

There are currently eight lateral buoys and two sets of shore and channel leading lights marking the channel into Mulifanua harbour. The two leading lights in the channel, and buoys numbers 6 and 7,

have no lights, and the shore leading lights are completely destroyed. The lack of these AtoN can potentially cause the grounding of vessels accessing the harbour at night.
