Pacific Safety of Navigation Project

Risk assessment for the Port of Majuro, Republic of the Marshall Islands

November 2019

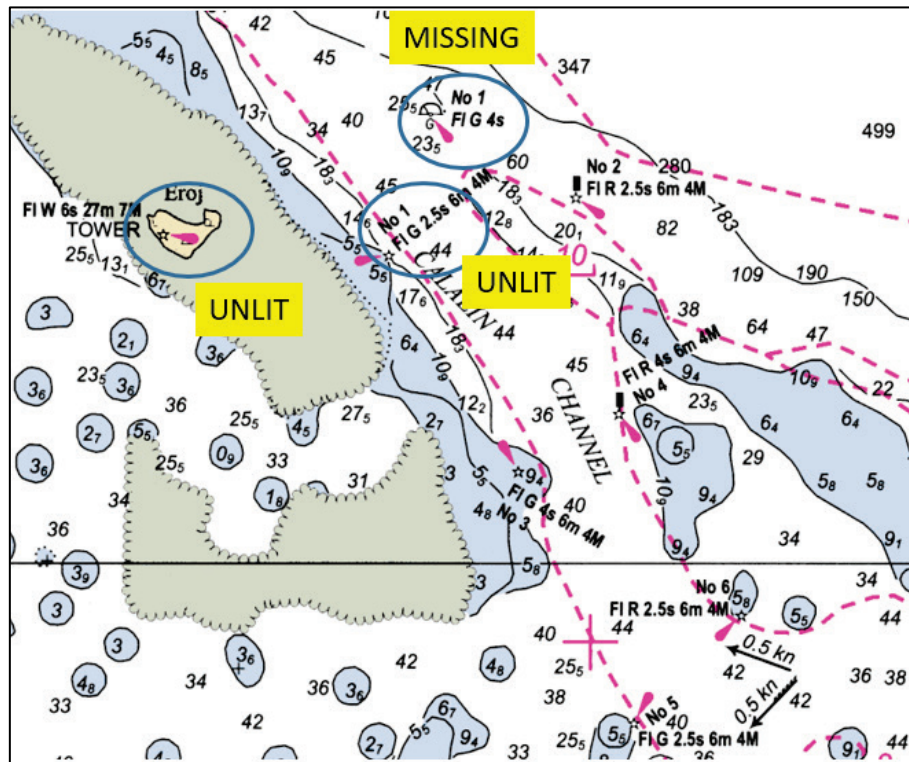
This recommendation addresses the potential grounding of fishing vessels on the reef at the entrance to Calalin Channel. This scenario is mainly due to the lack of IALA-compliant lit AtoN marking the channel's entrance. The starboard buoy marked no. 1 on the chart at the entrance is missing, while the lights on the tower at Eroj Island and the light on starboard beacon no. 1 are unlit.

It is recommended that IALA-compliant lit AtoN be installed in the entrance of the channel. This includes the light on the tower at Eroj Island and the light and dayboards on beacon no. 1. An H-note should be sent to the (PCA) informing it of changes to the chart.

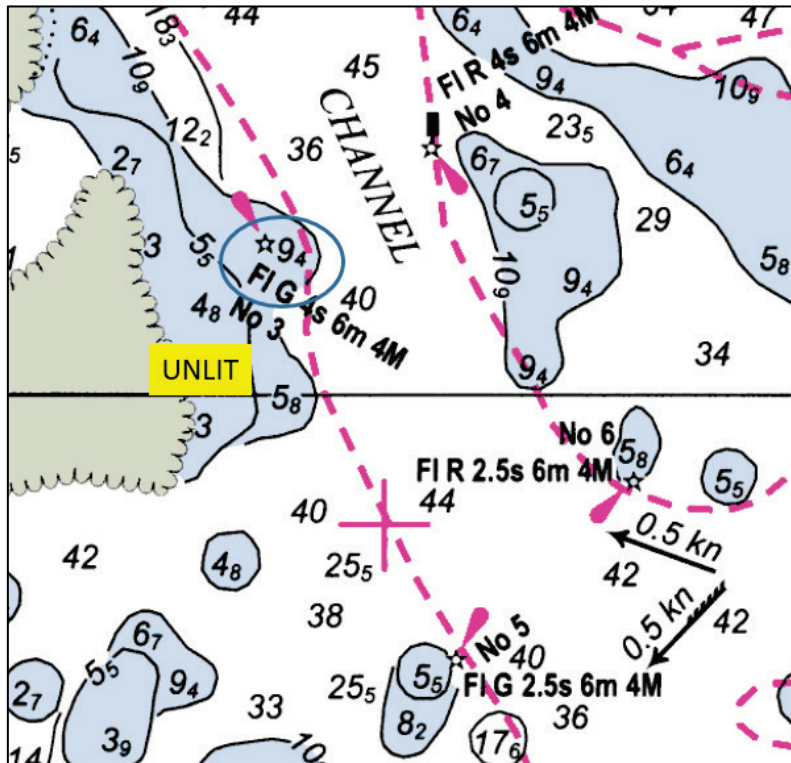
This recommendation addresses the potential grounding of fishing vessels in Calalin Channel due to the lack of IALA-compliant lit and conspicuous AtoN marking the channel. Starboard beacon no. 3 is unlit. It is recommended that a IALA-compliant light and new dayboards be installed on beacon no. 3 in Calalin Channel, and an H-note be submitted to the PCA, informing it of changes to the chart.

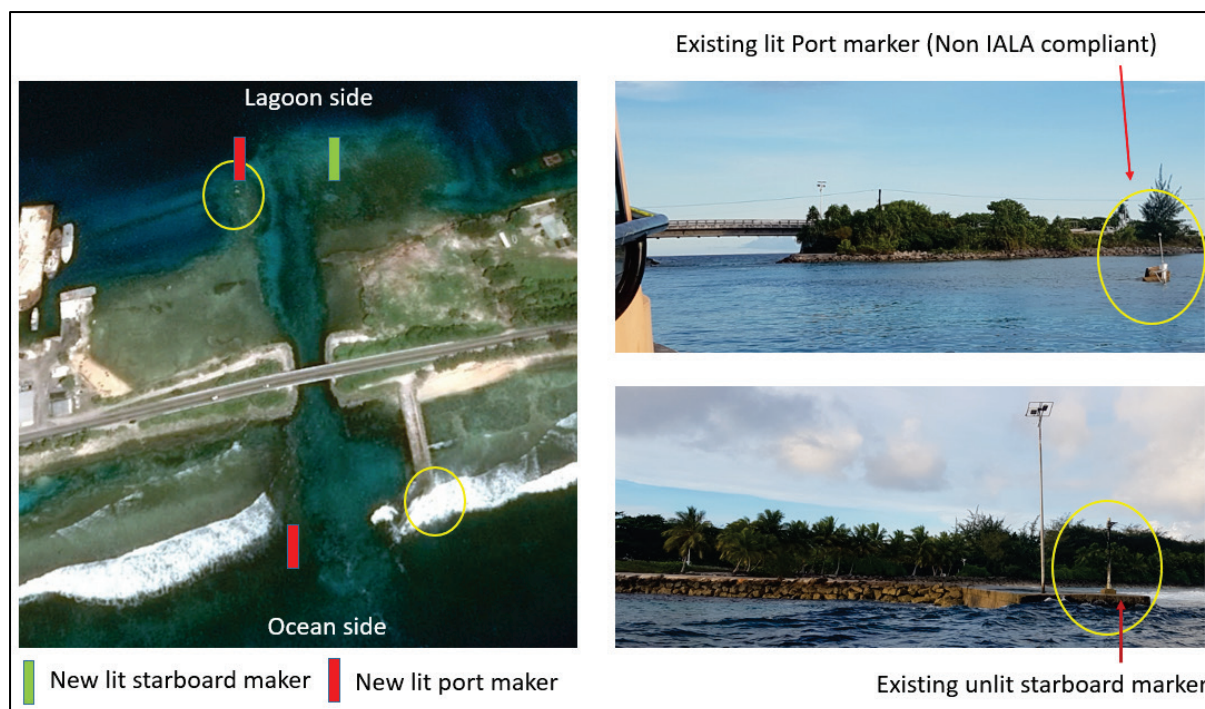
This recommendation addresses the potential foundering of small boats at the small boat crossing at the Majuro bridge channel.

This is mainly due to strong currents at incoming and outgoing tides, lack of proper AtoN marking the channel extents, and lack of crew competency. Currently there is an unlit starboard marker on the edge of the breaker on the lagoon side. There is also a small port marker on the lagoon side that is non-IALA-compliant.

It is recommended that IALA-compliant AtoN be installed to mark the channel extents and that more small boat safety awareness programs be delivered.

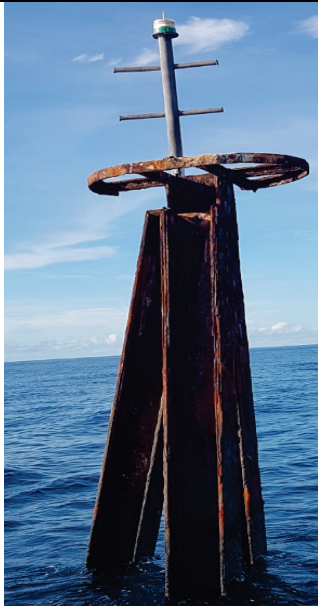
<p>AtoN Number Number on AtoN Feature name: Description: Light: Characteristics: Position (WGS84): Comments:</p>	<p>1 non Starboard-hand beacon Spar beacon with no dayboard Unlit Fl G 2.5s 6m 4M 07°09.7116'N 171°10.4012'E This is the starboard AtoN marking the entrance to the channel. The beacon needs urgent maintenance along with a dayboard and new light.</p>

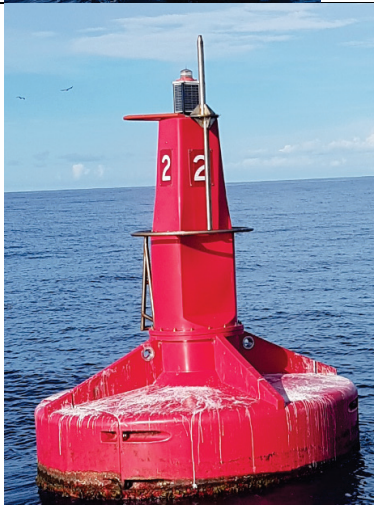
<p>AtoN Number Number on AtoN Feature name: Description: Light: Characteristics: Position (WGS84): Comments:</p>	<p>2 2 Port-hand buoy Buoy Red Fl R 2.5s 6m 4M 07°09.8471'N 171°10.8385'E This is the port-hand buoy marking the entrance to the channel. The buoy is missing the top mark and needs urgent cleaning. Recommendation is to put bird spikes on buoy.</p>

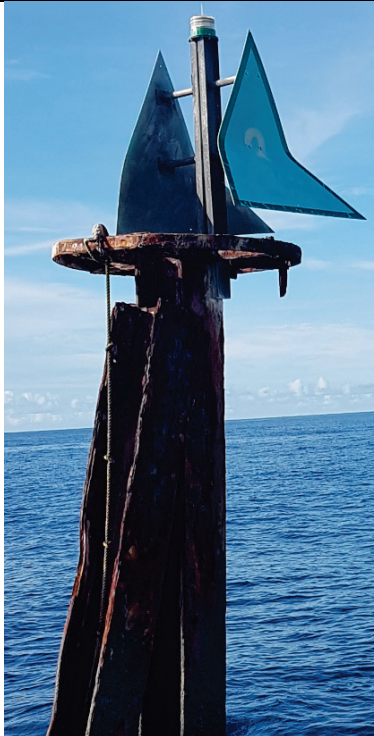
<p>AtoN Number Number on AtoN Feature Name: Description: Light: Characteristics: Position (WGS84):</p> <p>Comments:</p>	<p>3 3 Starboard-hand beacon Spar beacon with triangular dayboard Green, Unlit Fi G 4s 6m 4M 07°09.2128'N 171°10.7029'E</p> <p>This is the starboard beacon that needs urgent maintenance along with new dayboards and a new light.</p>

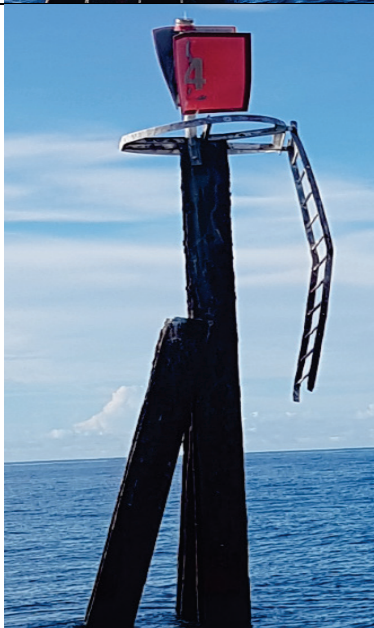
<p>AtoN Number Number on AtoN Feature Name: Description: Light: Characteristics: Position (WGS84):</p> <p>Comments:</p>	<p>4 4 Port-hand beacon Spar beacon with square dayboard Red Fl R 4s 6m 4M 07°09.3444'N 171°10.9391'E</p> <p>This is the port-hand beacon that has been damaged due to waves and allision by vessels. This beacon needs urgent maintenance and new dayboards.</p>

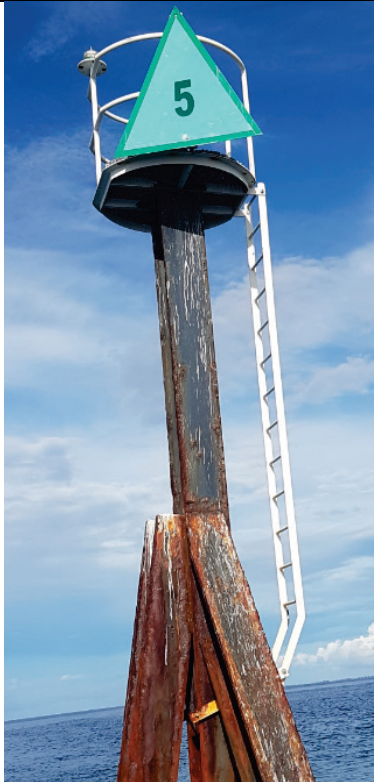
<p>AtoN Number Number on AtoN Feature Name: Description: Light: Characteristics: Position (WGS84):</p> <p>Comments:</p>	<p>5 5 Starboard-hand beacon Spar beacon with triangular dayboard Green Fl G 2.5s 5m 4M 07°08.6280'N 171°10.9712'E</p> <p>This beacon was recently installed. It is in good condition, although the dayboard needs to be replaced.</p>

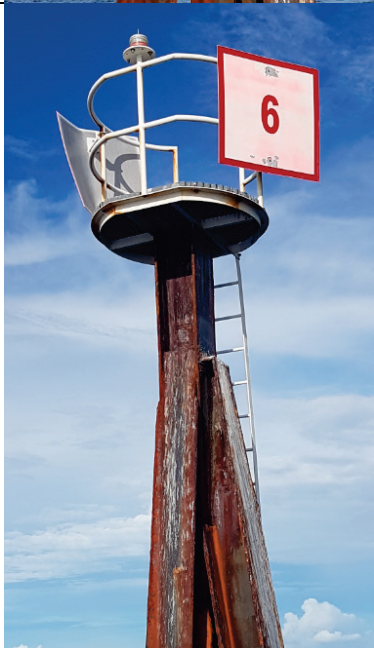
<p>AtoN Number Number on AtoN Feature Name: Description: Light: Characteristics: Position (WGS84):</p> <p>Comments:</p>	<p>6 6 Port-hand beacon Spar beacon with square dayboard Red Fl R 2.5s 6m 4M 07°08.8792'N 171°11.2195'E</p> <p>This beacon was recently installed. It is in good condition, although the dayboard needs to be replaced.</p>

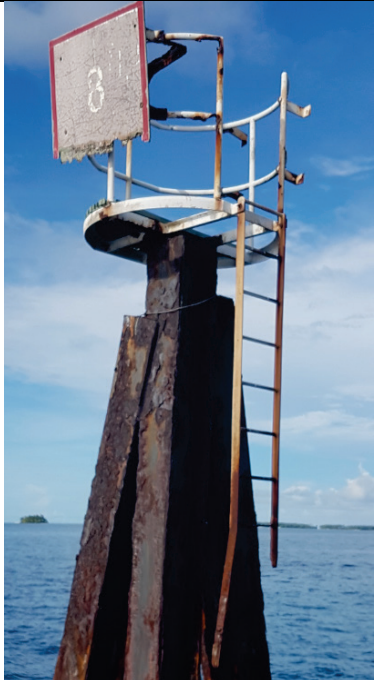
<p>AtoN Number Number on AtoN Feature Name: Description: Light: Characteristics: Position (WGS84):</p> <p>Comments:</p>	<p>8 8 Port-hand beacon Spar beacon with square dayboard Red, missing Fl R 4s 6m 4M 07°08..0958'N 171°14.7701'E</p> <p>This port-hand beacon is in very poor condition and needs urgent replacement.</p>

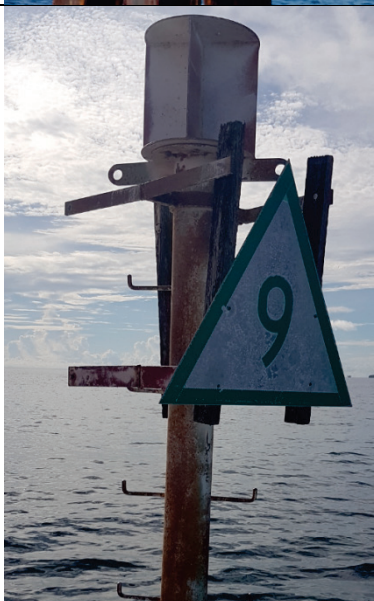
<p>AtoN Number Number on AtoN Feature Name: Description: Light: Characteristics: Position (WGS84):</p> <p>Comments:</p>	<p>9 9 Starboard-hand mark Spar beacon with one triangular dayboard Green, missing Fl G 2.5s 5m 4M 07°06.0249'N 171°15.8470'E</p> <p>This starboard beacon is in fair condition but needs a new light and one dayboard</p>

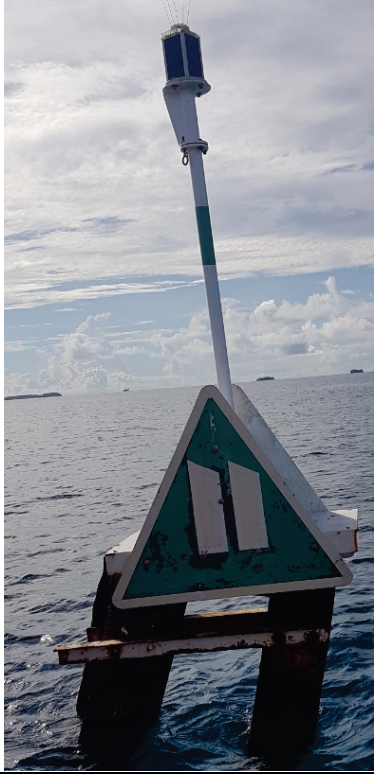
<p>AtoN Number</p> <p>Number on AtoN</p> <p>Feature Name:</p> <p>Description:</p> <p>Light:</p> <p>Characteristics:</p> <p>Position (WGS84):</p> <p>Comments:</p>	<p>11</p> <p>11</p> <p>Starboard-hand mark</p> <p>Spar beacon with triangular dayboard</p> <p>Green</p> <p>Fl G 2.5s 6m 4M</p> <p>0706.4272°N 171°17.4206'E</p> <p>This beacon has been damaged by a ship and now sits too close to the water level. It needs urgent maintenance.</p>
