South Pacific Commission

CAPTURE SECTION REPORT
OF
TUNA LONGLINE FISHING ASSISTANCE TO
THE NATIONAL FISHERIES CORPORATION (POHNPEI DIVISION)
FEDERATED STATES OF MICRONESIA

27 MARCH – 19 JUNE 1996

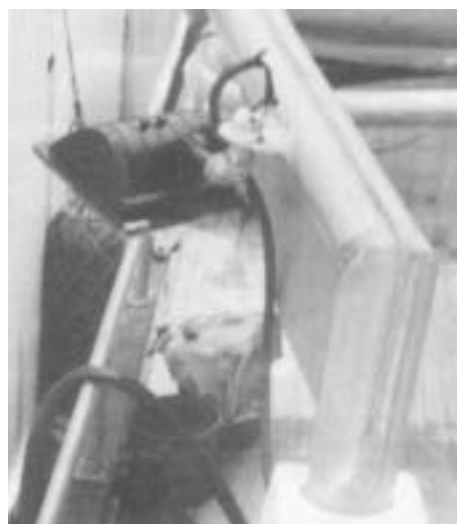
Figure 4: Quartz light mounted on davit to light up the line-hauling area at night

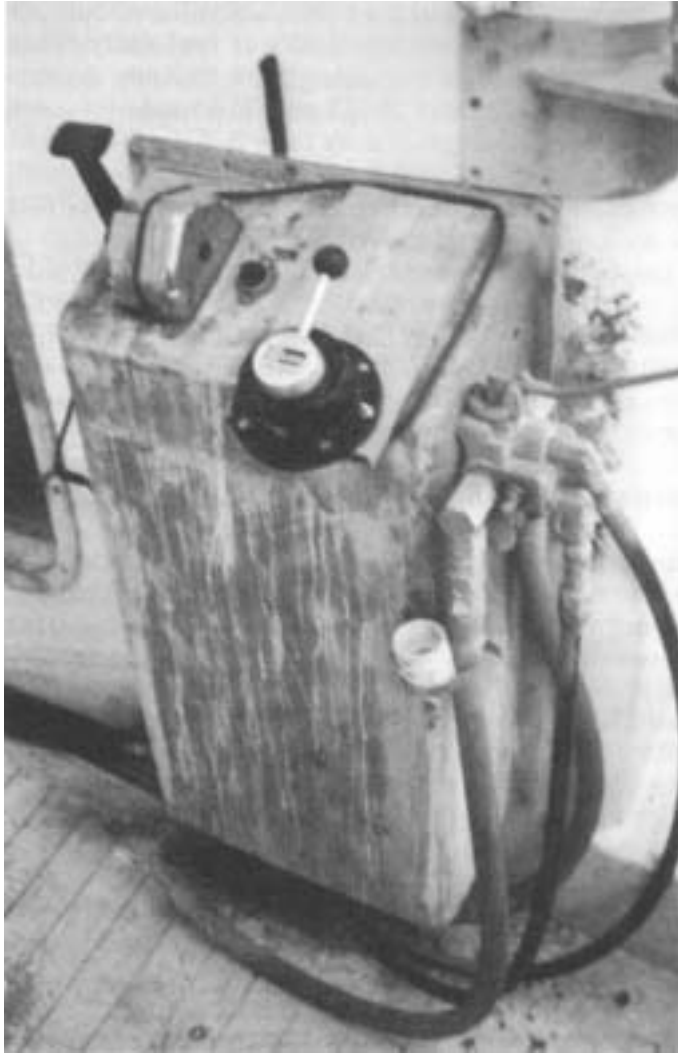
Figure 5: New mounting for the Wagner jog steering control and control valve for operating the LP reel

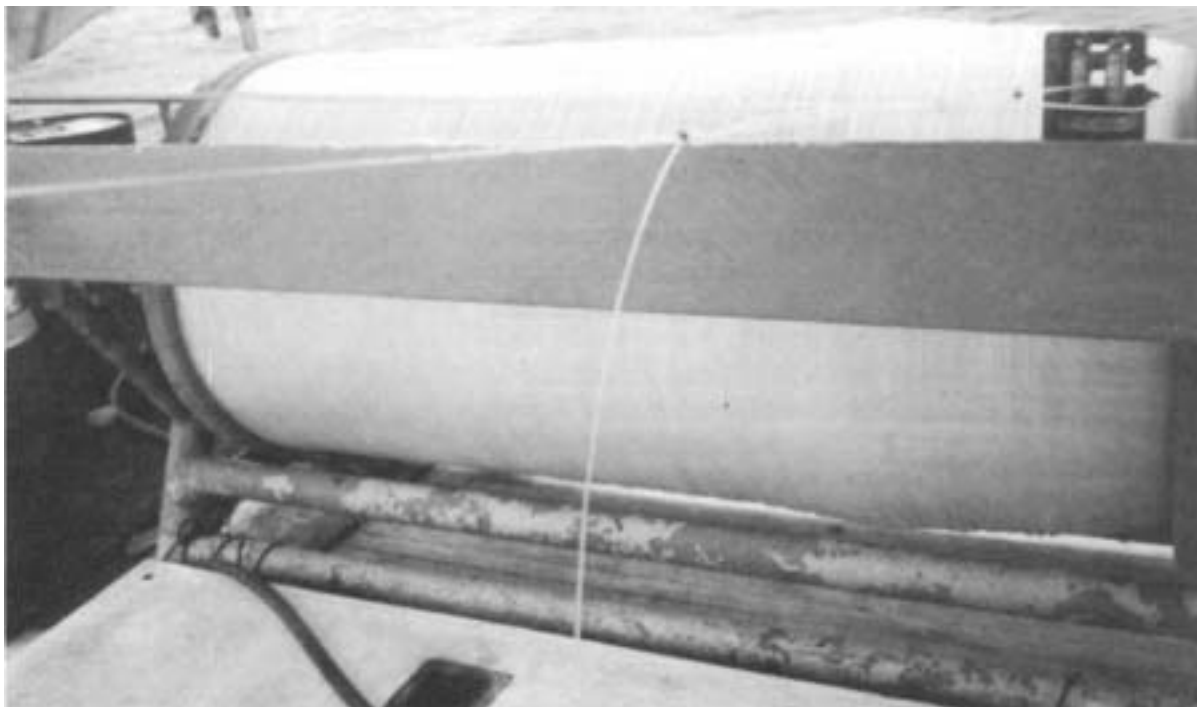
The LP reel and the LP LS-3 shooter were in need of some general maintenance. The line shooter required a new drive wheel, line guides and all rubber parts replaced. The leader cart, however, was unrepairable as no parts were readily available. In any event, leader carts are not in general use in the tuna longline fishery, so a decision was made to remove it from the vessel. Floats would be pulled in by hand and floatlines hand-coiled as is done on most longline vessels.

Figure 6: LP reel with new monofilament mainline installed
