Secretariat of the Pacific Community

FIELD REPORT No. 25
on
TECHNICAL ASSISTANCE PROVIDED
TO THE LONGLINE FISHING
VESSEL, F/V *TEKOKONA III*,
CHRISTMAS ISLAND,
REPUBLIC OF KIRIBATI

21 October to 16 December, 2003

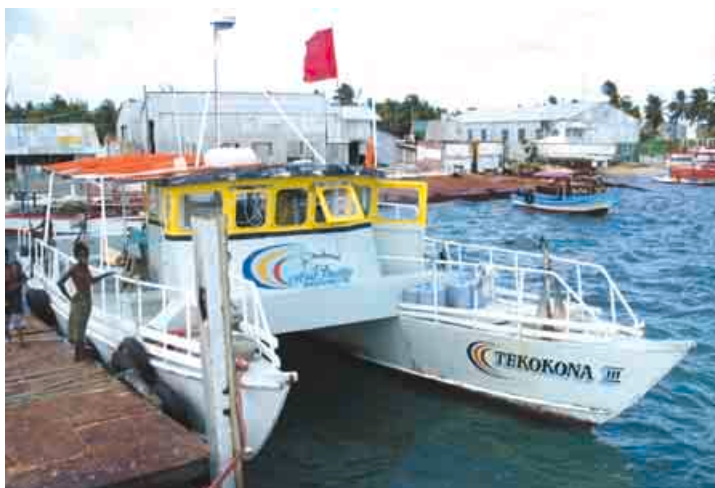
F/V *Tekokona III* was a 13 m wood outrigger canoe powered by a small inboard diesel engine (Figure 6). The vessel was designed by Oyvind Gulbrandsen. The design is called a KIR-16. F/V *Tekokona III* was built by Mike Savins at Betiraoi Boatbuilding in Tarawa, Kiribati. The vessel construction was financed by the government of Japan.

Figure 6: F/V Tekokona III at the wharf at Kiritimati

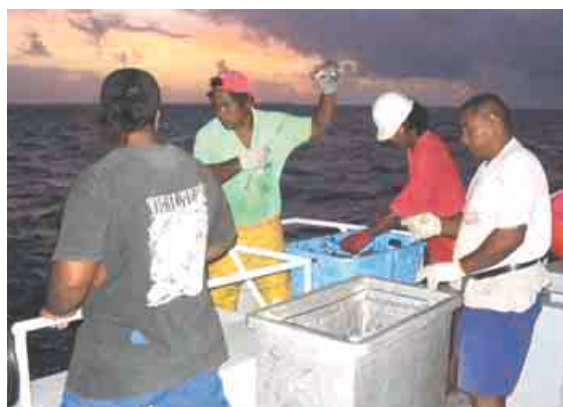
Figure 9: Setting the longline gear at first light

On 12 December the second longline set was made starting at 0600 hours at 01° 59.56'N and 157° 32.00'W going south (Figure 9). The set was finished at 0710 hours. A total of 378 hooks were set in 25 hook baskets using milkfish bait. No problems were encountered during setting.

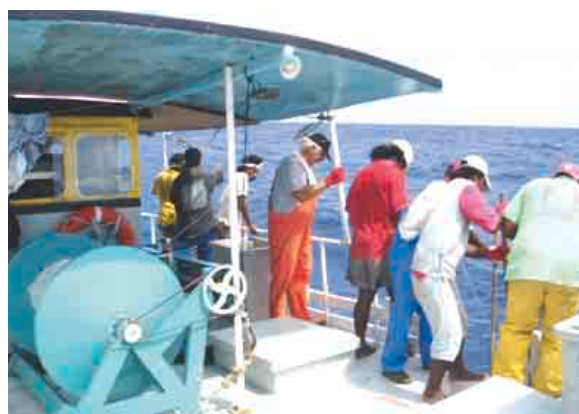
Figure 10: Hauling the longline from F/V Tekokona III

Hauling started at 1145 hours and finished at 1420 hours (Figure 10). No problems were encountered during the haul as the branchlines had all been shifted to two separate branchline bins. Two men could now work simultaneously coiling branchlines with no interruptions. The catch was four yellowfin tuna, one bigeye tuna, four big-scaled pomfrets, one silky shark, one thresher shark, and one sunfish.

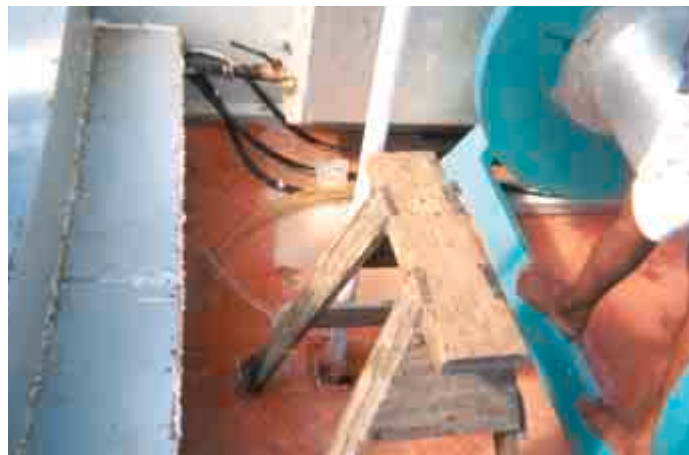
Another problem was that the deck was flat with no crown or camber. When the port fish hold started filling with fish the boat listed slightly to port. It was not possible to compensate for this by shifting fuel or by flooding a hold as would normally be done on a mono-hull boat. The list, in any case, did not interfere with the seaworthiness of the boat. What it did do, however, was to cause seawater and fish blood to accumulate on the deck where the working deck meets the port hull (Figure 13). This created a dangerous situation as the deck became very slippery. Another problem was that this water eventually found its way into the wheelhouse in this area. After hauling was completed seawater was discovered in the wheelhouse under the bunks. This would damage anything stored in the storage space under the bunks and would eventually cause problems with wood rot. Unsealed wood that is wet and dry continually will suffer from dry rot. A small drain hole (weep hole) was cut in this area at one time (see Figure 8) but a larger drain hole with screen was needed.

Figure 13: Water accumulating on flat deck

- A bigger weep hole is needed on deck just behind the wheelhouse on the port side of the reel — cut a hole about 4 cm and put a screen on it;
- Wheelhouse needs to be sealed watertight where it joins to the deck aft. The wood beam in this area needs replacing. Water coming in here will ruin anything stored under bunks and eventually rot the timber;
