Annex A - Detailed information on PV sites

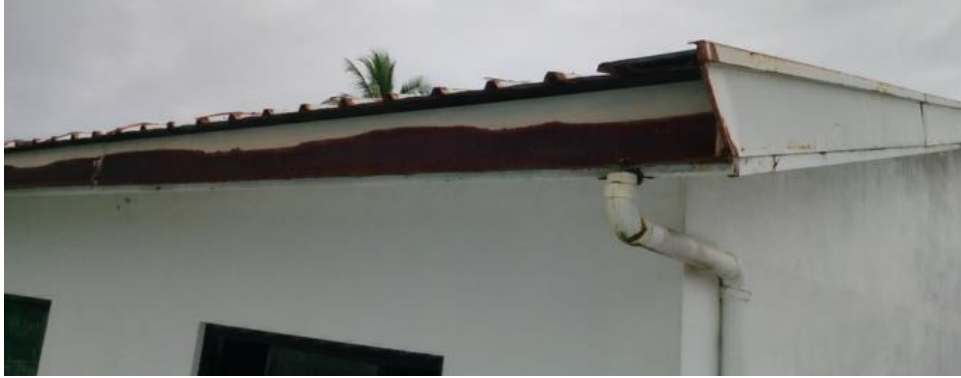
Figure 3. Edge of the Sapota 1-storey elementary school roof

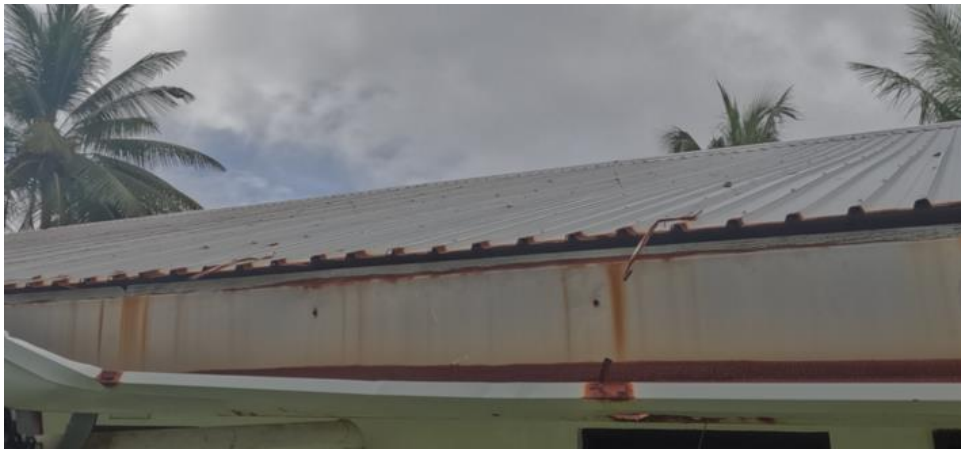
Figure 4. Edge of the Sapota 1-storey elementary school roof 2

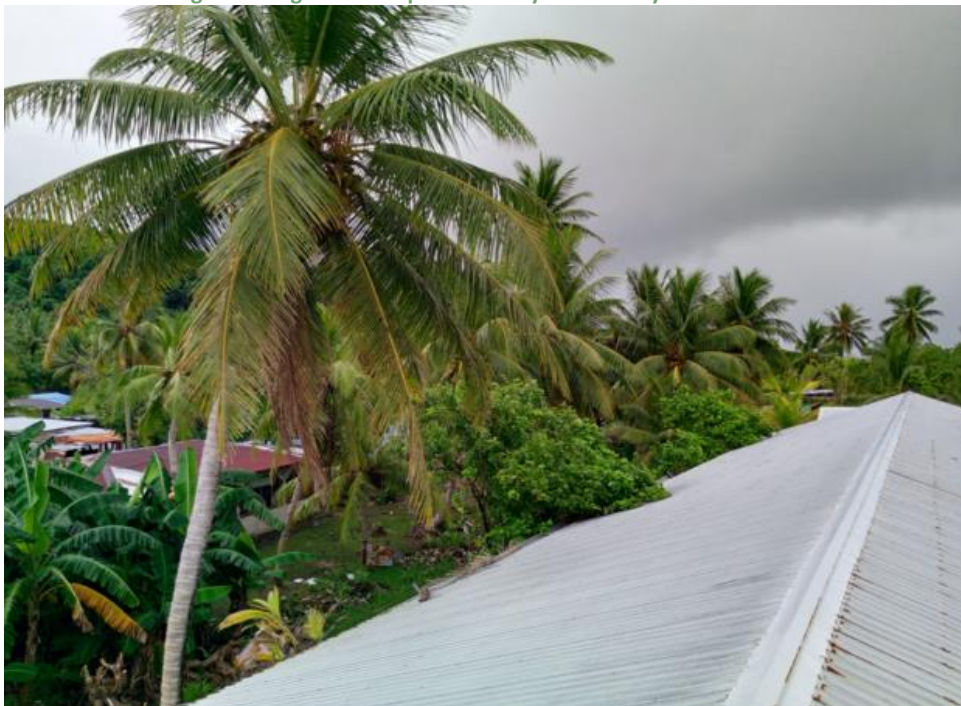
Figure 5. West part of the Sapota 1-storey elementary school roof

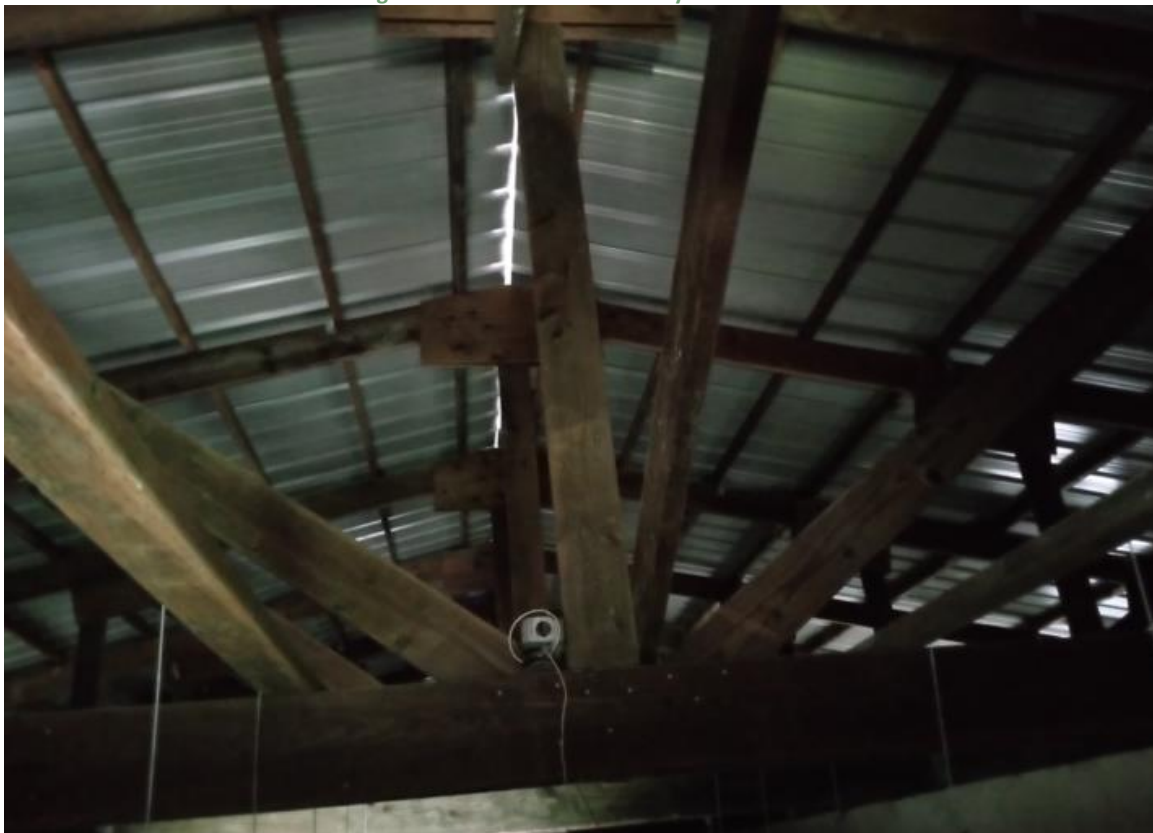
Figure 11. Roof structure of the Sapota 2-storey elementary school

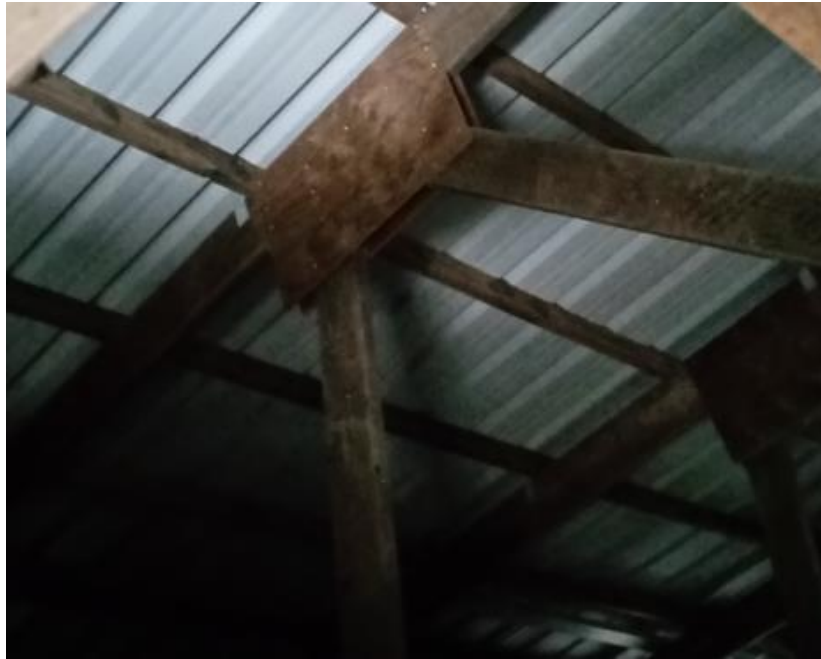
Figure 12. Figure 11. roof structure of the Sapota 2-storey elementary school 2

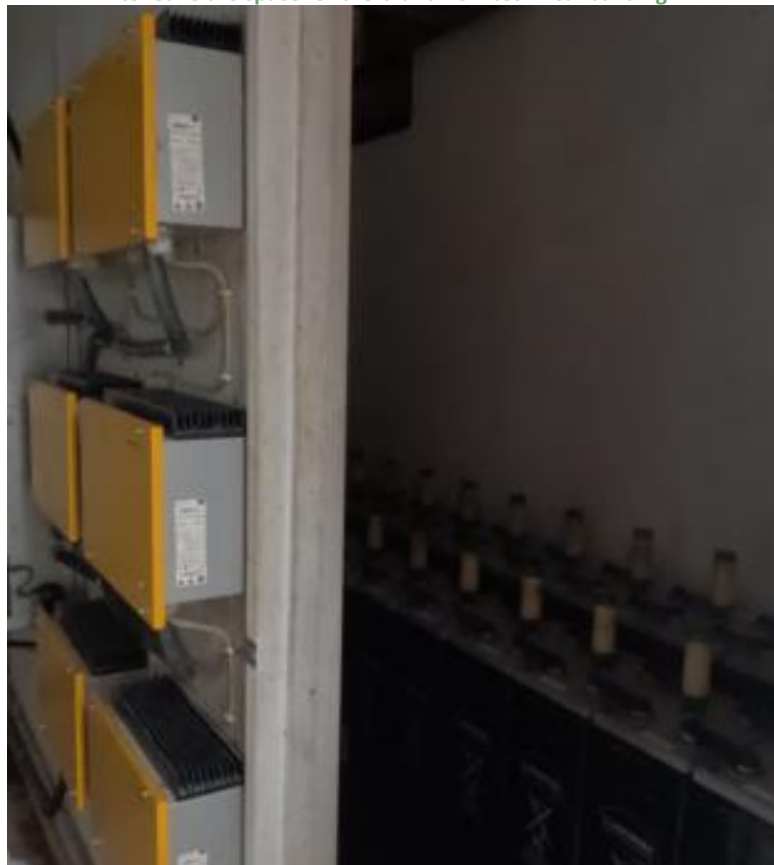
Figure 15. Sapota current solar system, that will be removed and placed somewhere else by CPUC

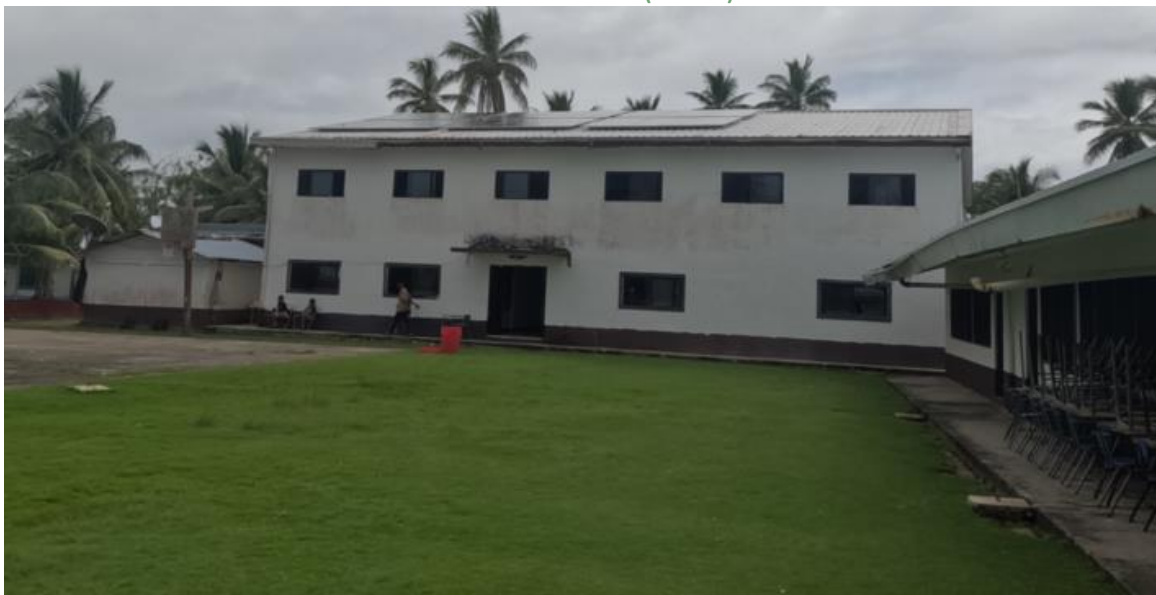
Figure 19. Same view of Sapota 2-storey high school. The concrete blocks on the grass are not connected to a sewage system or tubes.

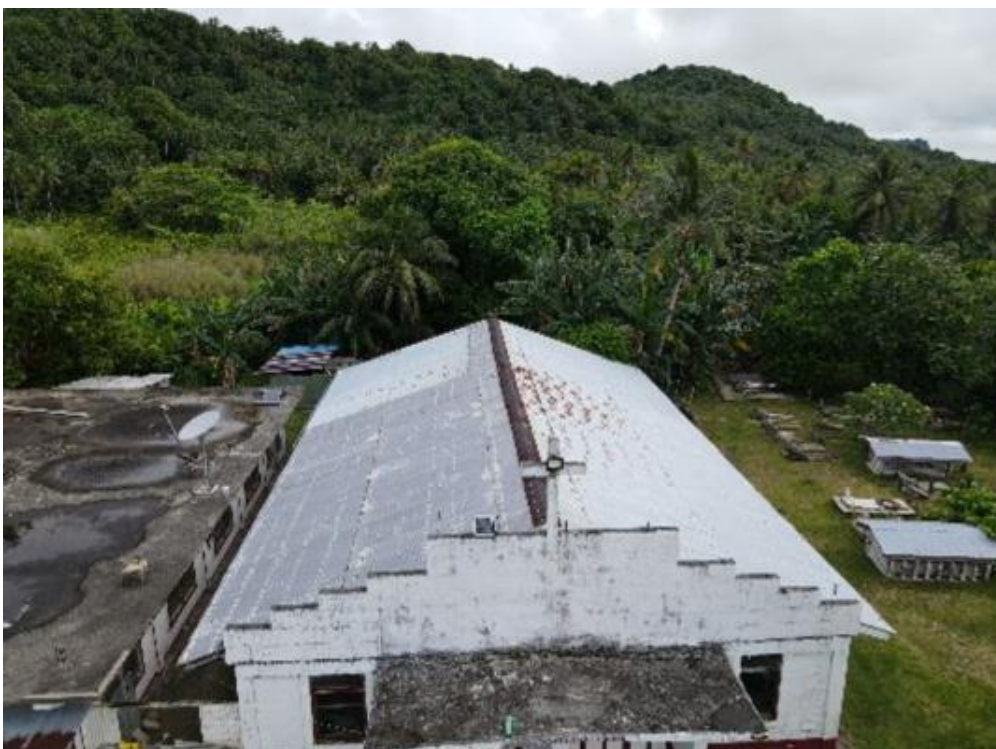
Figure 21. Drone front elevated view of roof in G1-RT3

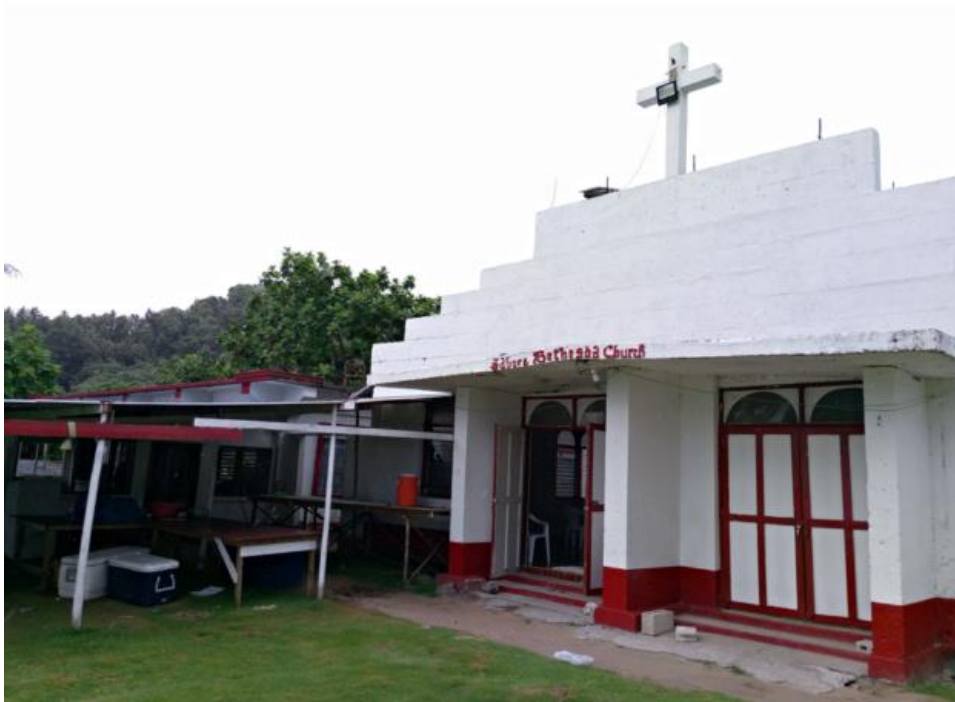
Figure 22. Front of the Sapota church. At the left is the existing canopy and the community building at its back.

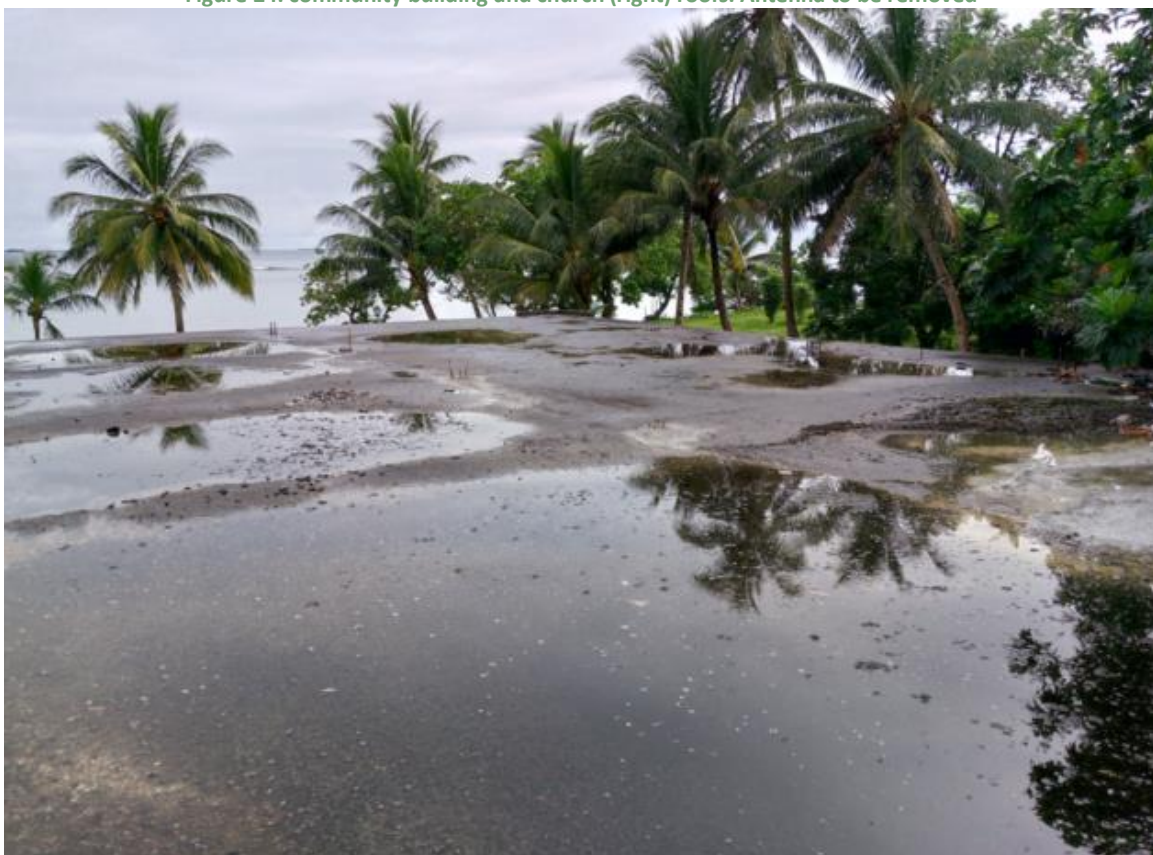
Figure 25. Community building roof

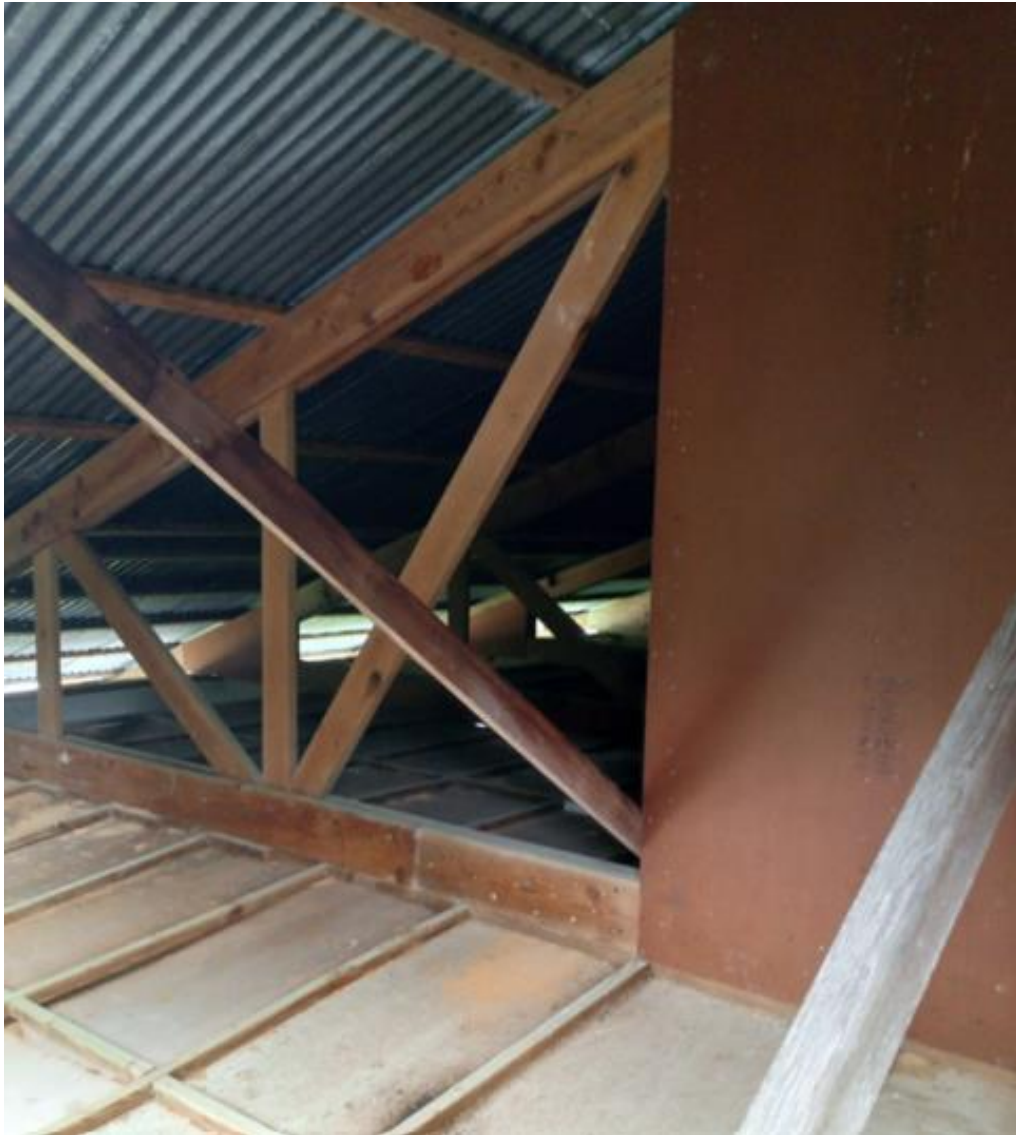
Figure 28. Sapota church roof structure

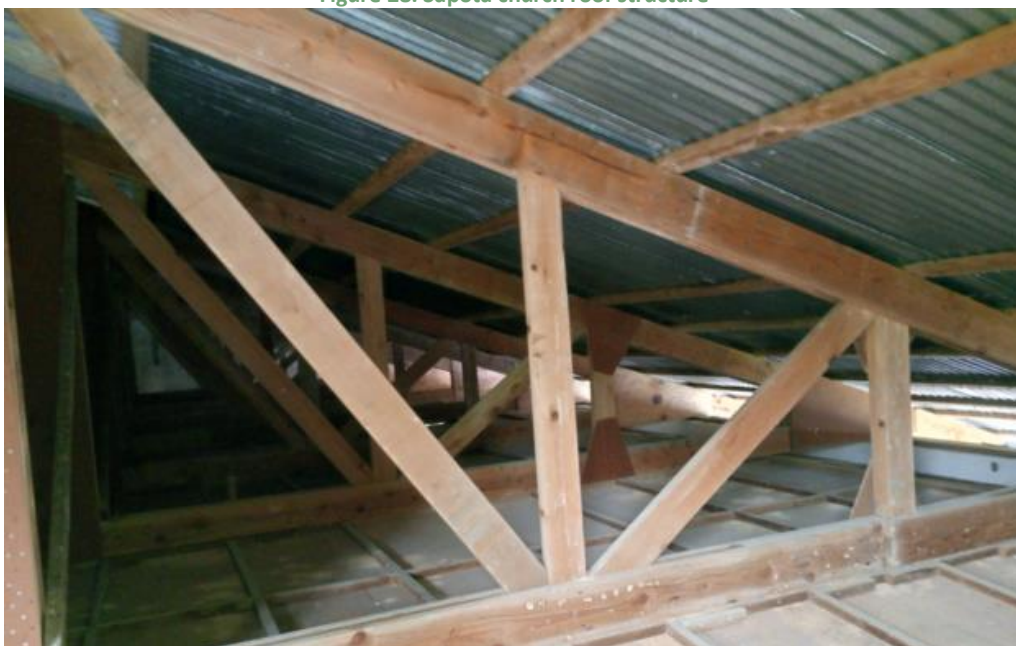
Figure 29. Sapota church structure 2

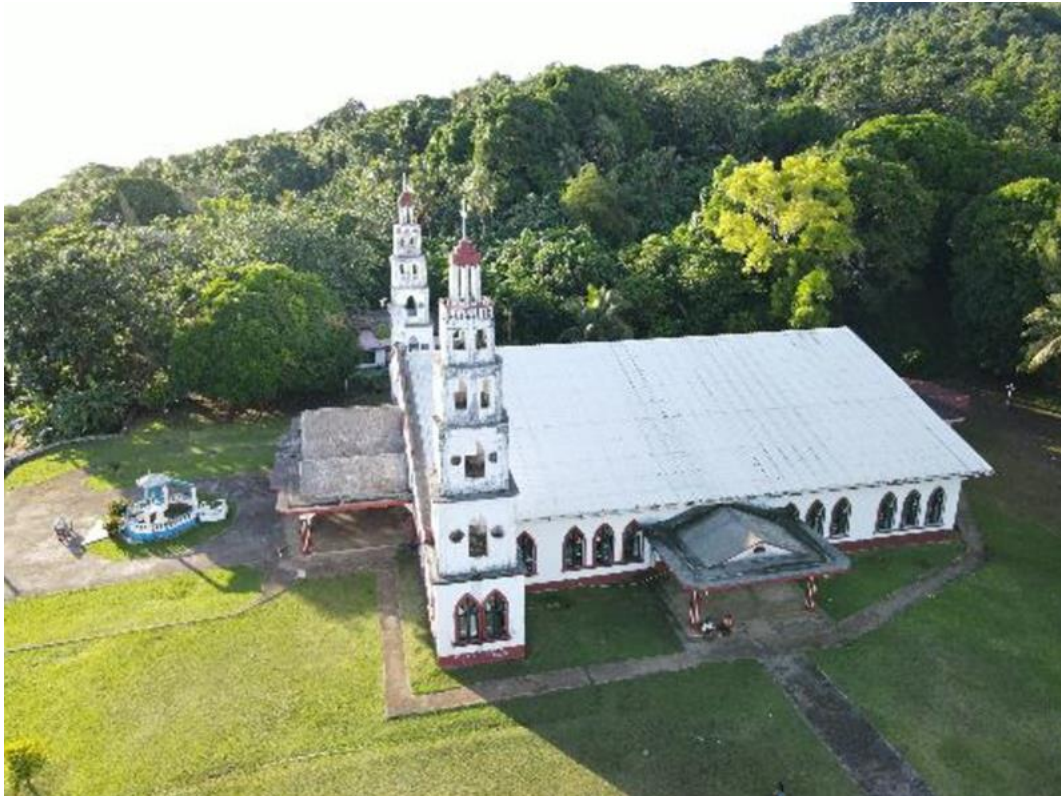
Figure 39. Drone footage of roof in G2-RT1

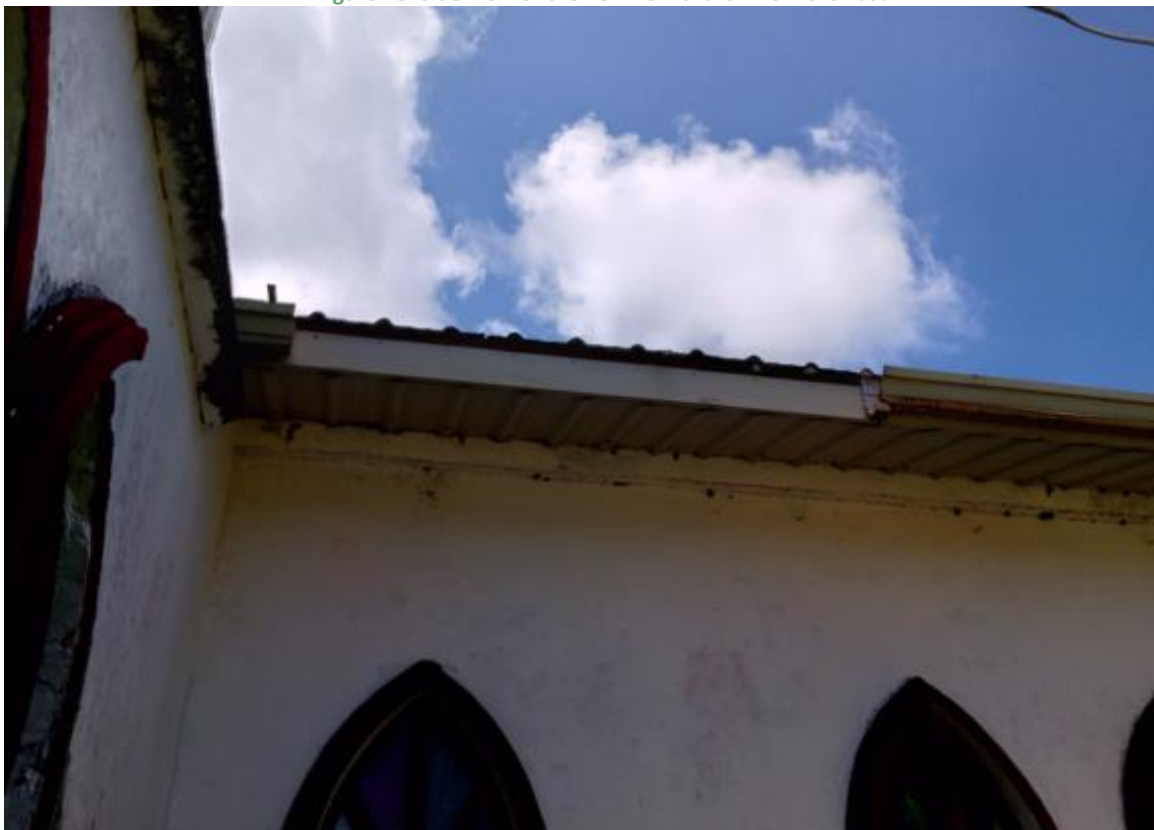
Figure 44. View of roof edge in G2-RT1

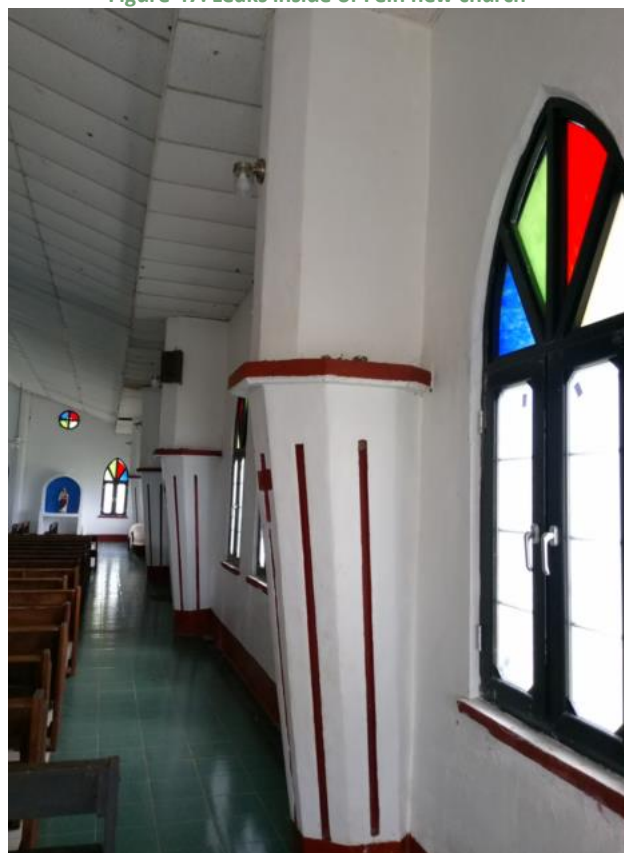
Figure 48. Concrete base of the trusses of Fein new church

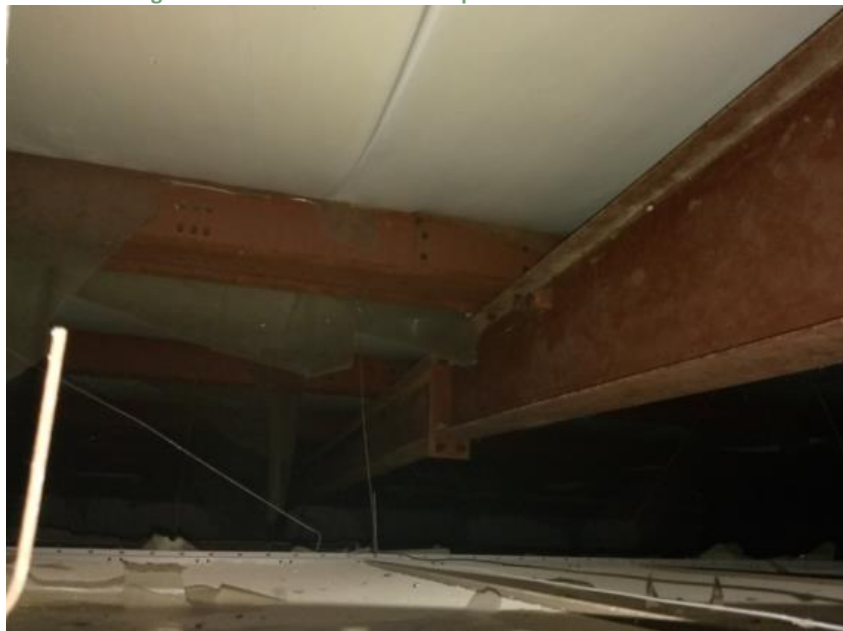
Figure 50. View of truss and purlins of Fein new church

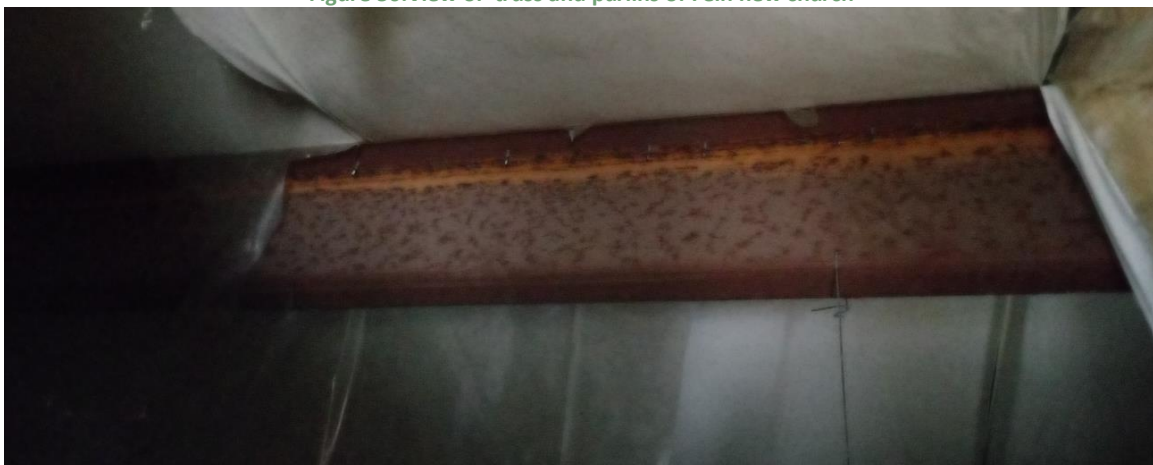
Figure 51. Steel purlins of Fein new church

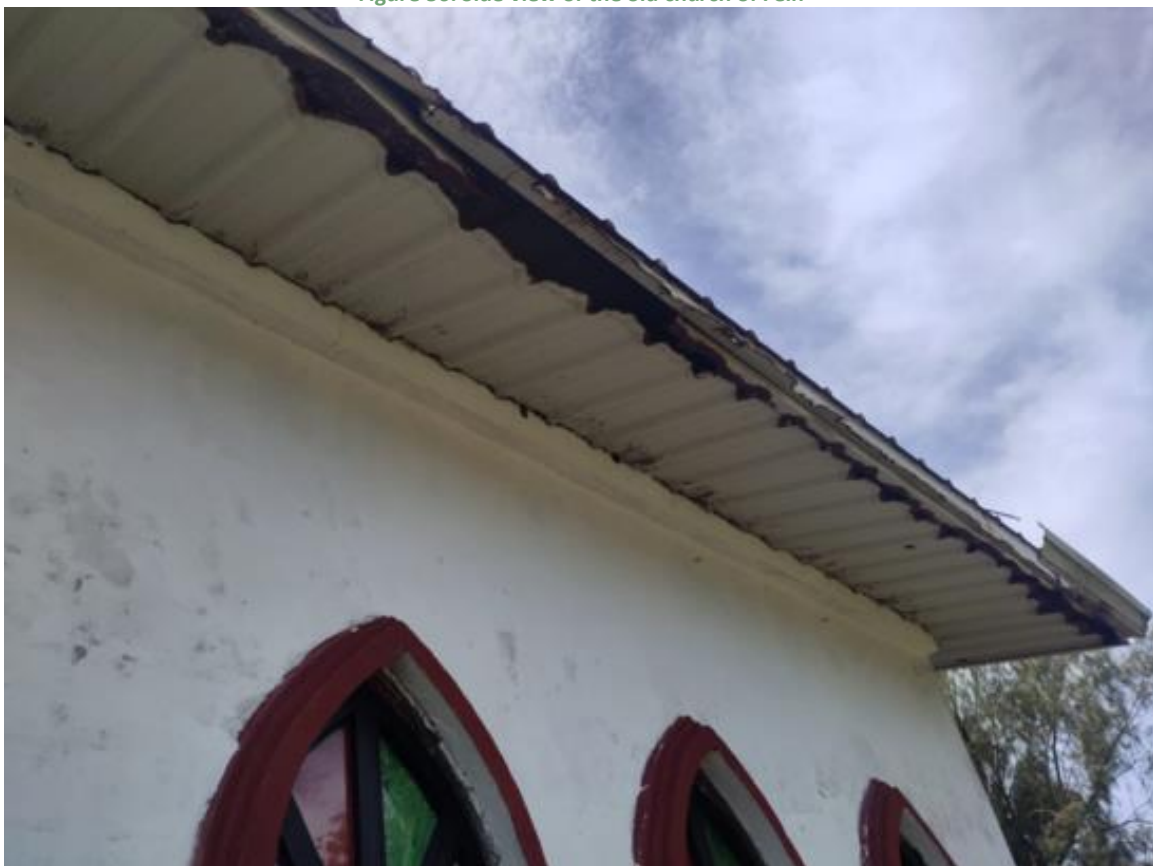
Figure 57. Roof edge of the Fein old church

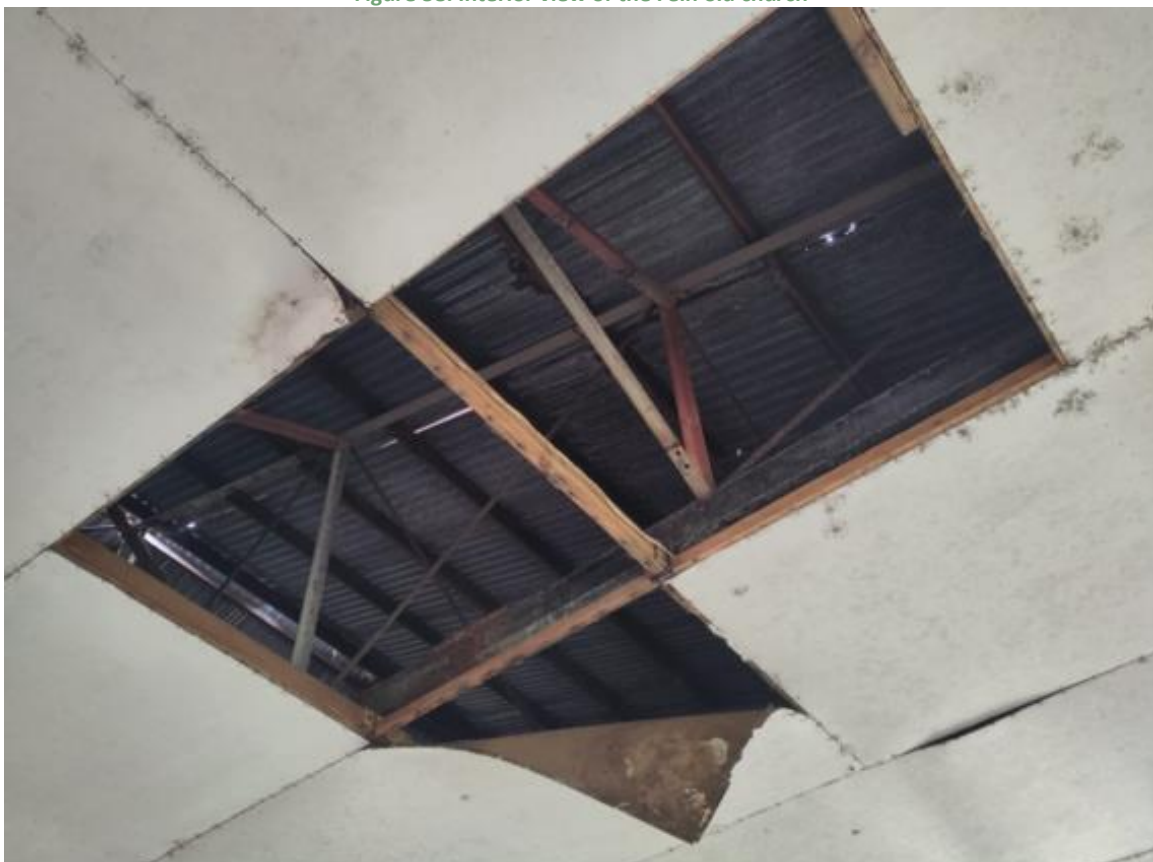
Figure 59. Steel structures of the old church's roof (truss)

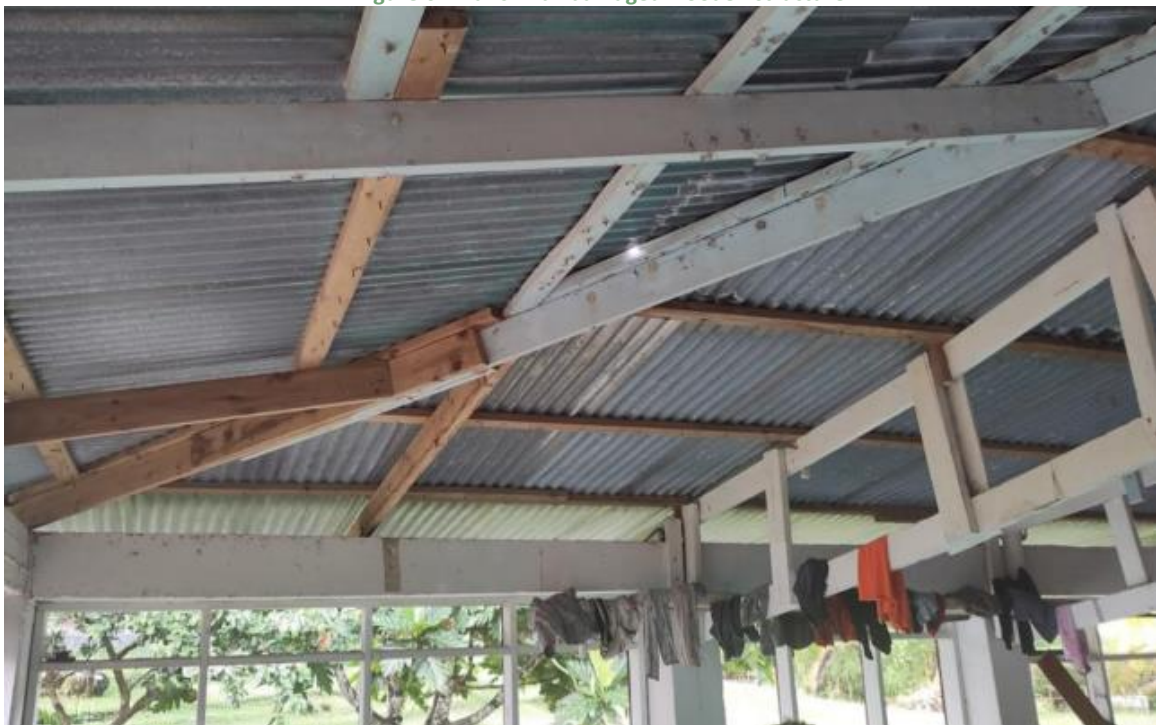
Figure 63. Parish hall wooden structure

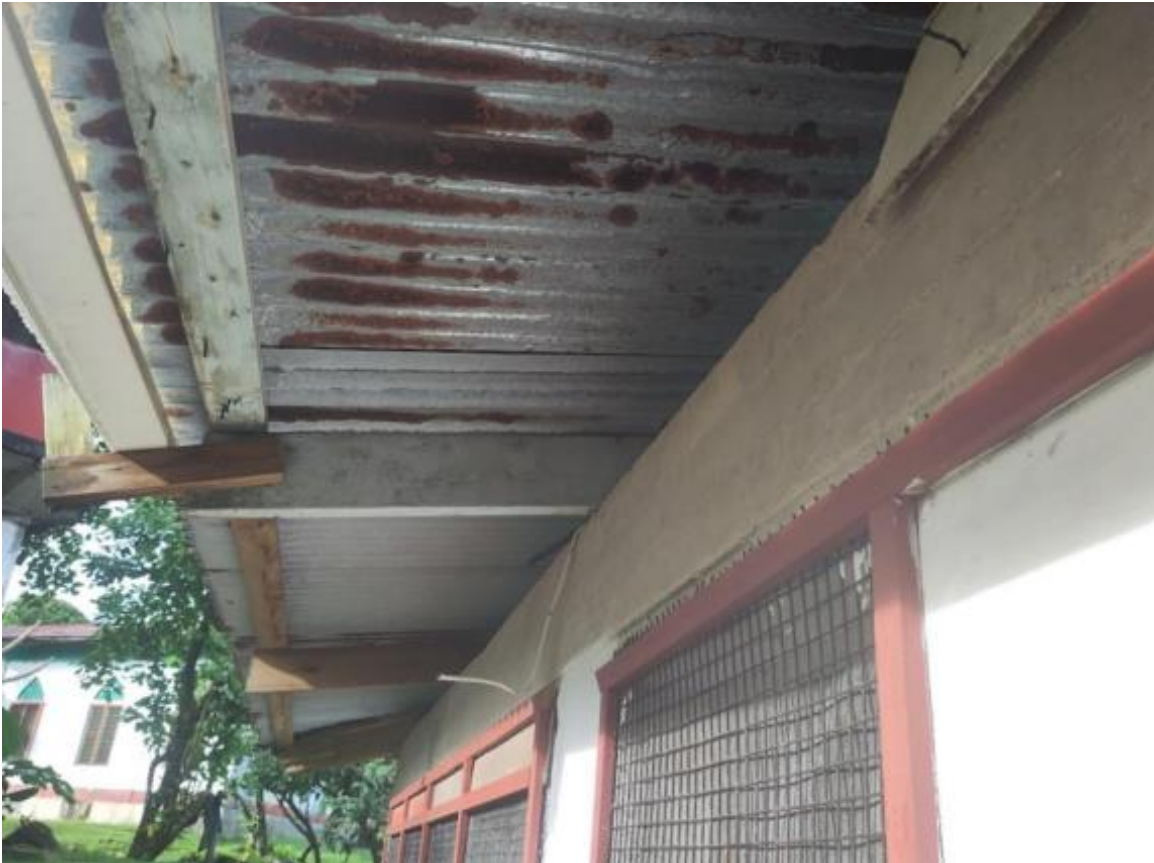
Figure 64. Parish hall roof edge

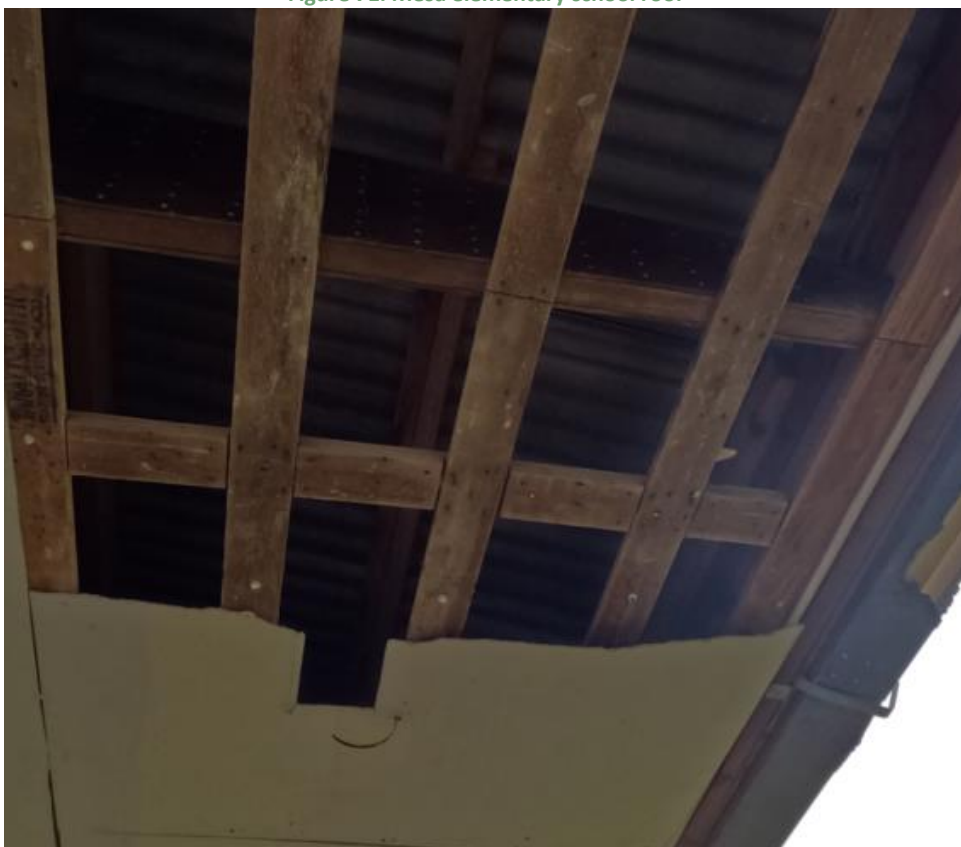
Figure 72. Wooden structure of the Mesa elementary school

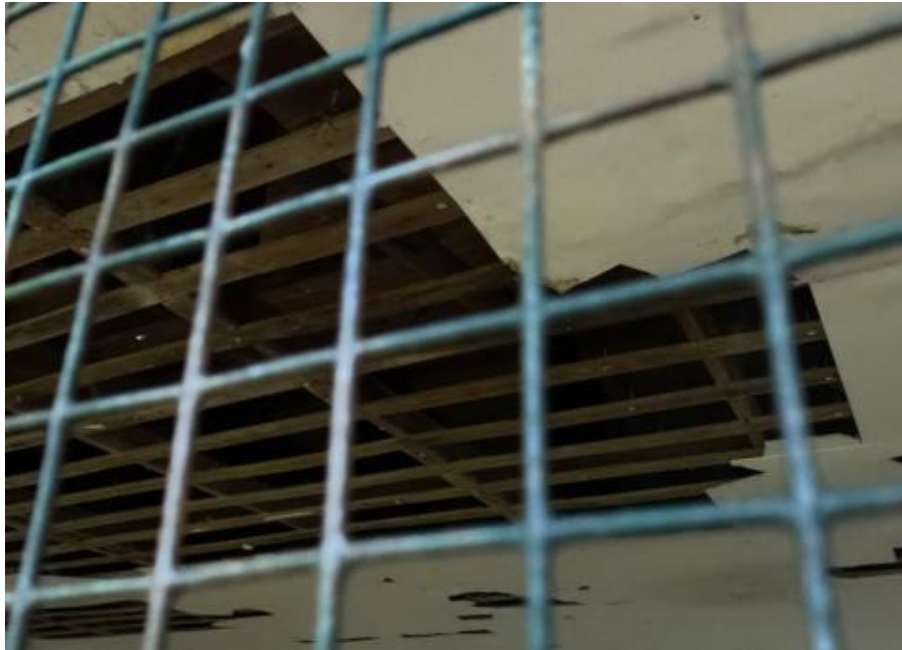
Figure 73. Ceiling of the Mesa elementary school

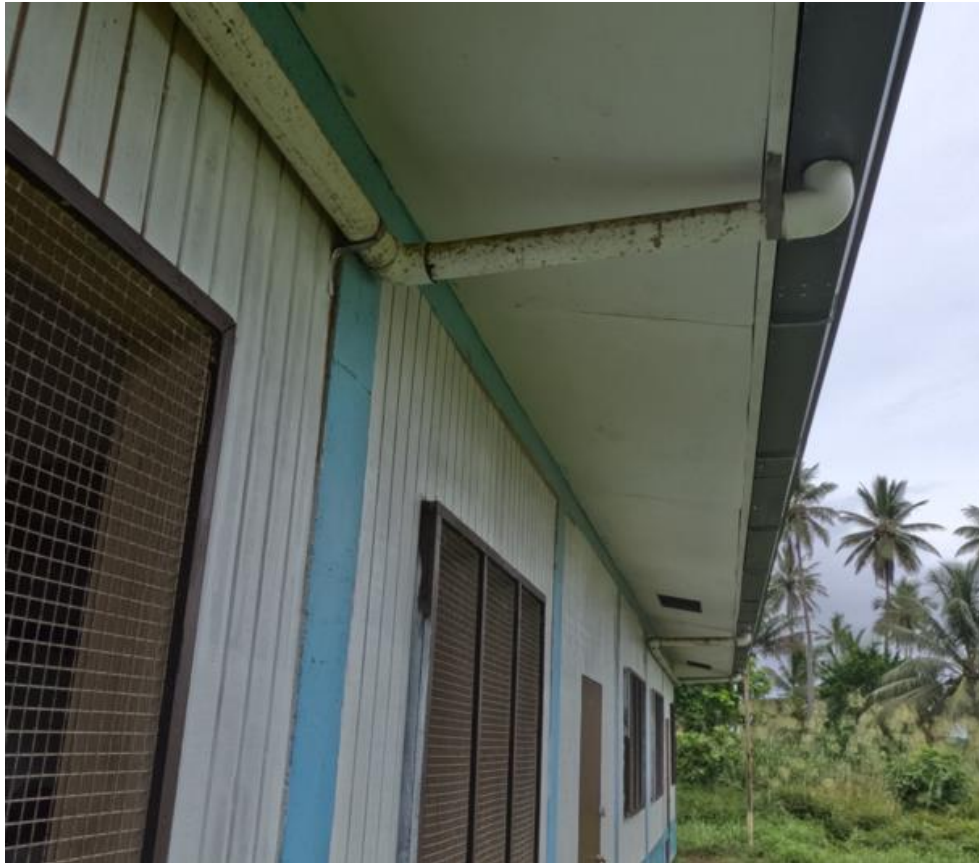
Figure 82. Side of the Mesa Municipal office displaying rain gutter

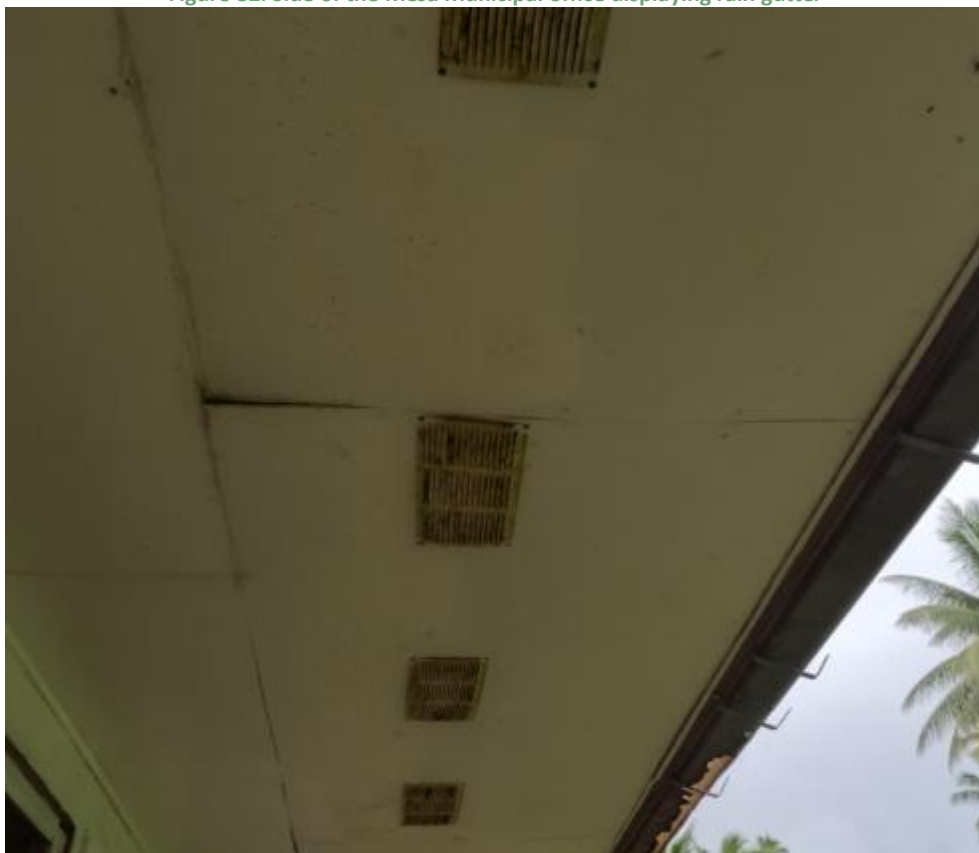
Figure 83. Overhang of the Mesa municipal office

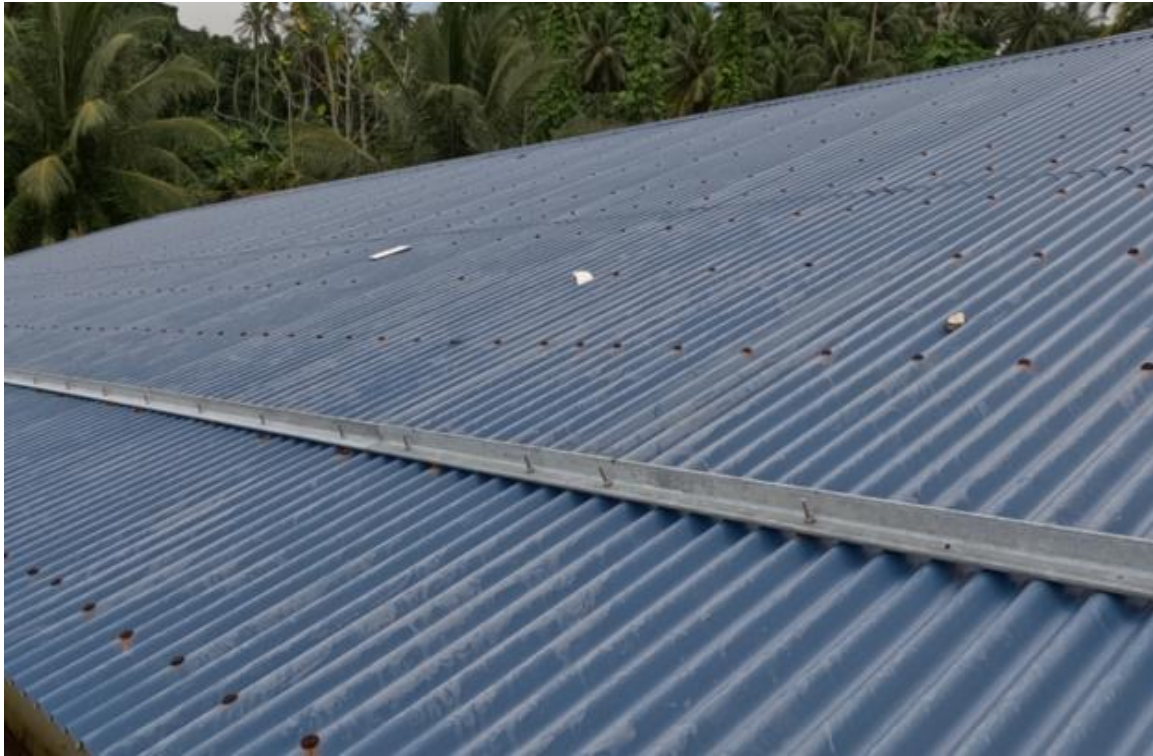
Figure 84. Roof of the Mesa municipal office

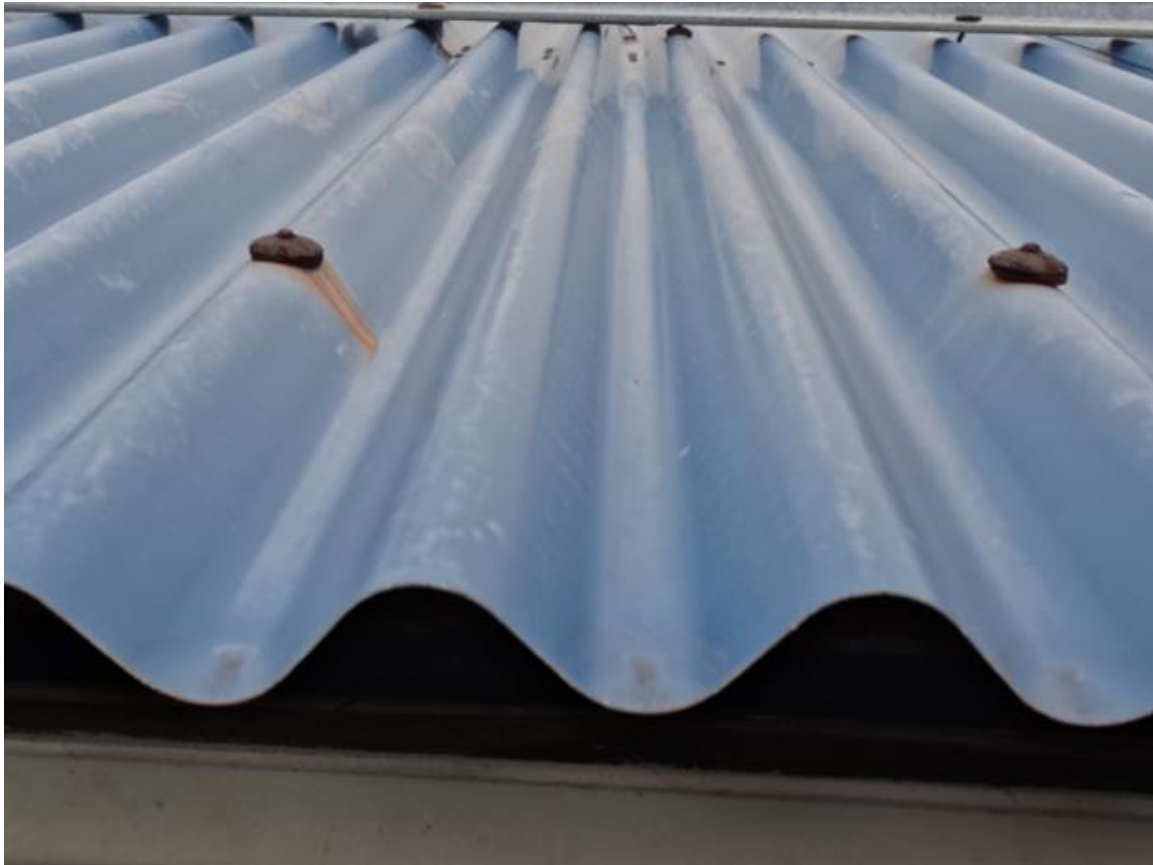
Figure 86. Edge roof of the Mesa municipal office

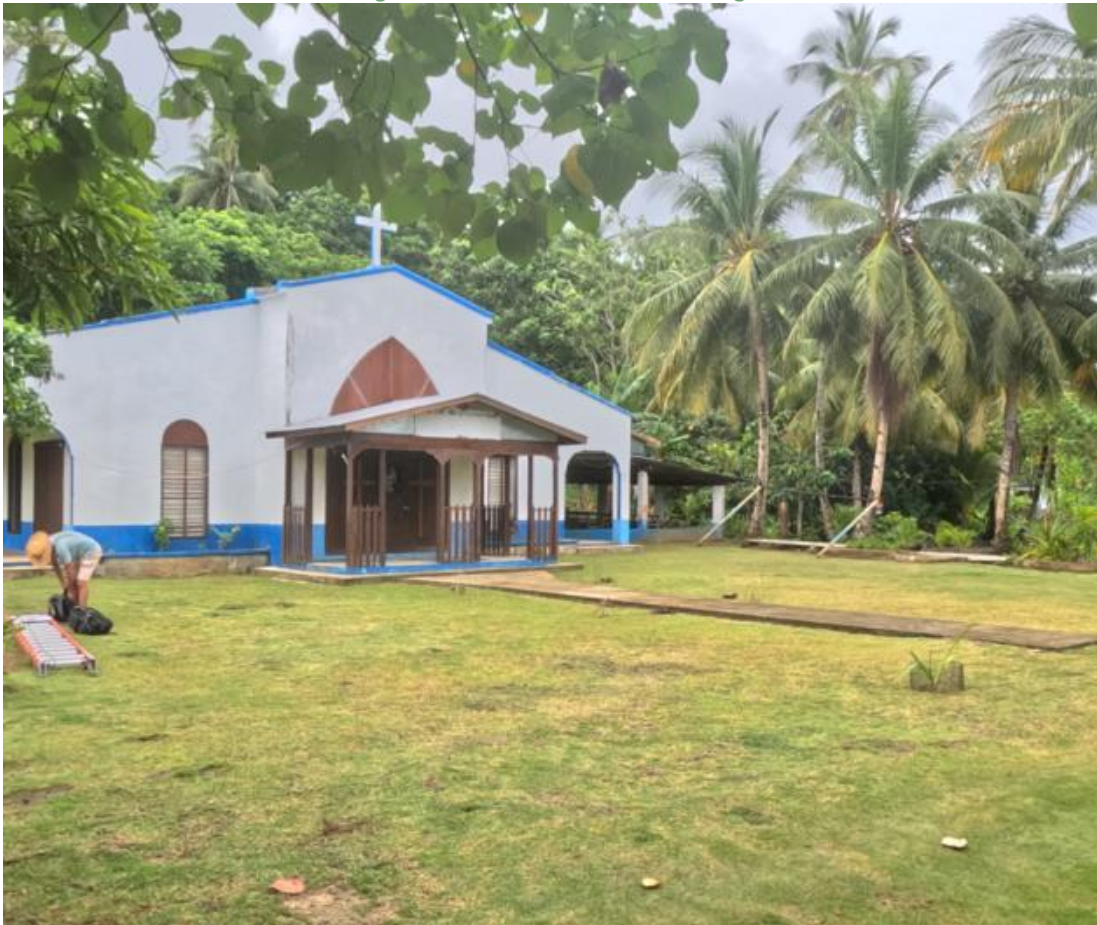
Figure 92: Mesa church and plot for the future canopy, from the road. The entrance could be removed.

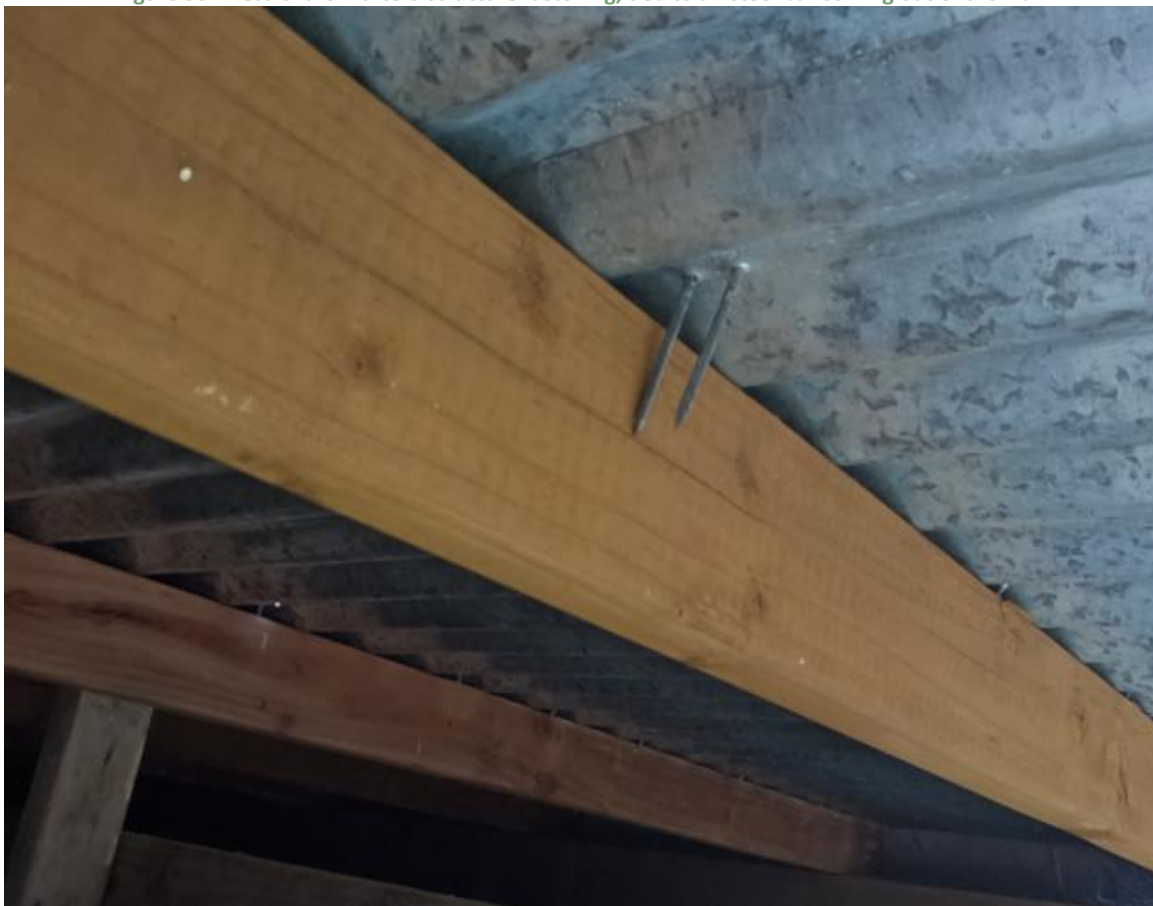
Figure 96. Mesa church roof nails
