Annex A - Detailed information on PV sites

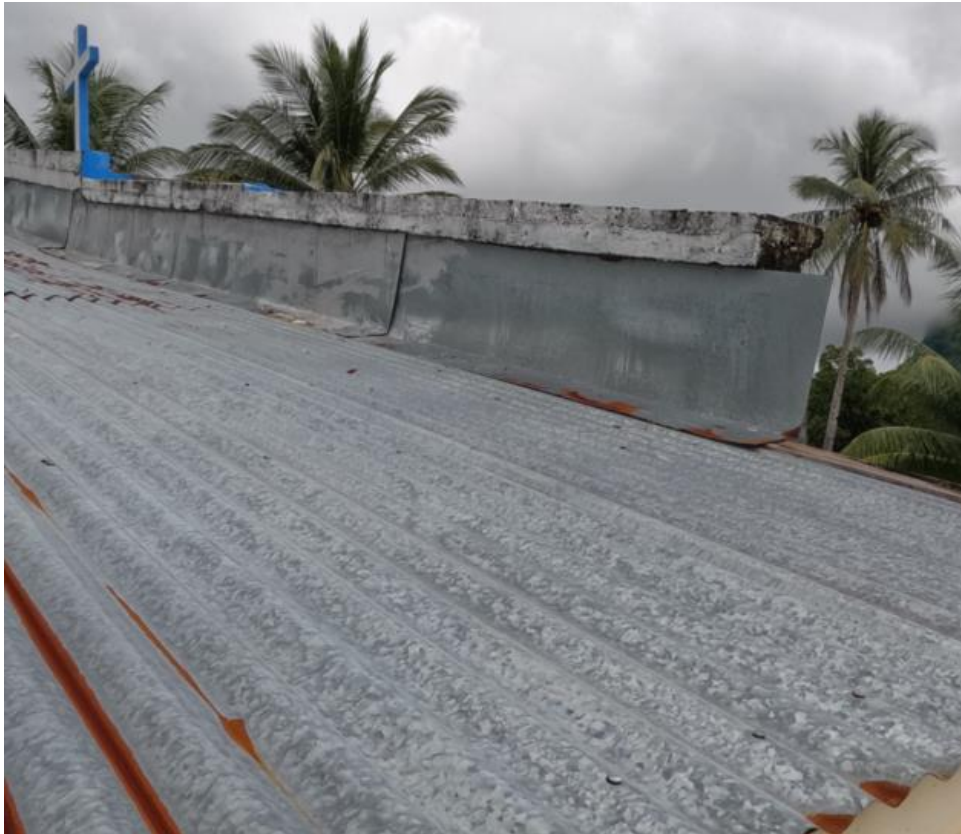
Figure 97. Mesa church roof

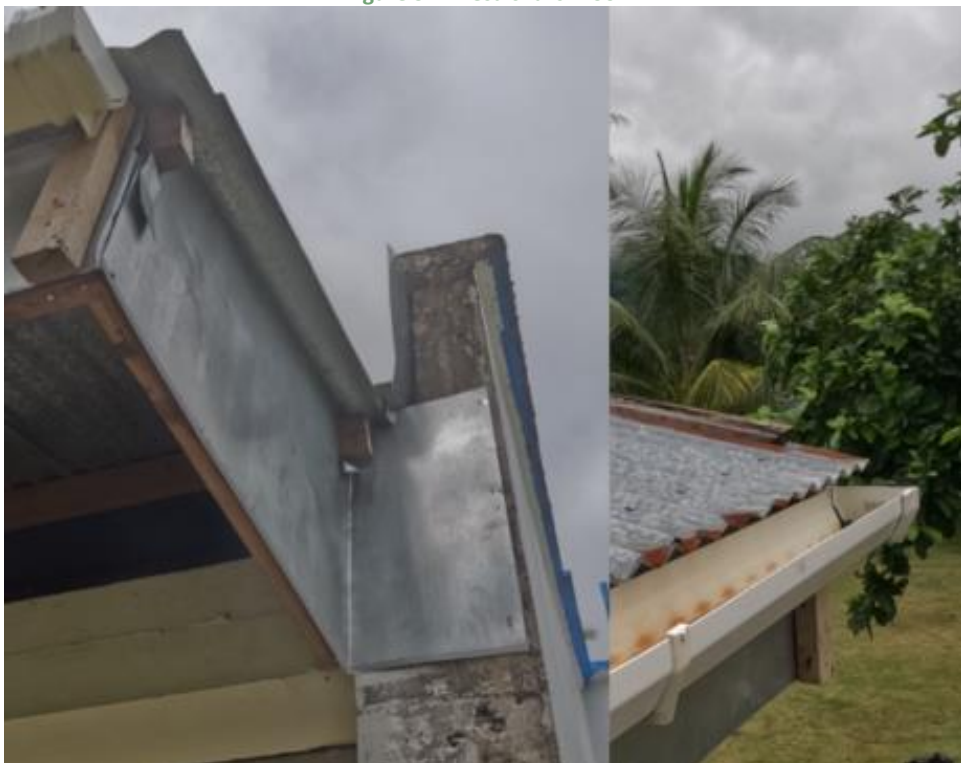
Figure 98. Mesa church roof 2 and edge (Eastern view)

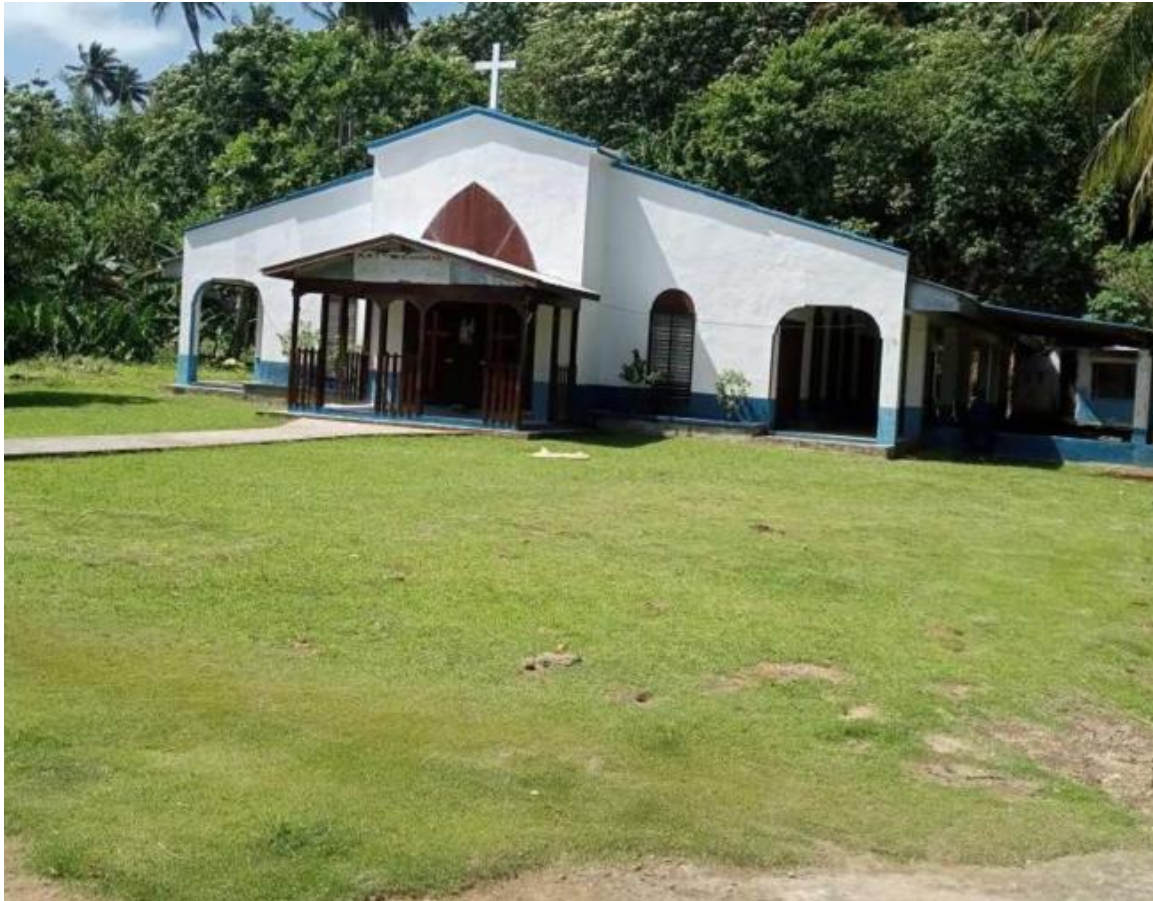
Figure 103. View of available land plot for installation of canopy
