South Pacific Commission

CAPTURE SECTION REPORT
OF
TUNA LONGLINE FISHING ASSISTANCE TO
THE NATIONAL FISHERIES CORPORATION (POHNPEI DIVISION)
FEDERATED STATES OF MICRONESIA

27 MARCH – 19 JUNE 1996

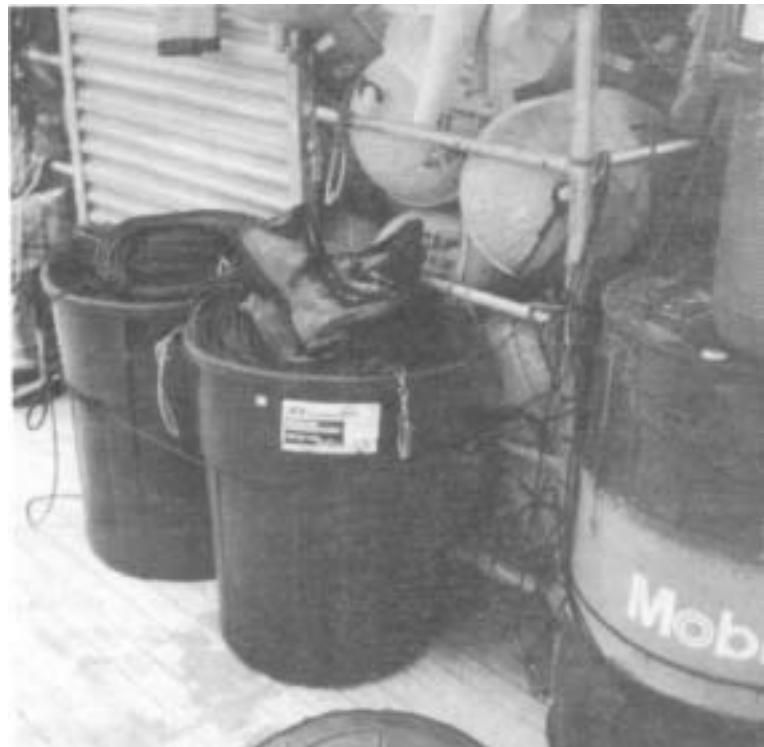
The crew of *NFC Waab* made up 80 new floatlines. These consisted of 30 m (15 fathoms) of tarred 6.4 mm (0.25 in) kuralon (the same type of line used in Japanese basket gear). An eye splice was put in one end of each line and a 9/0 swivel snap was spliced into the other end. The eye splice was for attaching floats during setting and the snap was for snapping the floatline to the mainline (9/0 refers to the size of swivel on the snap). These floatlines were stored on *NFC Waab's* deck in large plastic rubbish bins that were secured to the rail (Figure 7).

Figure 7: New floatlines stored in plastic rubbish bins secured to the rail

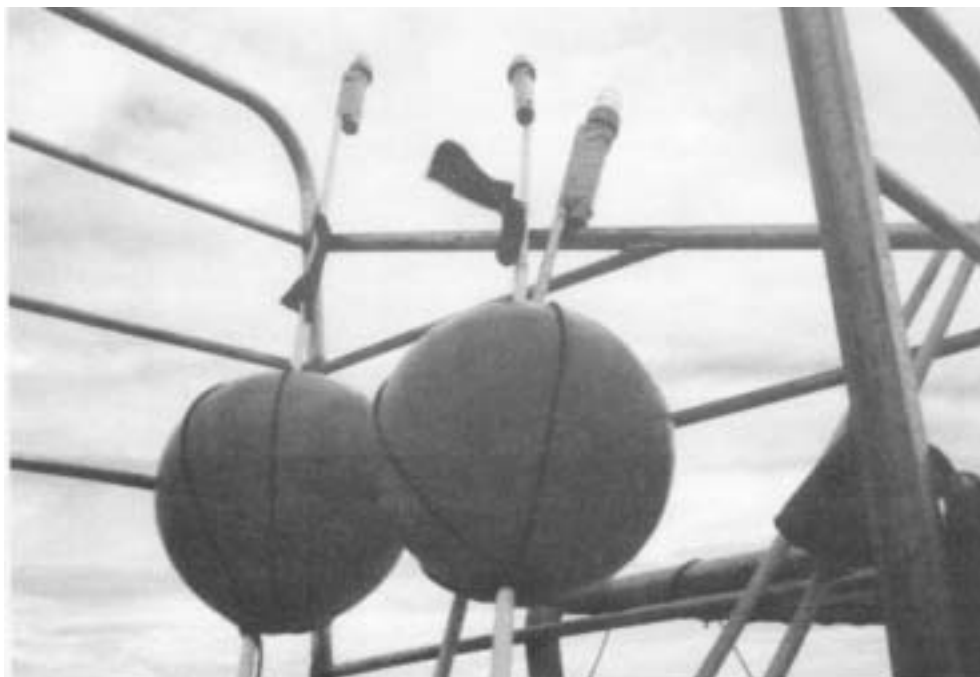
The Masterfisherman and the crew also made up four light buoys (Figure 8). These consisted of a 3 m (10 ft) fibreglass pole stuck through an inflatable light buoy float. Two 0.5 m (20 in) lengths of 19 mm (0.75 inch) steel rebar were clamped onto the lower end for counter balance, while a strobe light and a longline flag were attached to the top end. Reflective tape was added to improve visibility. These light buoys were attached to the mainline during setting, in between the radio buoys.

Figure 8: Light buoys made by the Masterfisherman and crew to go between radio buoys

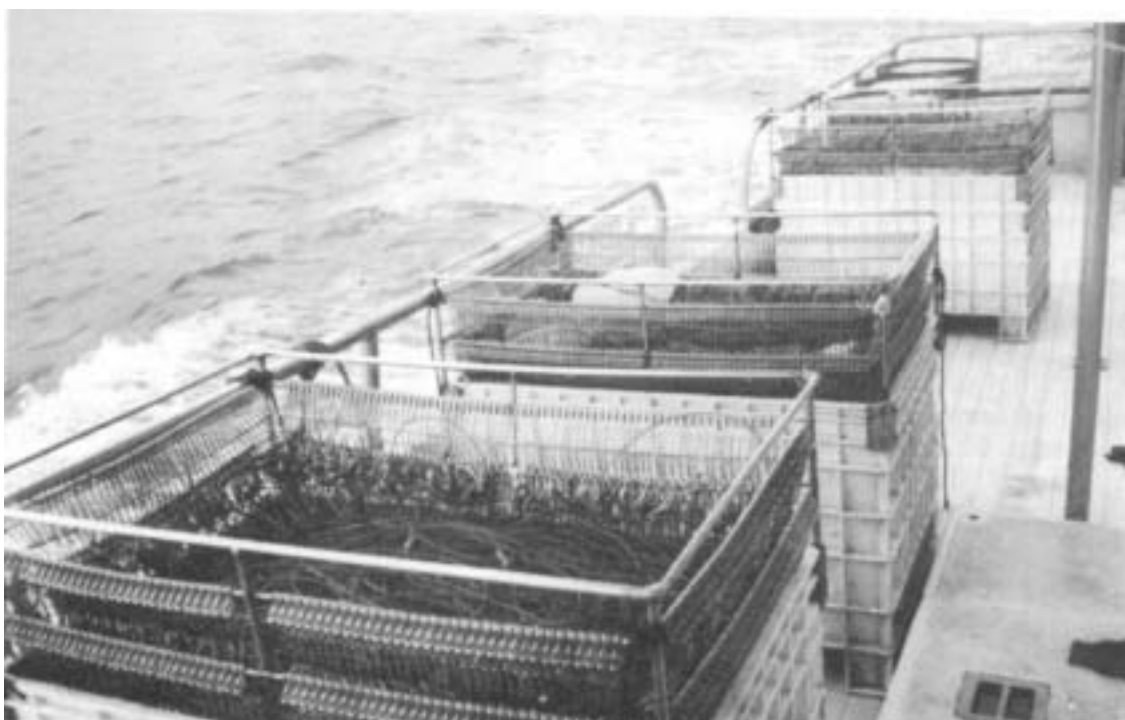
During the project 1,320 new branchlines were made up for *NFC Waab* and stored in the three bins (Figure 11). Several things contributed to the successful fishing experienced in the two trips made during the project (including a better maintenance regime and improved

Figure 11: The new tarred red polyester branchlines stored in the three bins
