Managing Coastal Aquifers in Selected **Pacific Small Island Developing States** Project (MCAP)

Groundwater investigation in Nui, Tuvalu

Suva, Fiji, 2023

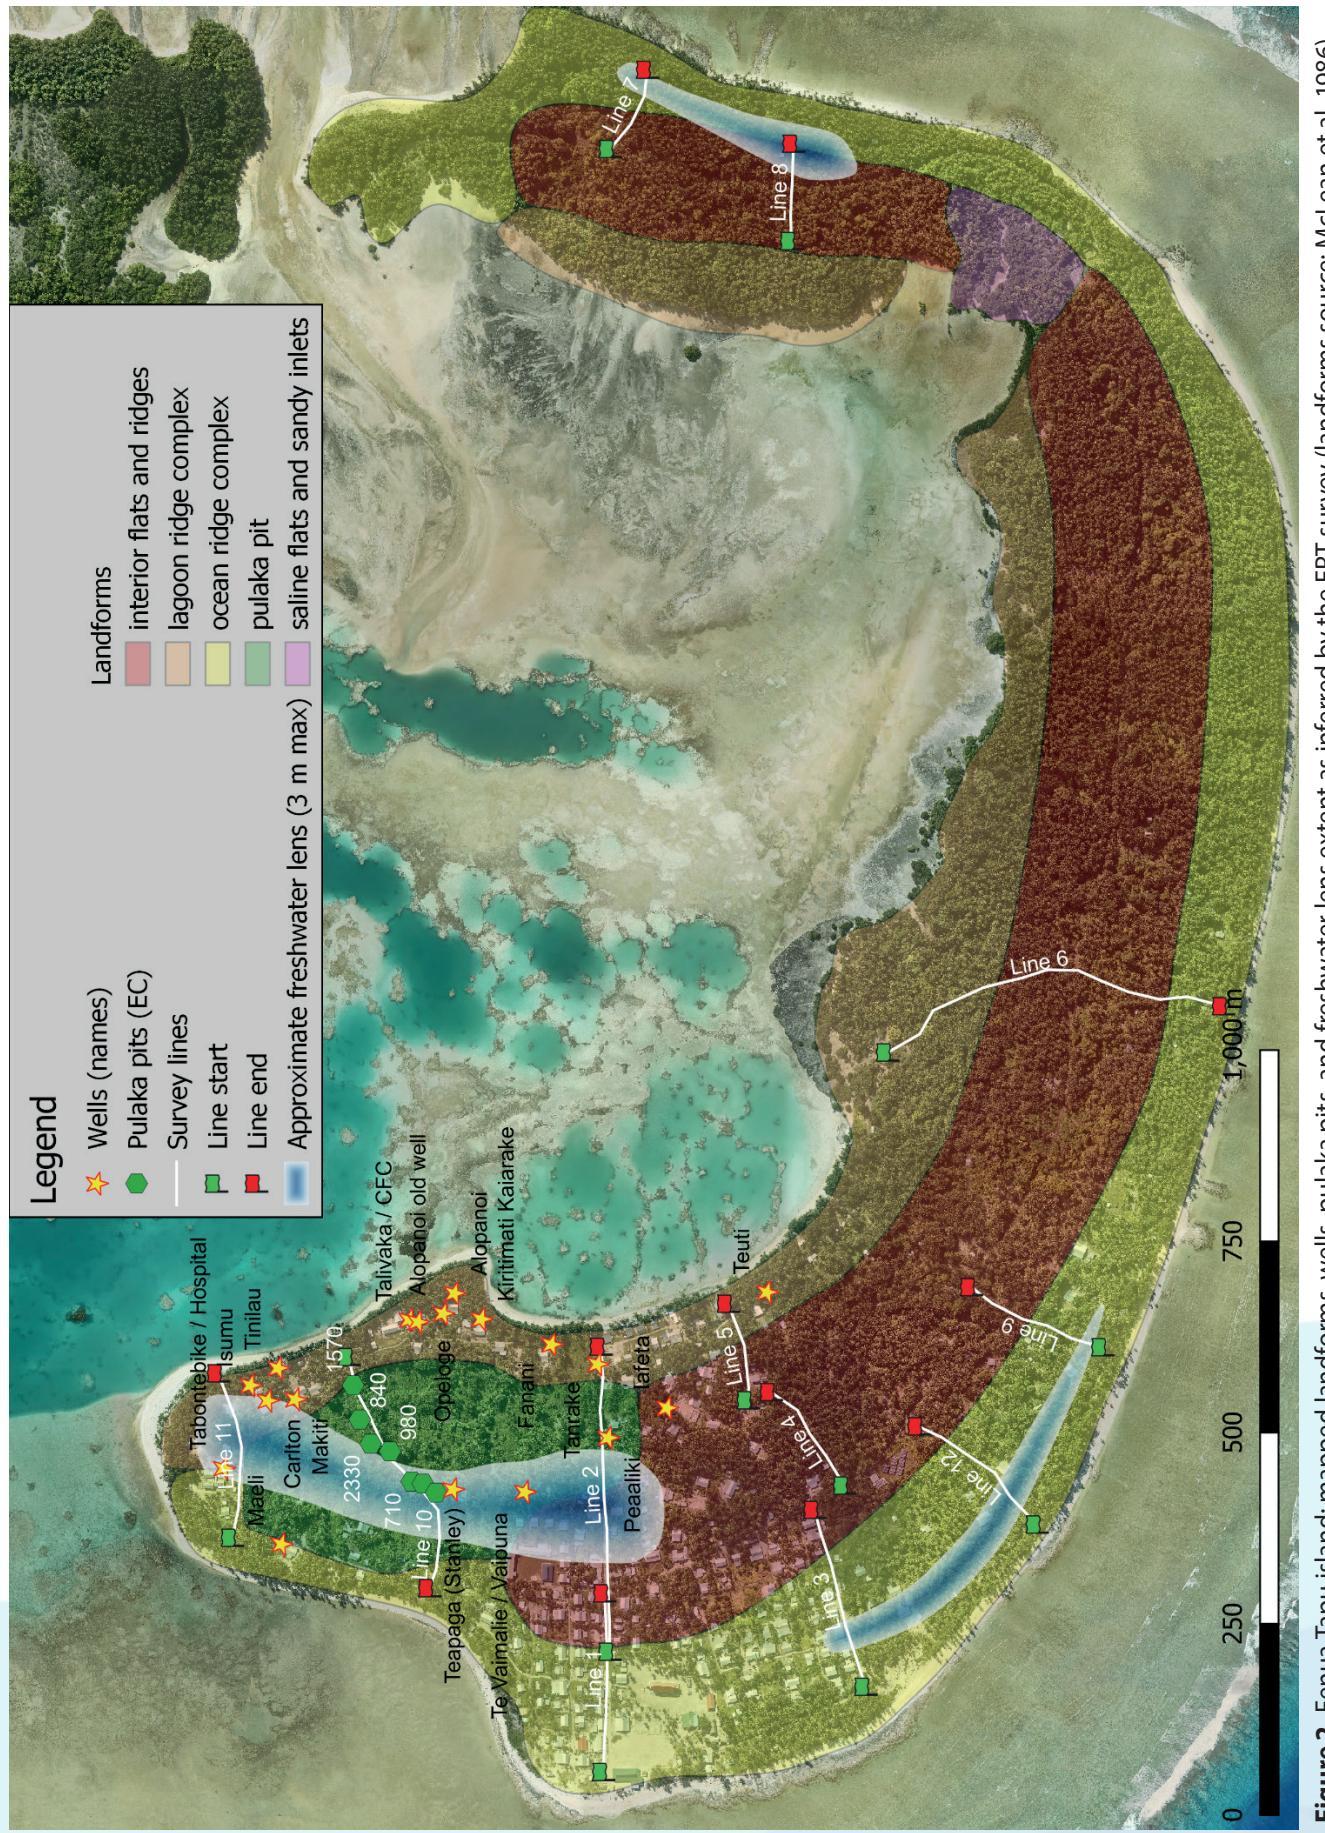
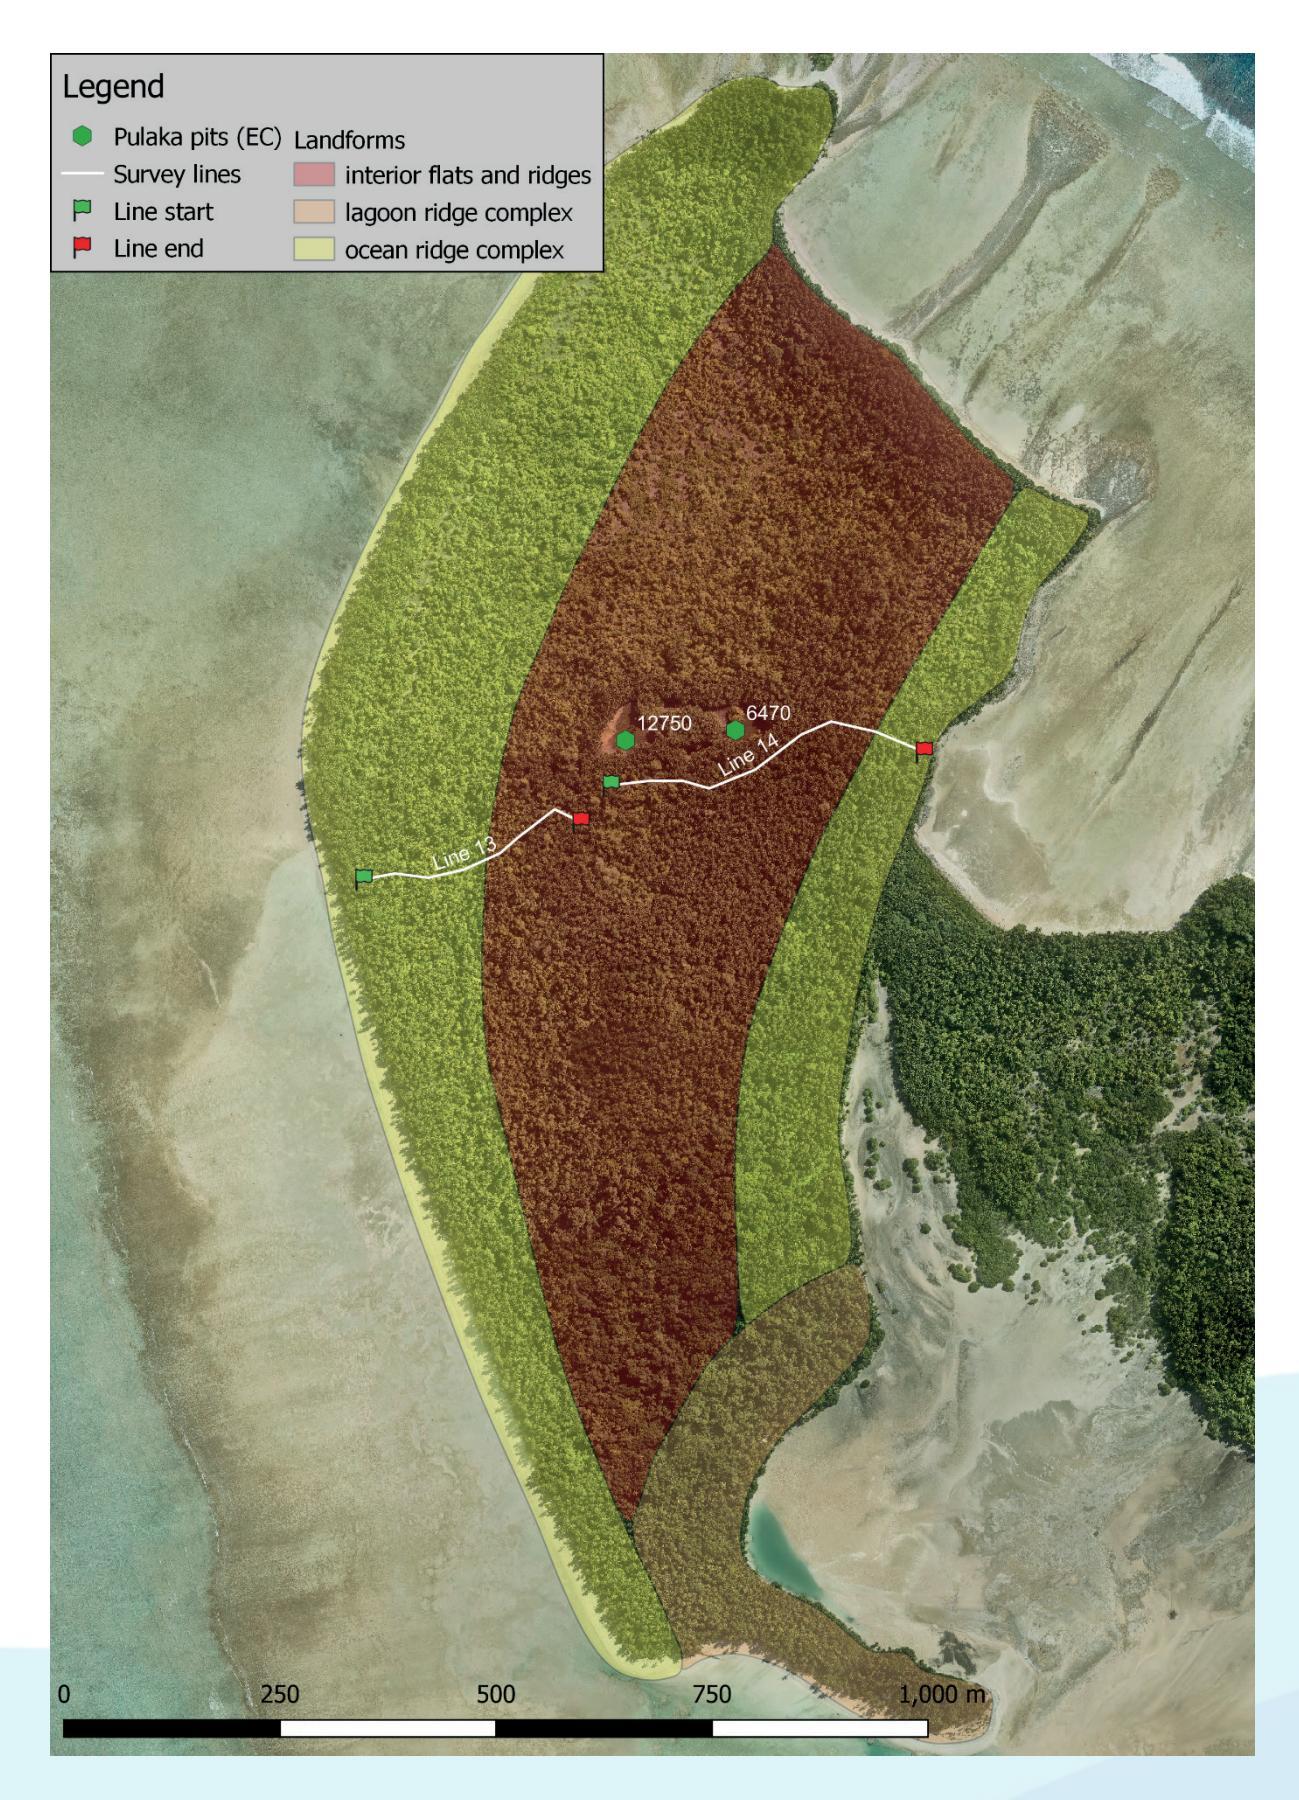
Figure 3. Meang island: mapped landforms, wells, pulaka pits, and ERT survey lines (landforms source: McLean et al, 1986).

Overall, the ERT lines conducted suggest the presence of a thin freshwater lens in the sandy beach deposits (Figure 2). One main fresh groundwater body and two secondary ones were identified on Fenua Tapu. The main groundwater body extends from the northern tip of western Fenua Tapu through to the pulaka pit area and into the village. Several shallow wells, including the Tabontebike (Hospital) well, Teapaga, and Te Vaimalie and existing pulaka pits tap this groundwater body. The thickness of the freshwater lens does not exceed 2 - 3 m. A secondary groundwater body of similar thickness (2 - 3 m) was identified in the eastern side of Fenua Tapu within the ocean ridge complex along survey lines 7 and 8 (Figure 2). No shallow wells seem to exist in this area. A third narrow fresh groundwater body potentially exists within the ocean ridge complex extending across survey line 12.

In Meang, the two survey lines conducted (13 and 14) from west to east along the central part of the island, suggest the presence of a very thin lens (1 - 2 m) primarily present in the central part where the old pulaka pits were dug (Figure 3). The limited extent of this groundwater body does not present any opportunities for further development.
