Annex A - Detailed information on PV sites

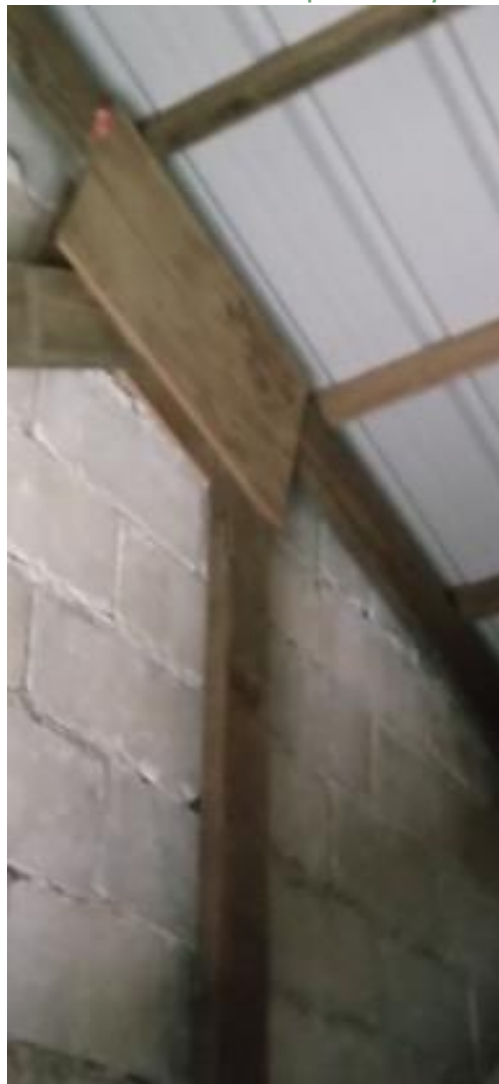
Figure 13. Roof structure details of the Sapota 2-storey elementary school 2

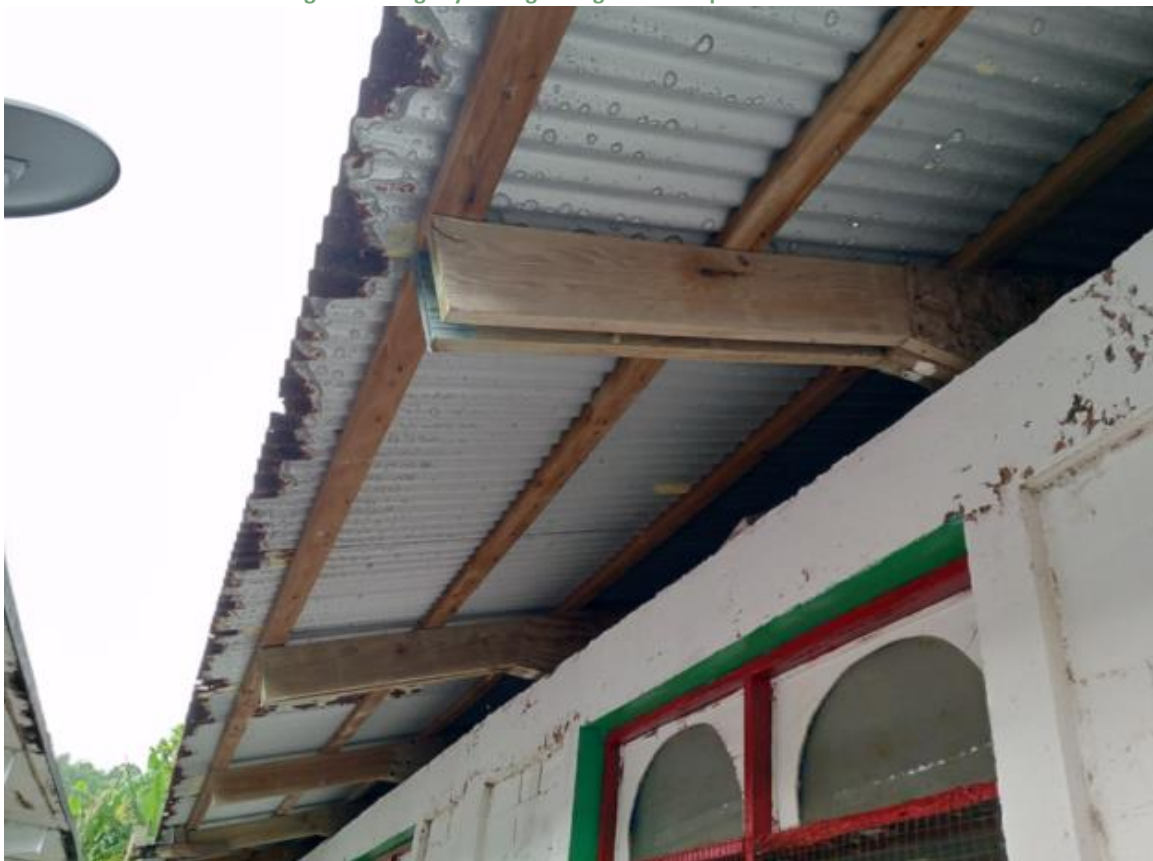
Figure 31. Edge of the Sapota church

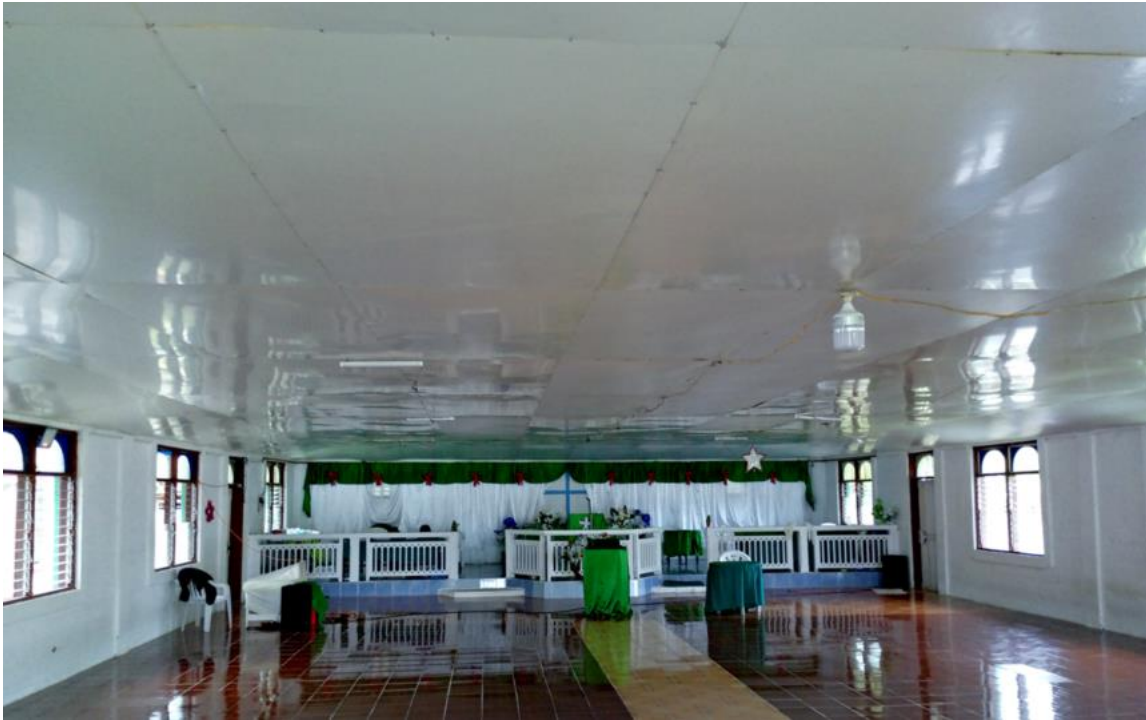
Figure 32. Inside the Sapota church

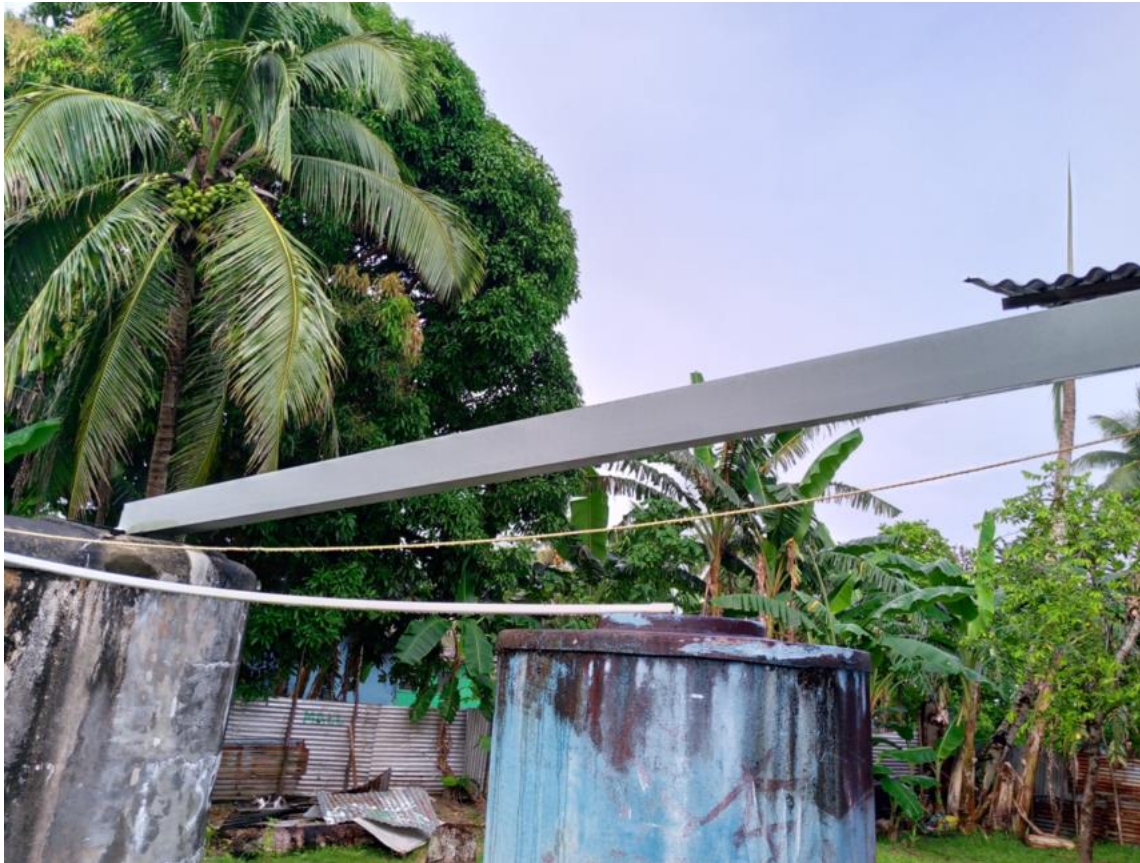
Figure 34. Current water collection

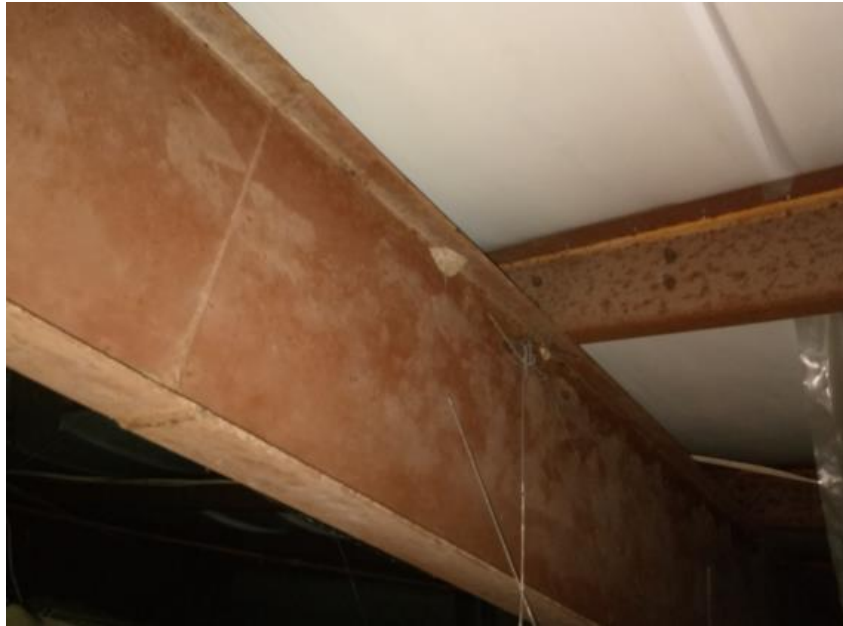
Figure 49. Junction main trusses-purlins of Fein new church

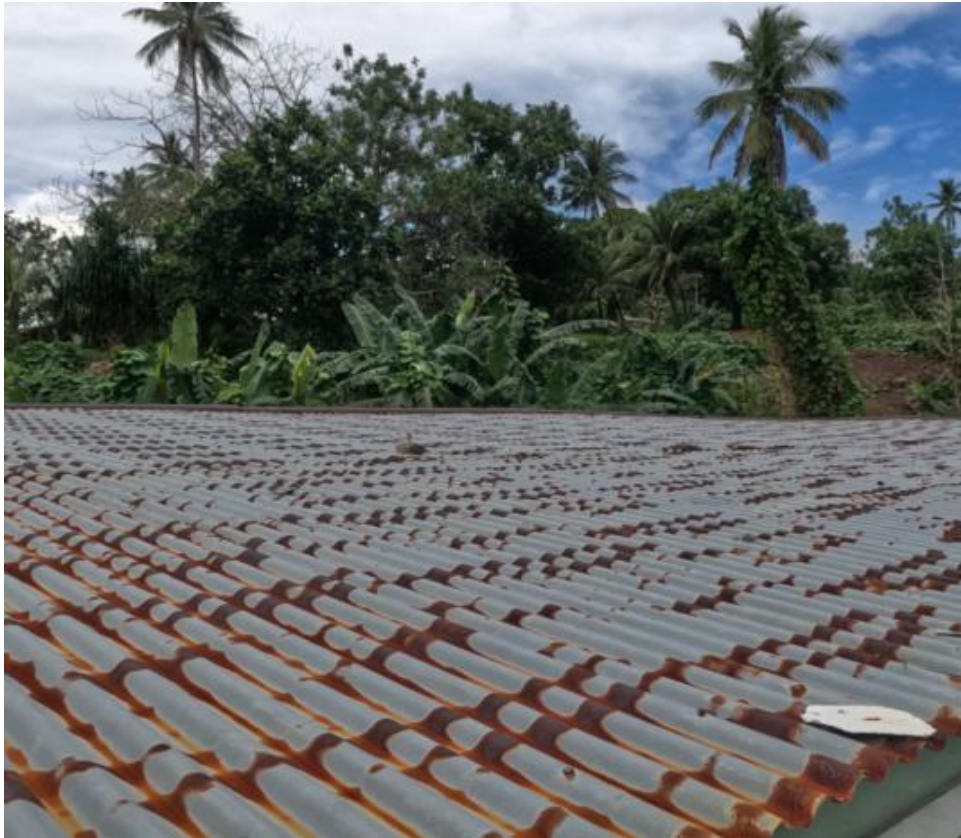
Figure 71. Mesa elementary school roof

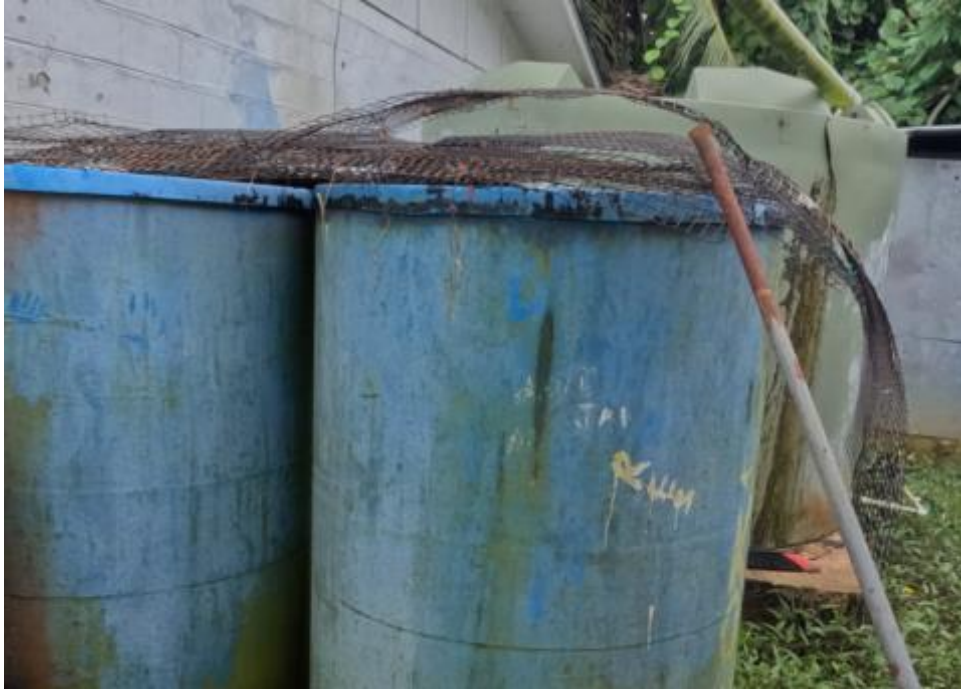
Figure 76. Water collection of the Mesa elementary school

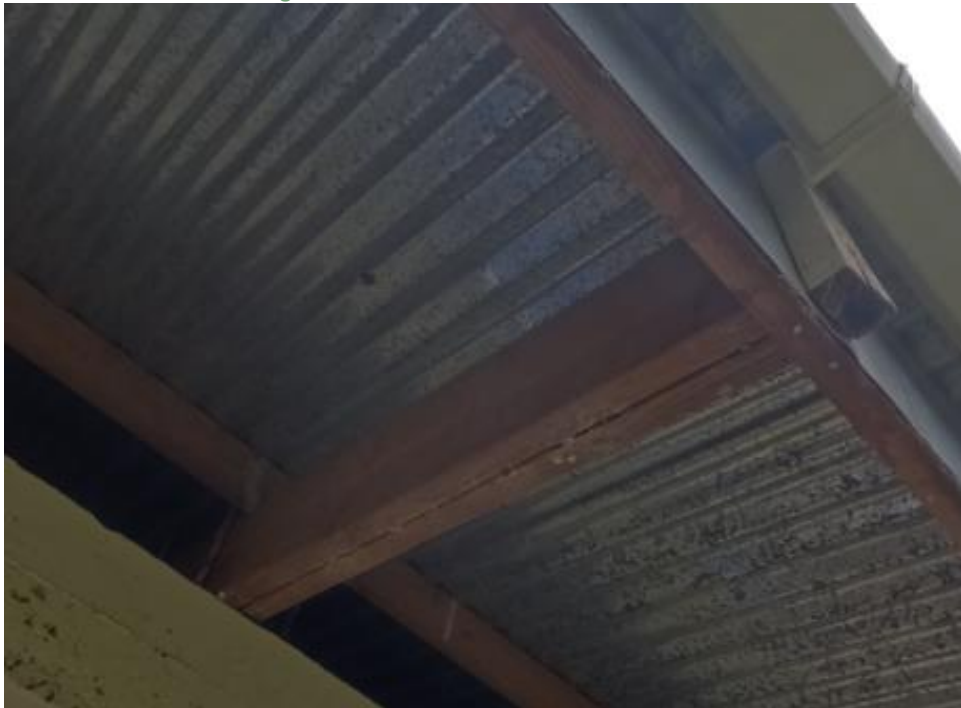
Figure 94. Mesa church overhang

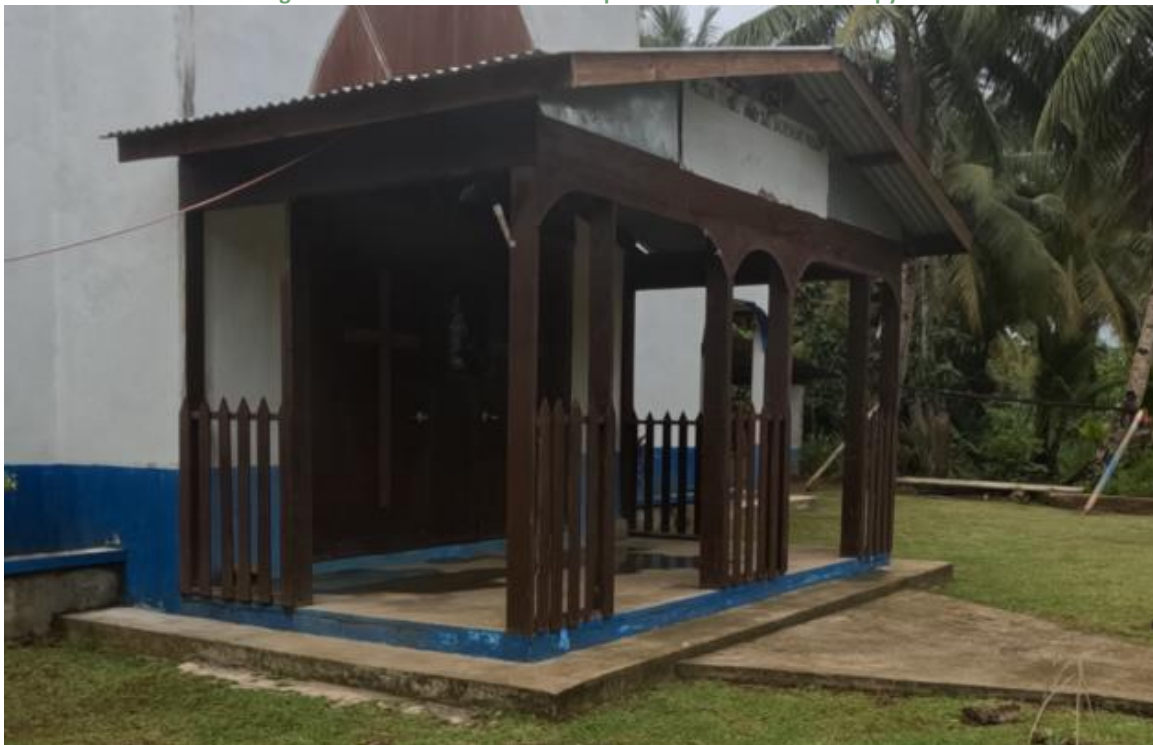
Figure 104. Mesa church entrance
